CALUMET WATER RECLAMATION PLANT Investigation of Explosion and Structural Collapse in Gravity Belt Thickener Room

Final Report

November 16, 2018

Metropolitan Water Reclamation District of Greater Chicago

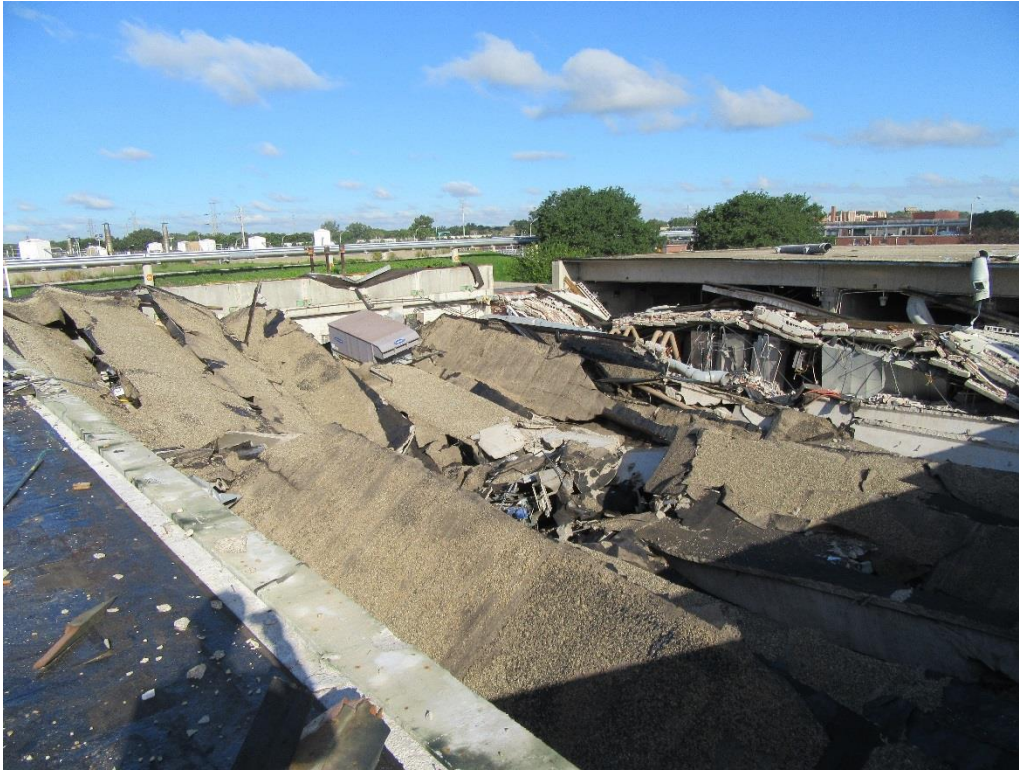
On August 30, 2018, at approximately 11:00 a.m., an explosion occurred in the GBT Room. The explosion severely damaged the floor structure and the roof structure in the GBT Room. Figure 1 shows an overall view of the collapsed structure. MWRD reported that ten workers were injured during the event. The details and the extent of the injuries were not reported to us.

Figure 1. Overall view of collapsed structure at GBT Room looking east

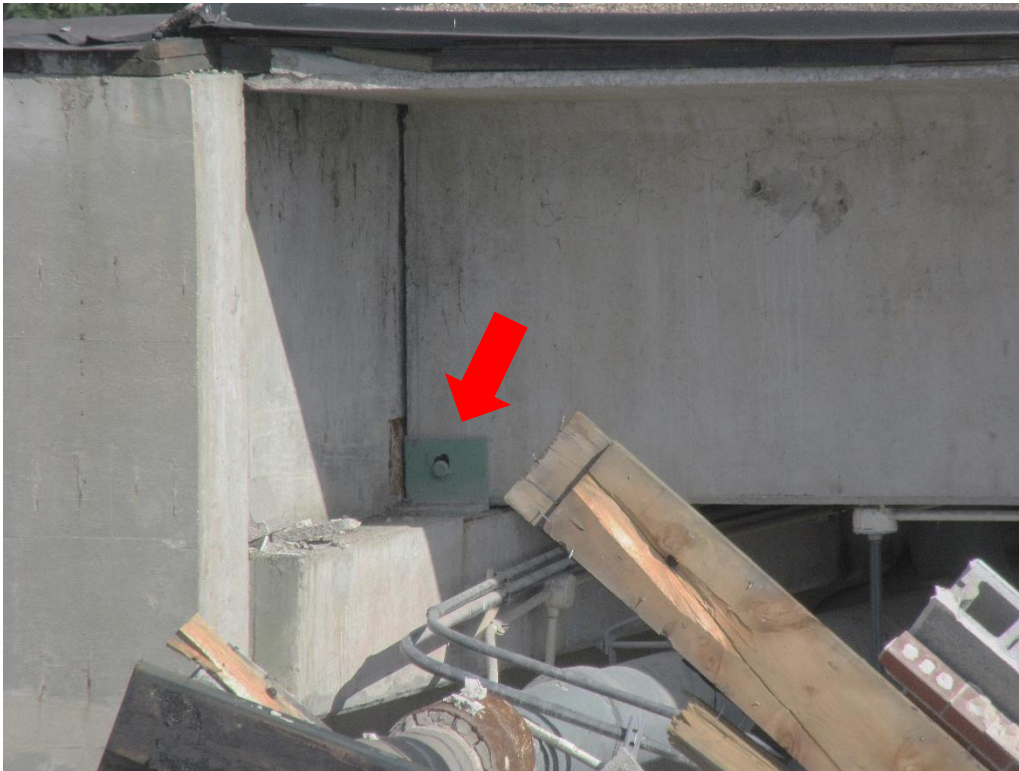
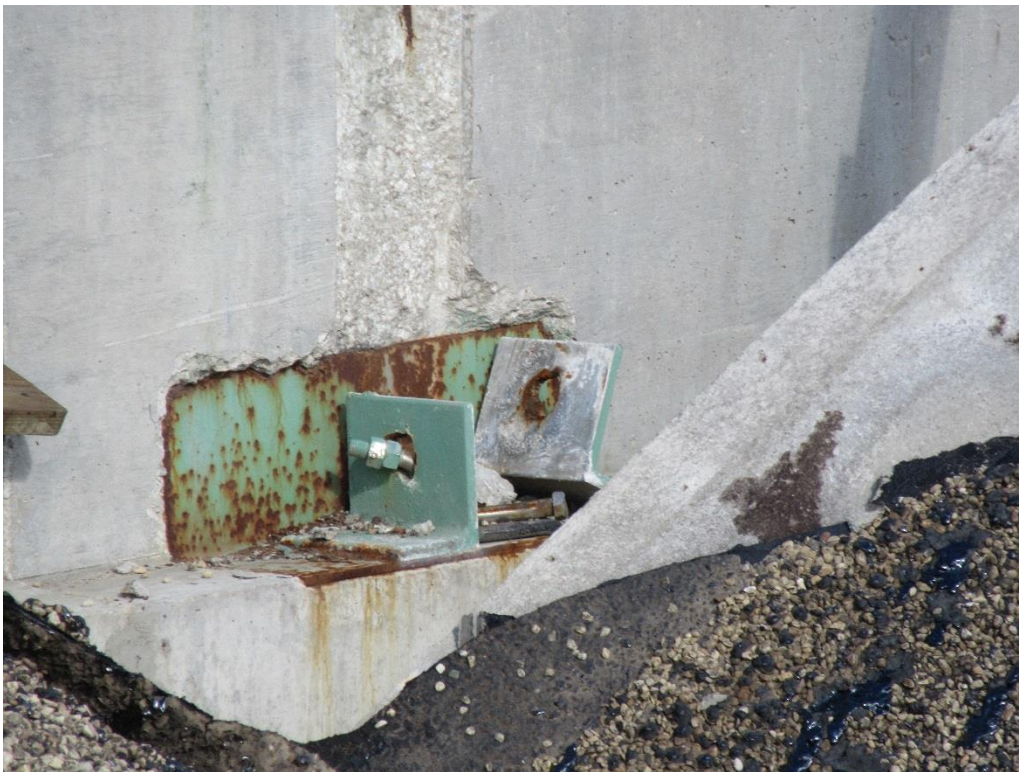
5. At the west exterior wall of the building, the six single tee beams at the north end of the GBT Room (Roof Beams 1 through 6) had come off of their support at the west wall. Since the stem of each roof beam was bolted to the double angle at the west wall support, this resulted in the bottom portion of the beam stems breaking at the support connection. The west end of Roof Beams 1 through 4 had fallen onto the GBT Room floor slab. Roof Beams 5 and 6 landed on the rolling overhead door, which had been in the open condition at the time of the explosion (see Figure 13). The southern two roof beams were still attached to their bolted connection at the west wall support. The interior end of the west roof beams had landed on the collapsed floor slab, which was then at a significantly lower elevation than the top of the wall separating the east tank from the center tank.

a) Undamaged connection for single tee roof beam over Sludge Screen/Polymer Rooms

b) Damaged connection at failed single tee over GBT Room

Figure 7. Single tee roof beam bolted connection at west wall

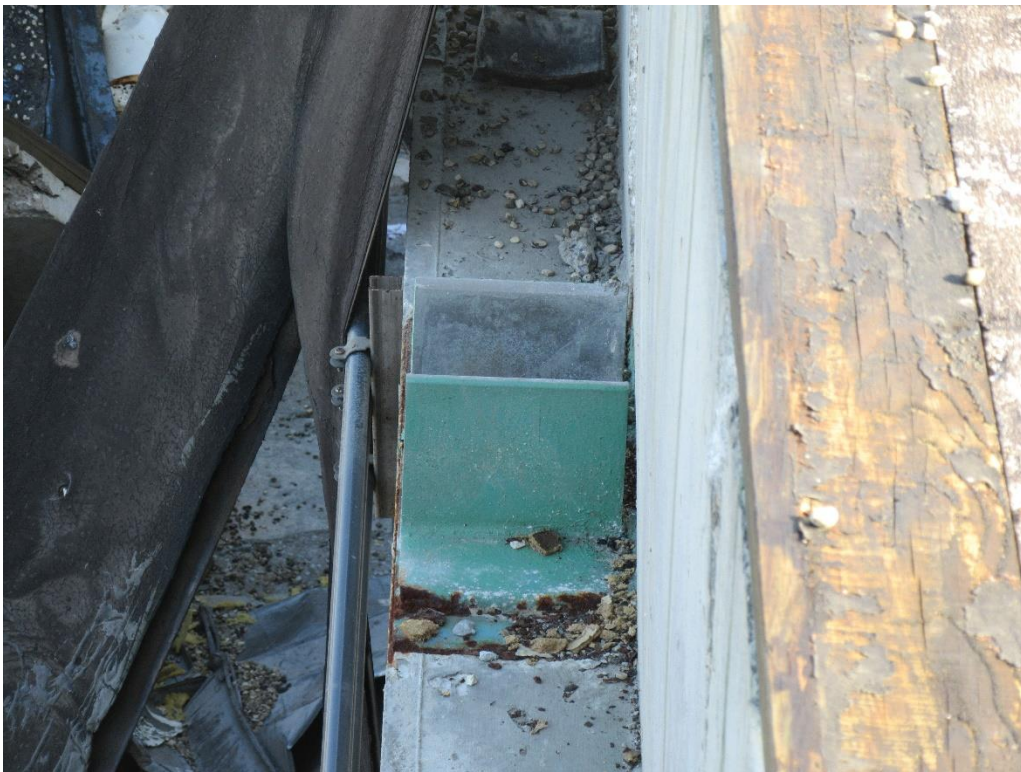
Figure 8. Single tee roof beam bearing location at east wall of GBT Room

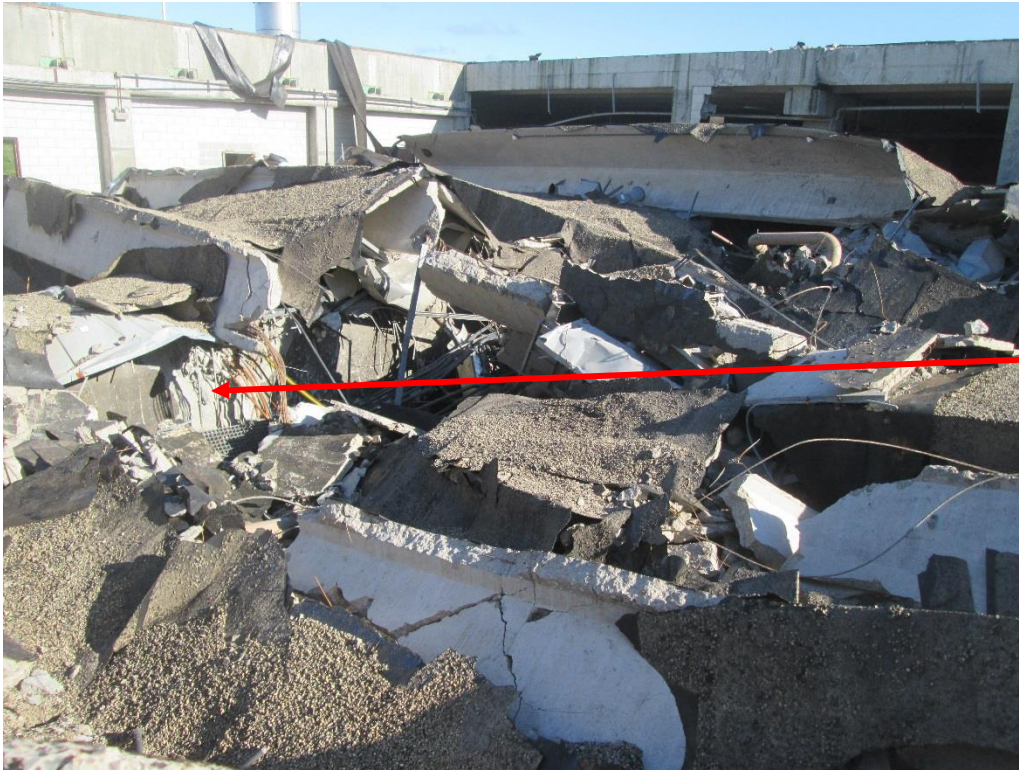
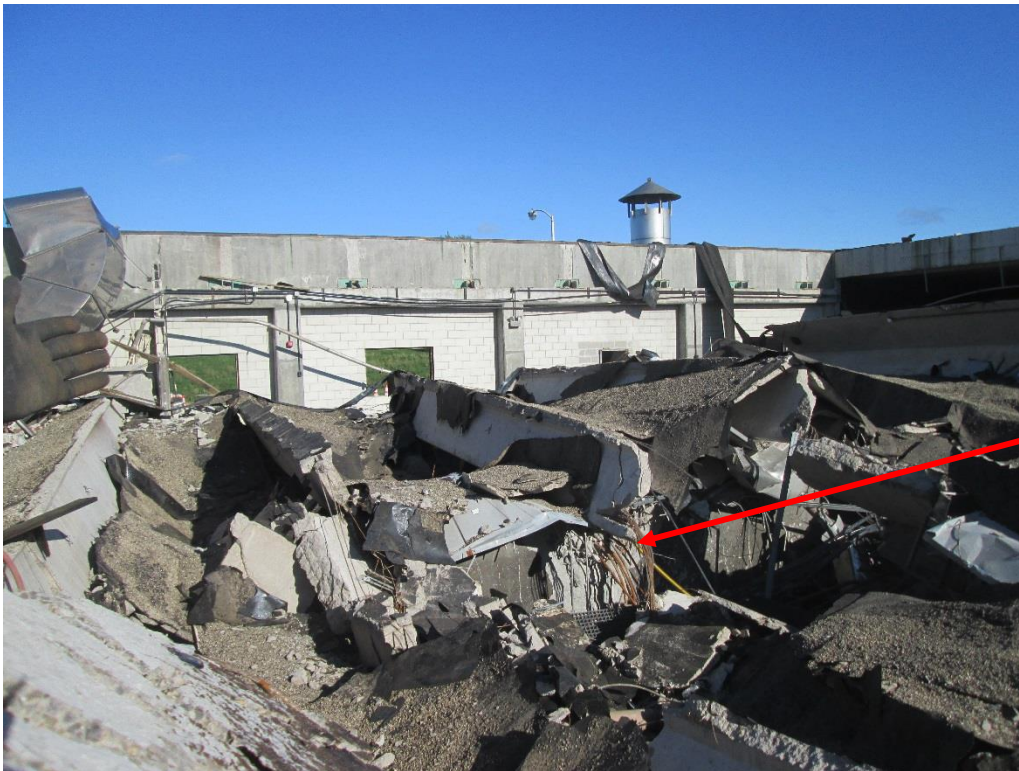
3. Each of the collapsed single tee roof beams broke into three sections; 1) a continuous section of the beam stem at the east end with lengths ranging from approximately 32 to 48 feet (see Figure 9); 2) a continuous section of the beam stem at the west end with lengths ranging from approximately 45 to 53 feet (see Figure 10); 3) and a center section where the beam stem was broken into numerous pieces that were mostly separated from the prestressing tendons (see Figure 11).

Figure 9. Continuous section of collapsed single tee roof beams at east end

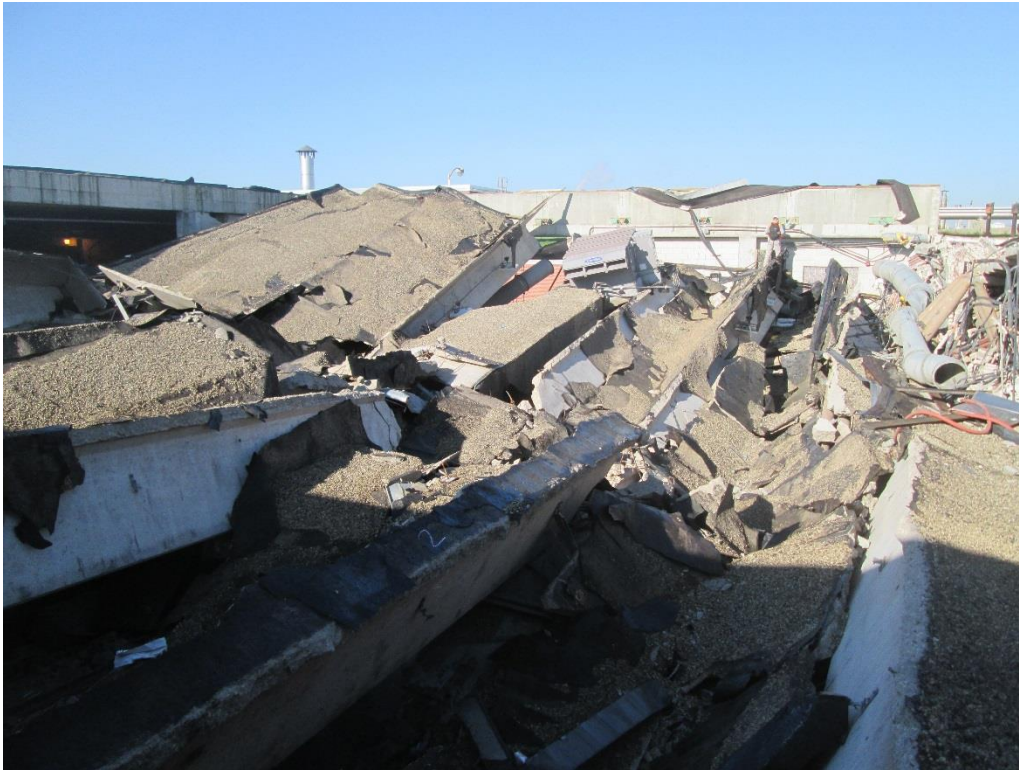
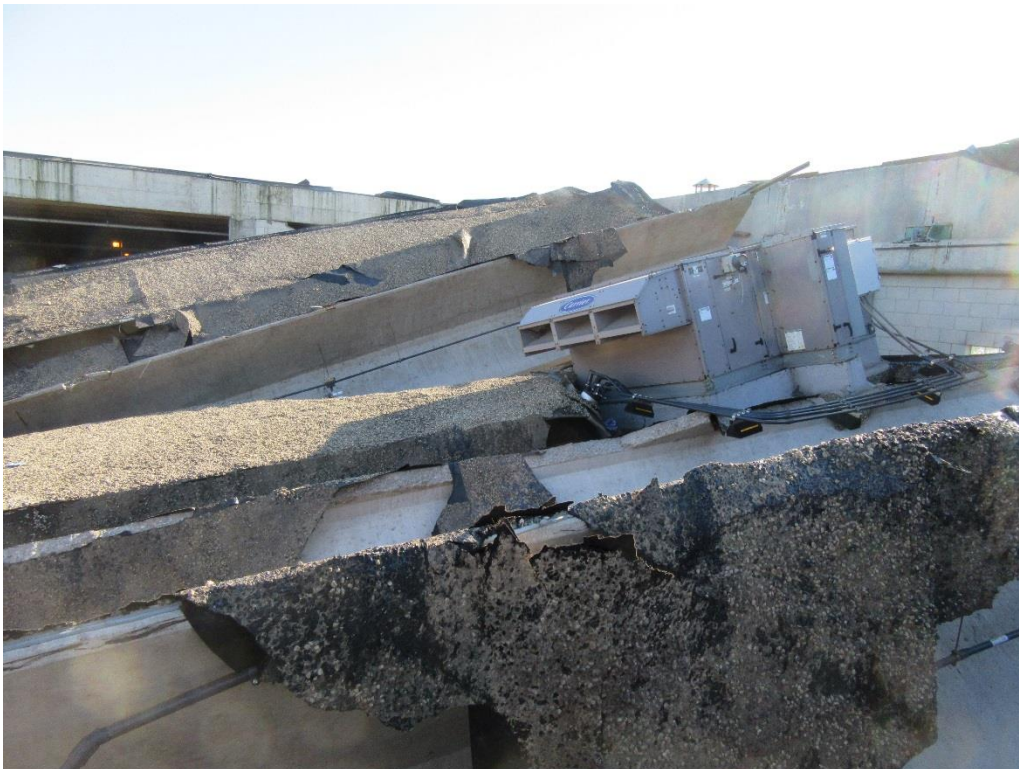
Figure 10. Continuous section of collapsed single tee roof beams at west end

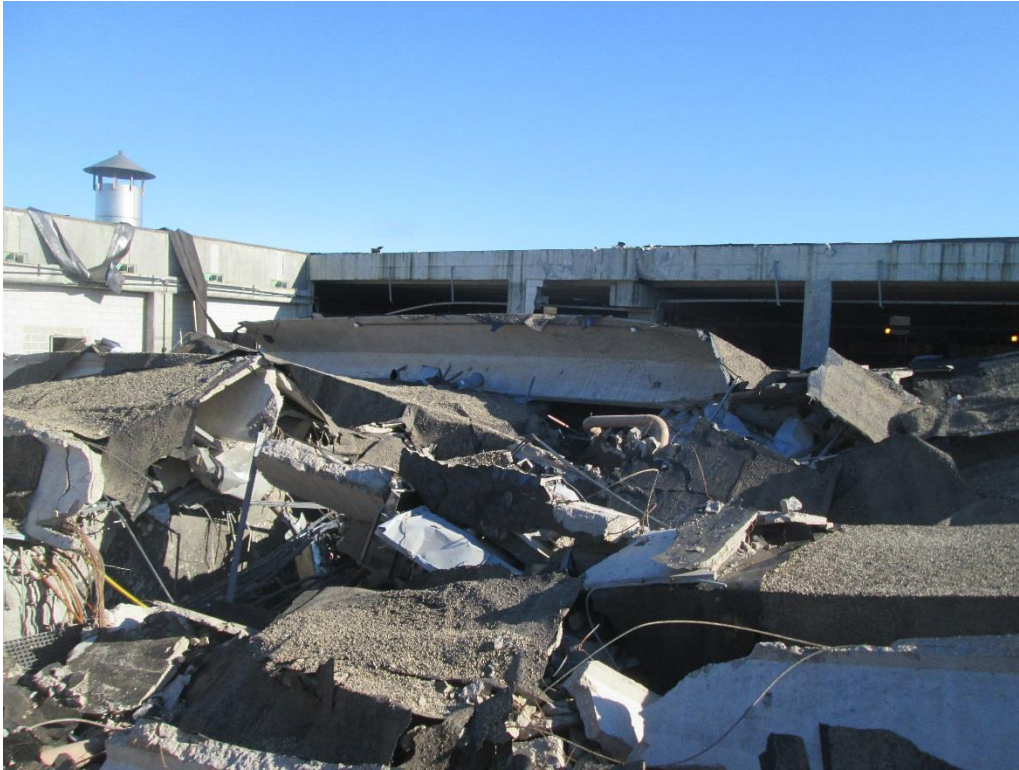
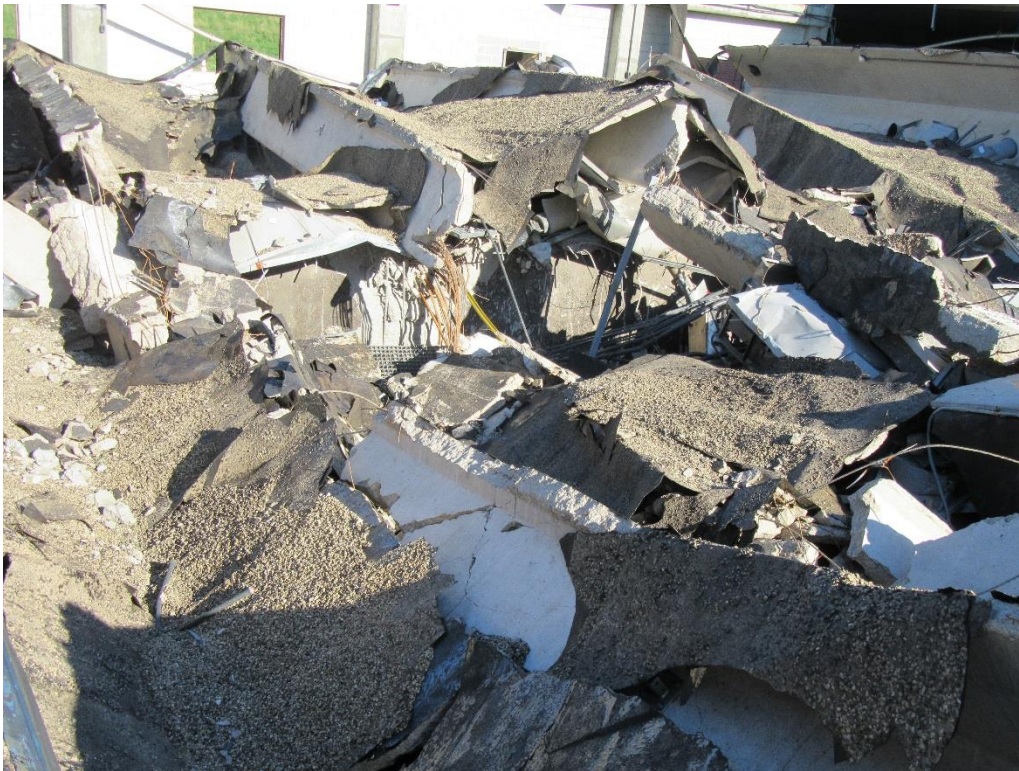
Figure 11. Center section of collapsed single tee roof beams broken in numerous small sections

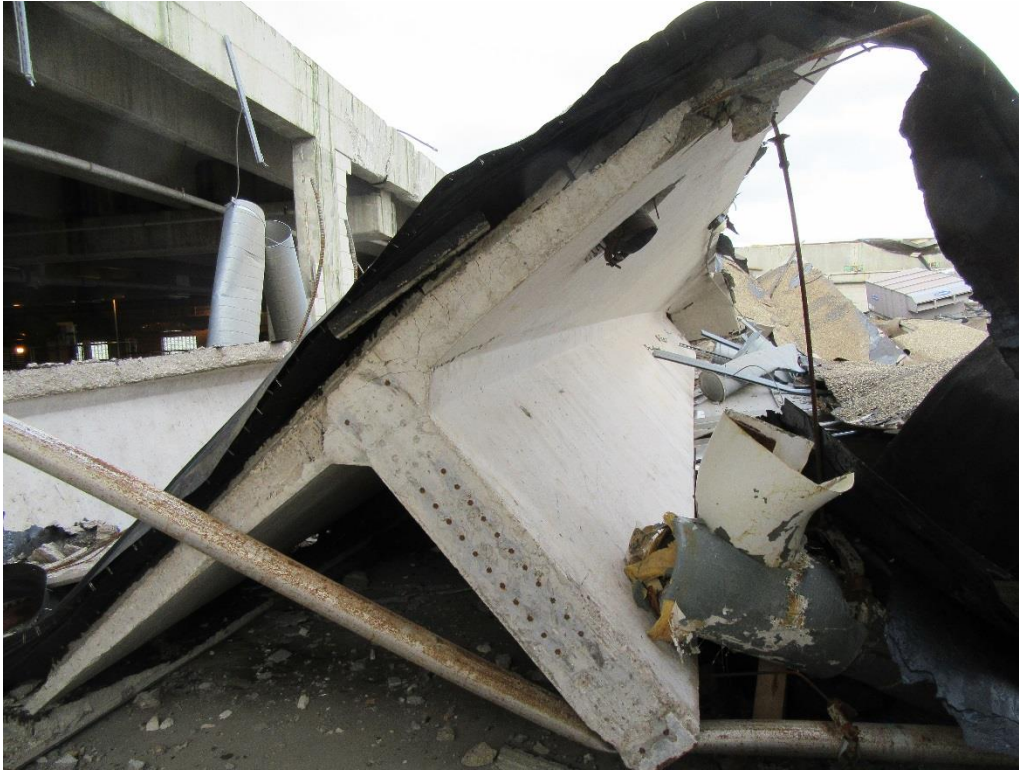
Figure 12. East end of single tee roof beam fallen from bearing on east wall

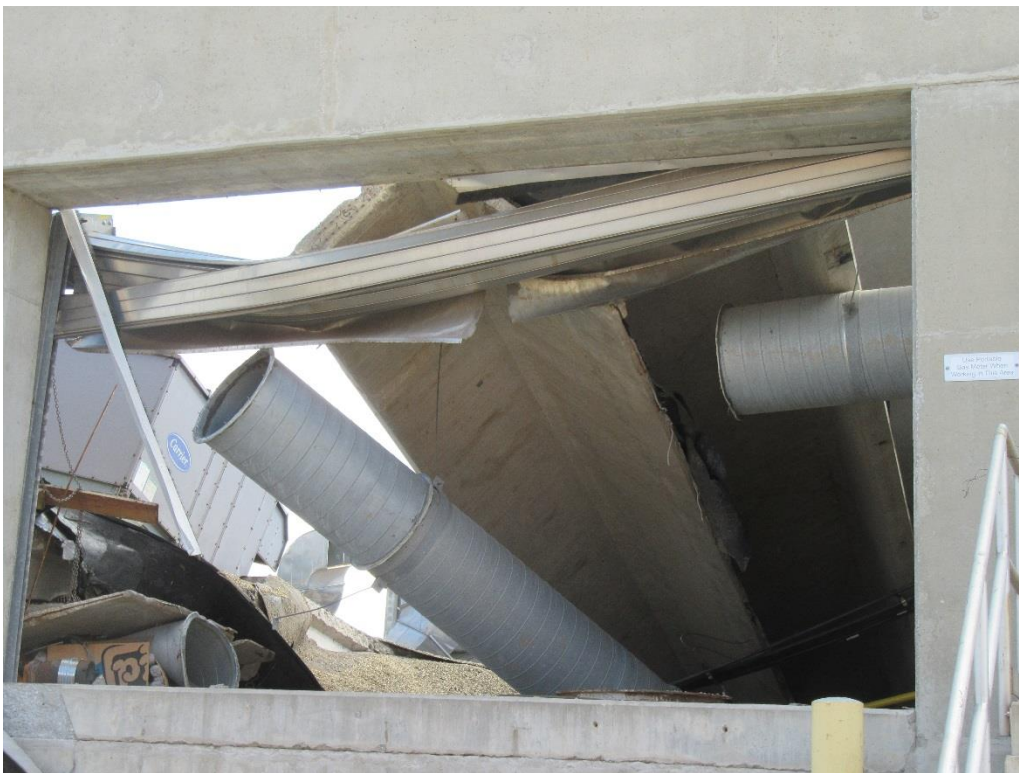
Figure 13. West end of collapsed single tee Roof Beam 5 and 6 supported on rolling overhead door

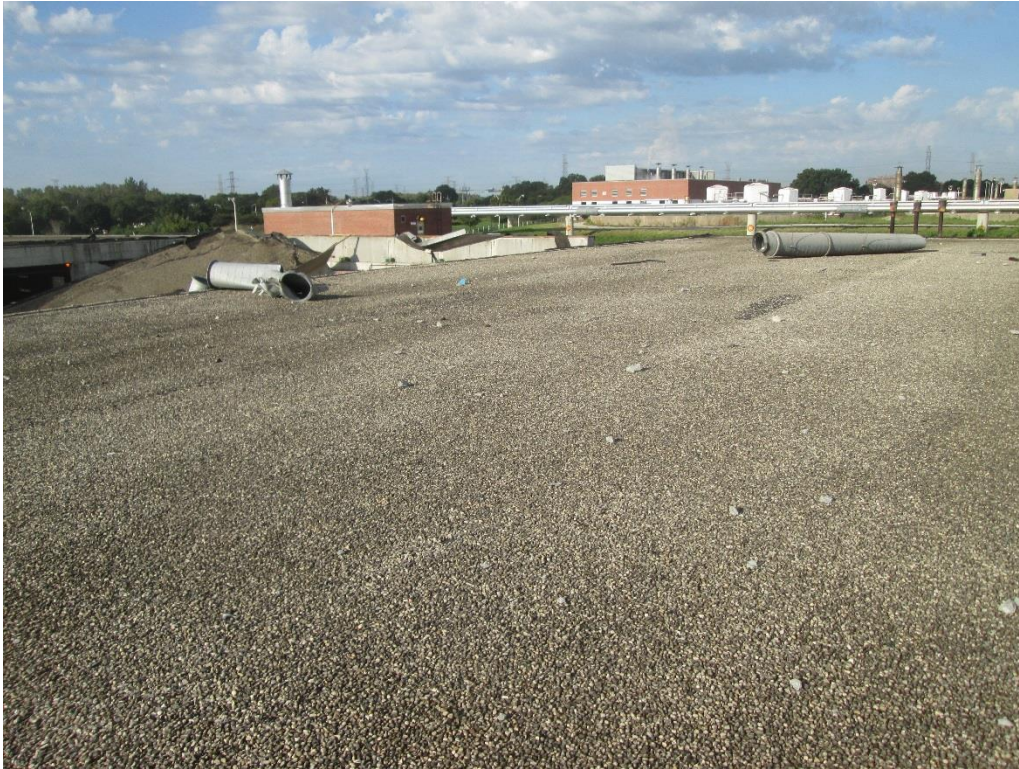
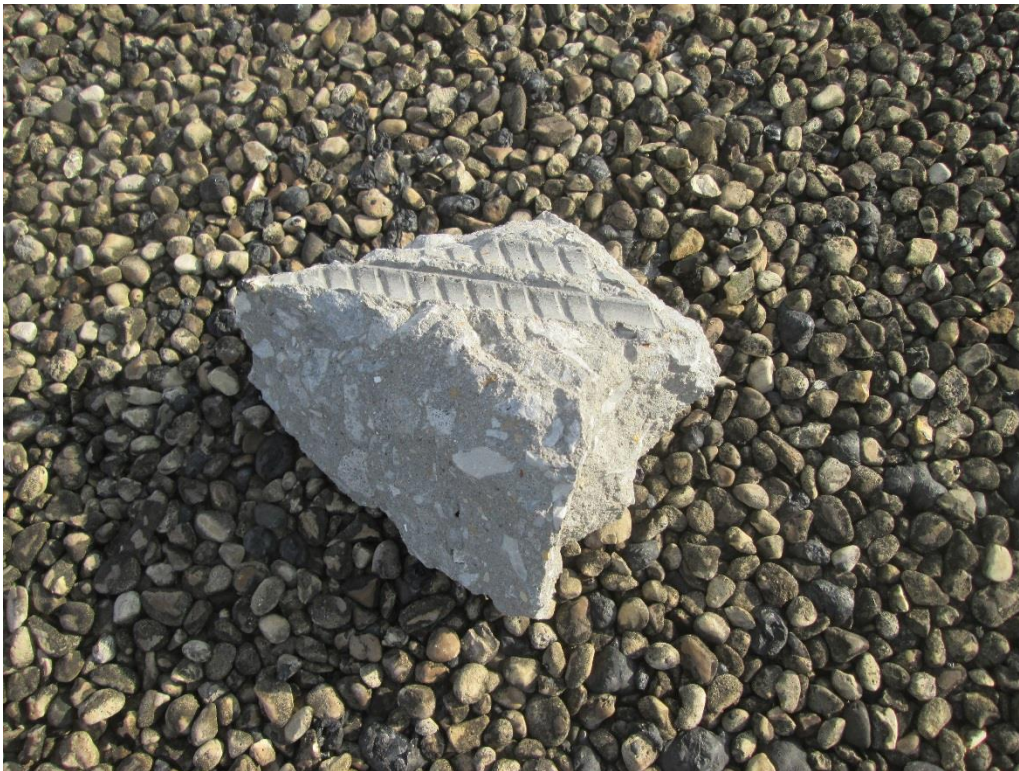
7. Small (maximum dimension of approximately 3 to 6 inches) pieces of crushed concrete was observed on the roof of the Sludge Screen/Polymer roof to the north of the GBT Room roof (see Figure 14). Based on the observed aggregates in this concrete debris, it appeared that the debris was part of the failed floor slab, which consisted of limestone aggregate, and not from the failed prestressed precast single tee roof beams, which were constructed with 3/8 inch lightweight aggregate.

Figure 14. GBT Room floor slab debris observed on roof of Sludge Screen/Polymer Room

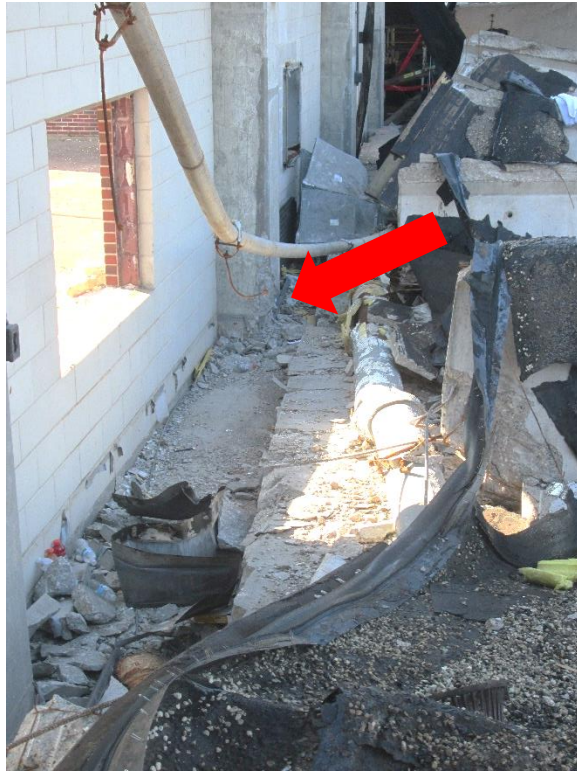
The east and west exterior walls of the GBT Room were in generally good condition. The cast-in-place reinforced concrete frame and the brick masonry and concrete masonry infill at both walls were found to be plumb. Also, there was no damage observed at the brick and concrete masonry walls. We were told that the glass block windows at the east wall were broken by the Chicago Fire Department during rescue operations. There was no damage observed at the glass block windows in the west wall. Damage was observed at the top of the cast-in-place reinforced concrete frame at both the east and west walls where the single tee roof beams were supported. Also, damage to the bottom of the concrete frame columns was observed at the east wall. This damage to the bottom of the columns appeared to be due to the movement of the floor slab against and around the columns (see Figure 15).

Figure 15. Damage at base of concrete column at east wall

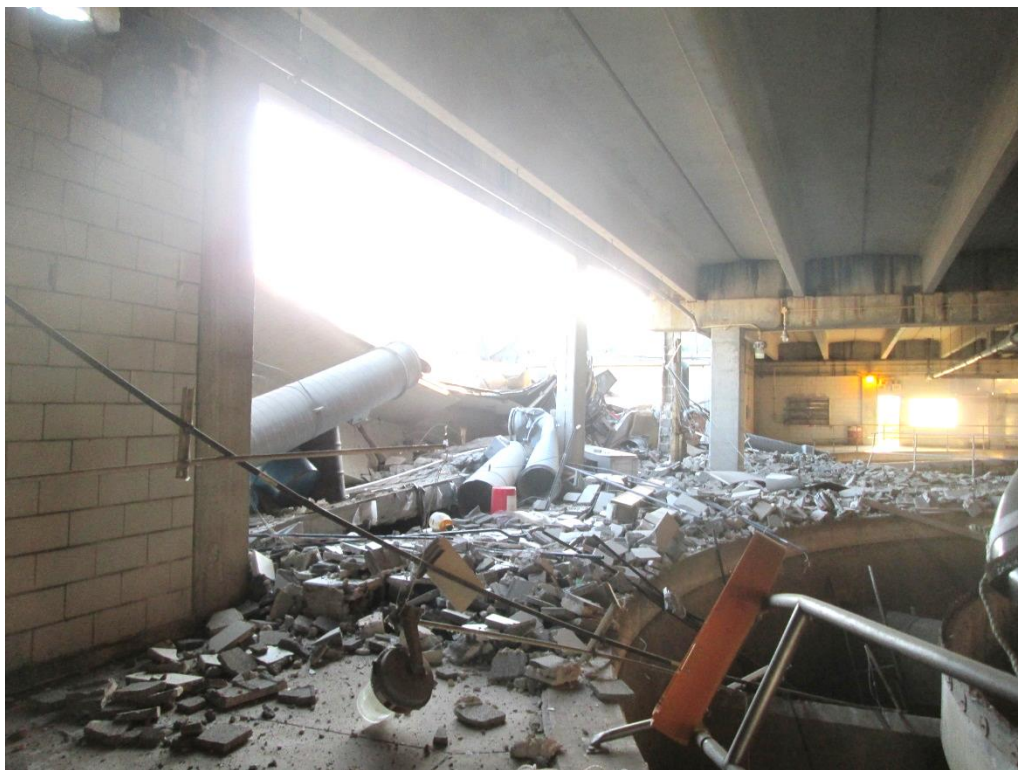
The south interior partition wall between the GBT Room and Gravity Concentration Tank area consisted of a reinforced cast-in-place concrete frame with glazed concrete masonry unit (CMU) infill walls. The reinforced concrete frame was significantly damaged at several locations. Approximately three-quarters of the south unreinforced concrete masonry infill wall that separated the GBT Room from the Gravity Concentration Tanks had completely collapsed. The debris from this wall was blown into and around the Gravity Concentration Tanks, which were empty and out of service at the time of the explosion (see Figure 16). The remaining quarter of this wall was damaged and leaning south toward the Gravity Concentration Tanks.

Figure 16. Collapsed concrete masonry wall separating GBT Room and gravity concentration tanks

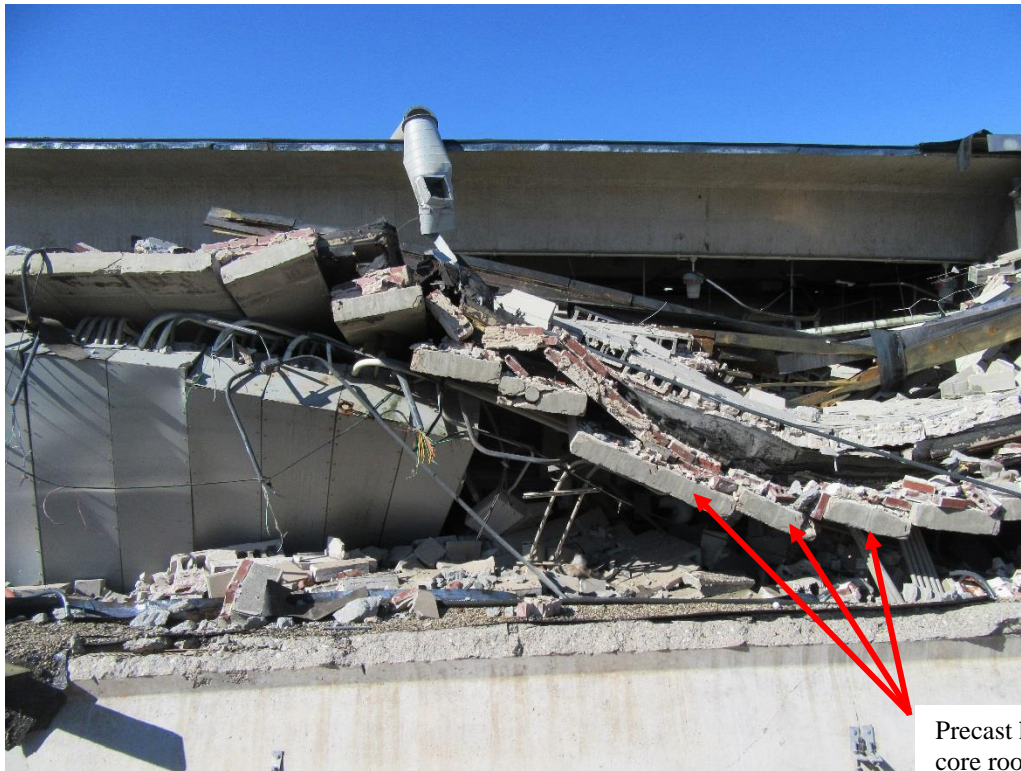
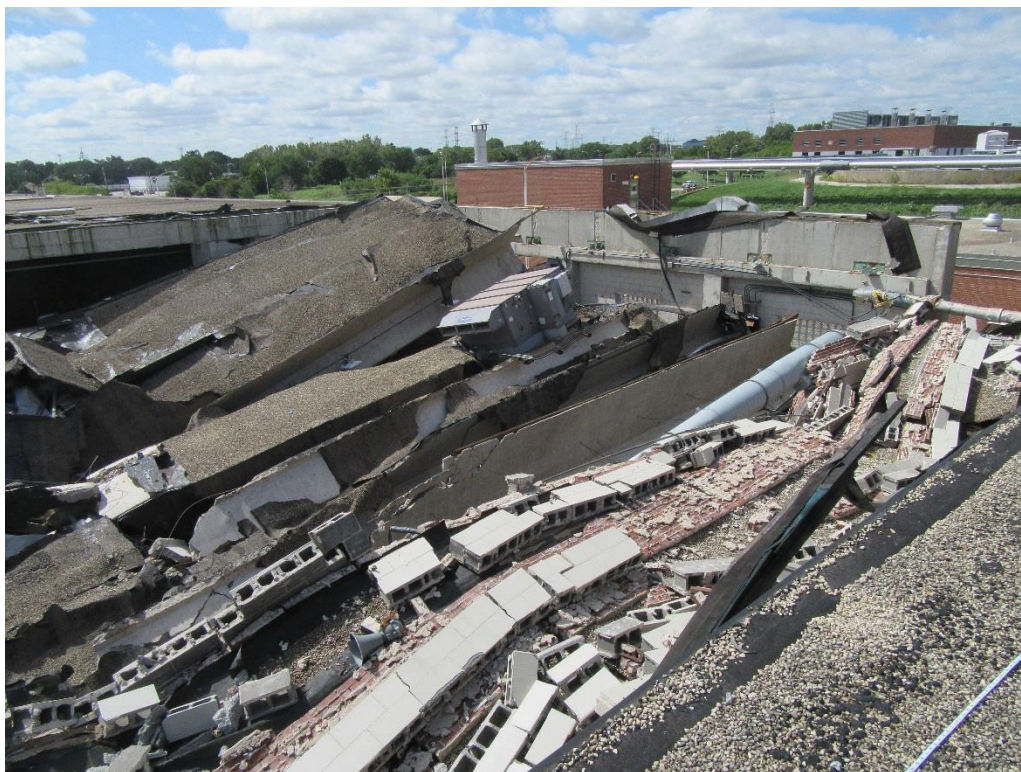
The unreinforced brick and concrete masonry walls on both the north and south sides of the Operating Gallery were severely damaged. These walls were both generally blown to the north with much of the debris landing within the Polymer Room and the Sludge Screen Room. With both of the Operating Gallery walls severely damaged, the precast prestressed hollow core roof planks had fallen onto the electrical and mechanical equipment in the Operating Gallery (see Figure 17).

Figure 17. Collapsed roof and masonry walls at Operations Gallery

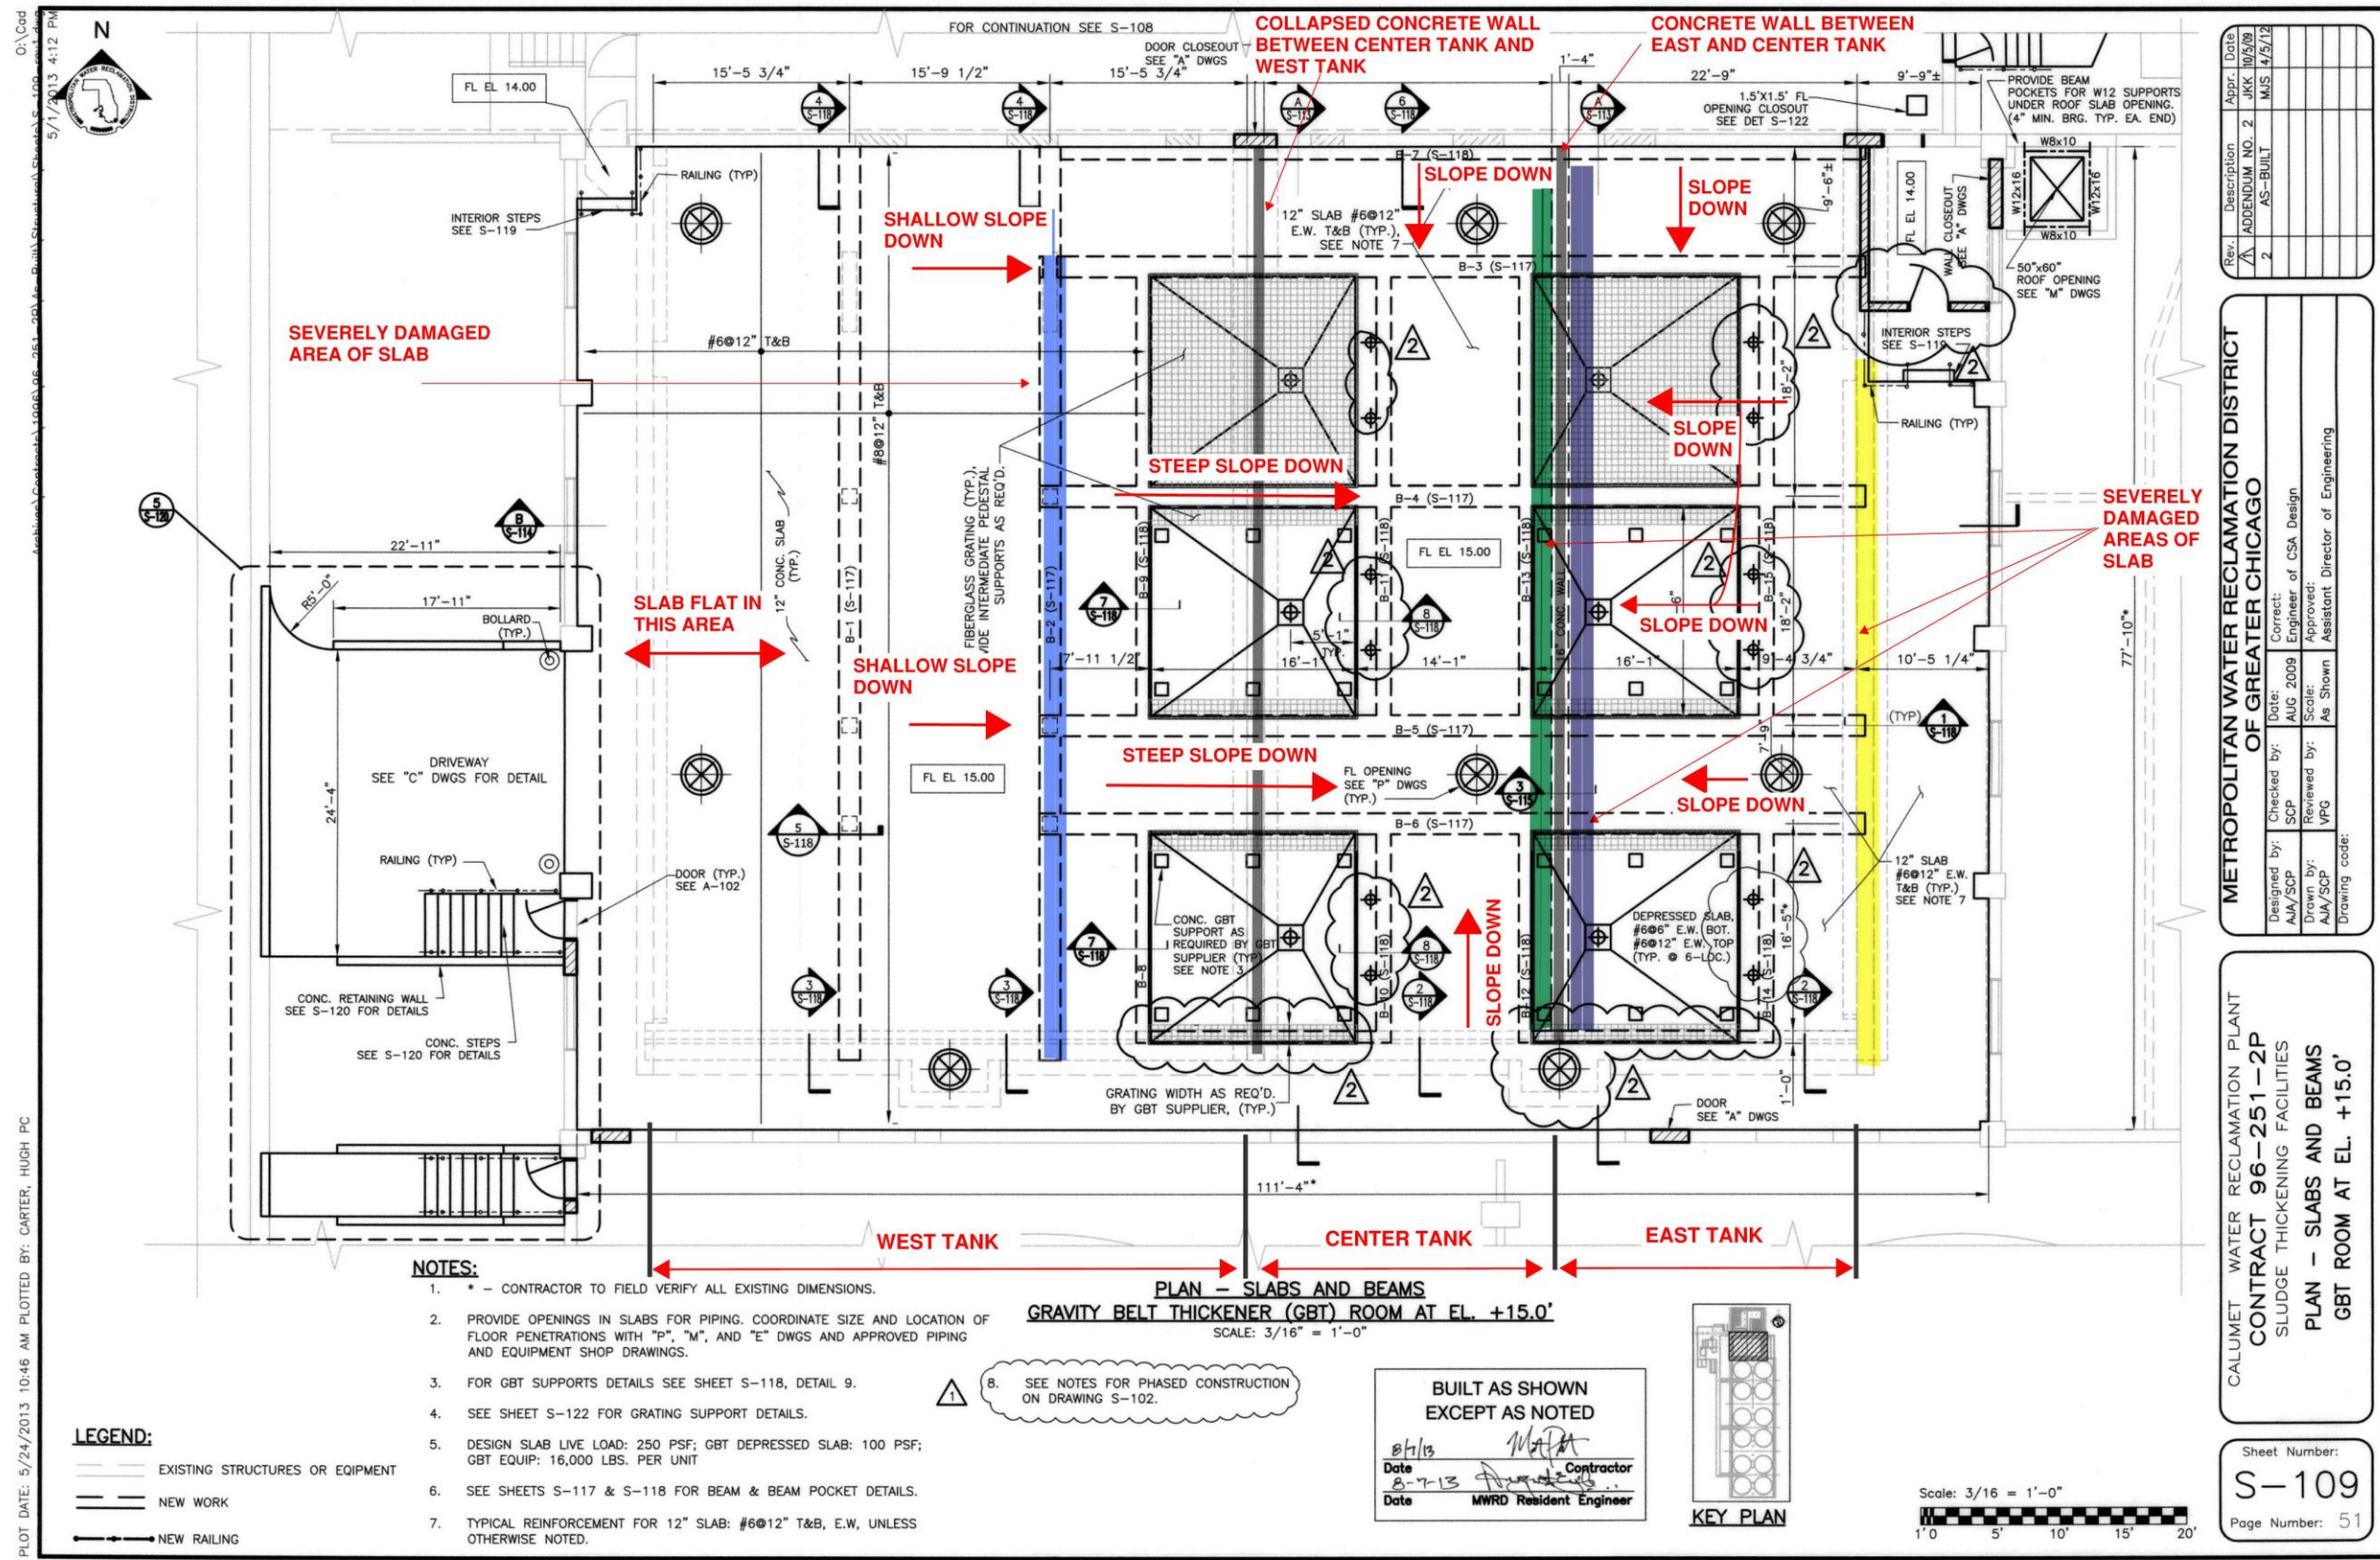
Figure 18. Annotated GBT Room floor plan showing location of observed distress at floor slab

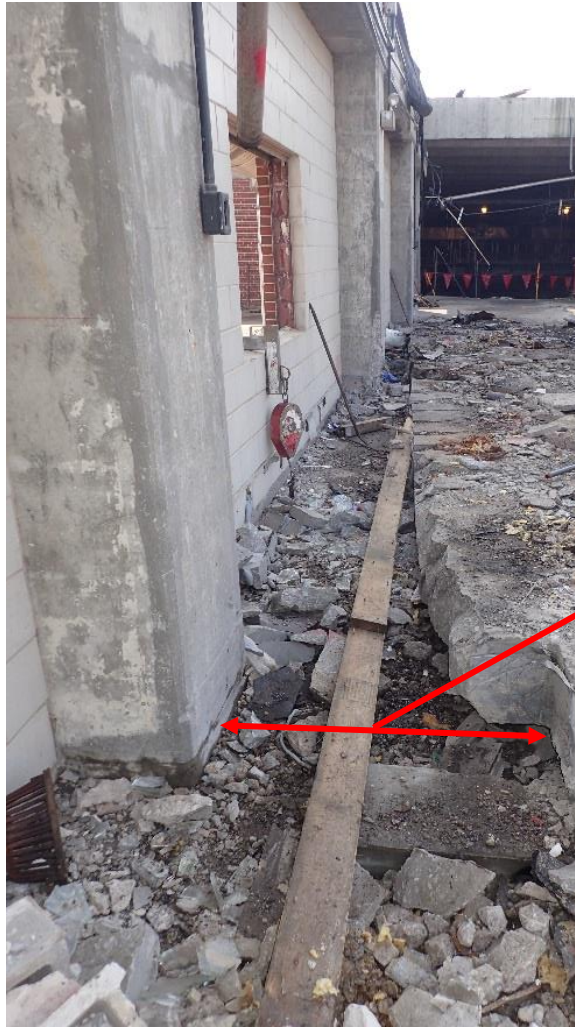
original building construction over the fill material between the east building wall foundation and the east below-grade tank wall. This slab movement is shown in Figure 19.

Figure 19. Floor slab movement at east wall, looking south

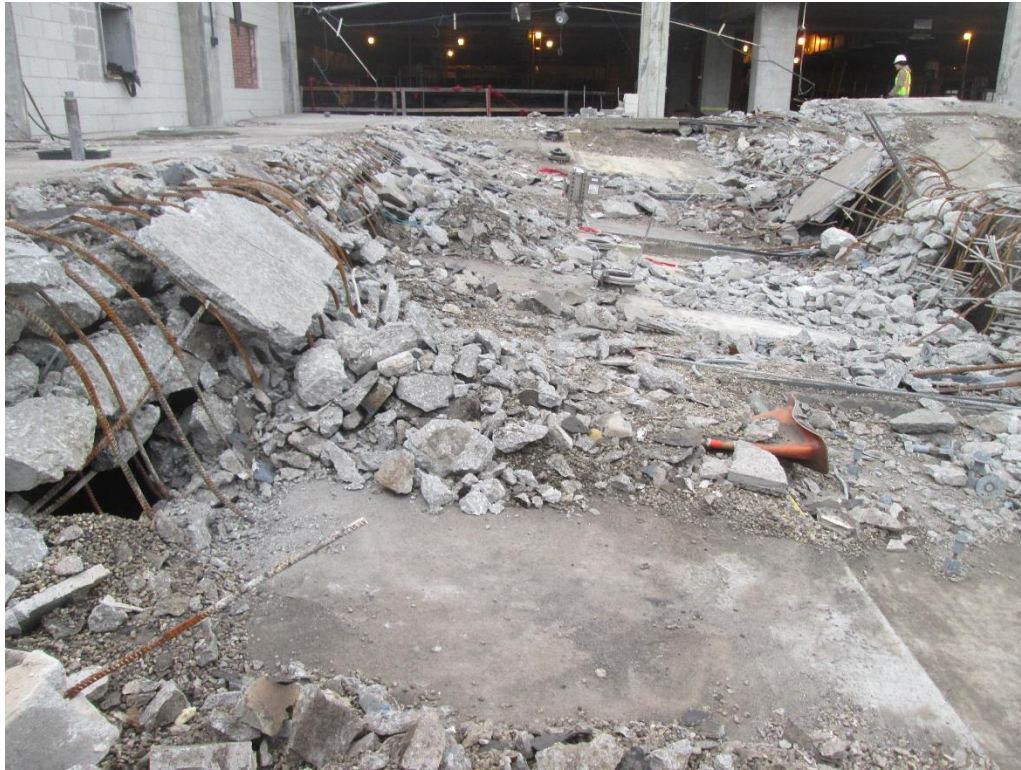
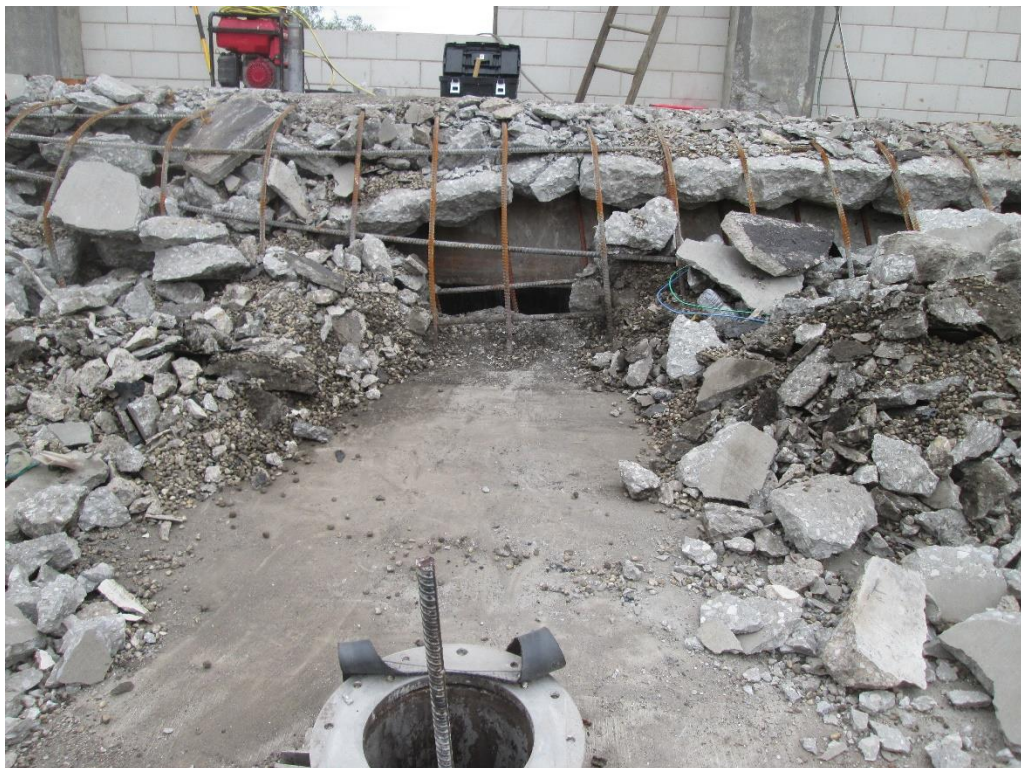
2. At the east side of the GBT Room, the slab was severely damaged along the east wall of the below grade tanks. East of this location, the slab was in a horizontal position where it was supported on the original slab-on-grade between the east tank wall and the east building wall. At the edge of the east tank wall, the slab sloped downward steeply toward the west. Only the reinforcing bars remained at this damaged area of the slab. Generally the width of the area with exposed reinforcing bars ranged from 2 to 3 feet; however at one location between the north and south GBT equipment, the exposed portion of reinforcing bars extended 5 to 6 feet west of the east tank wall. An overall view of this damage is shown in Figure 20.

Figure 20. Damaged GBT Room floor slab along east wall of east tank

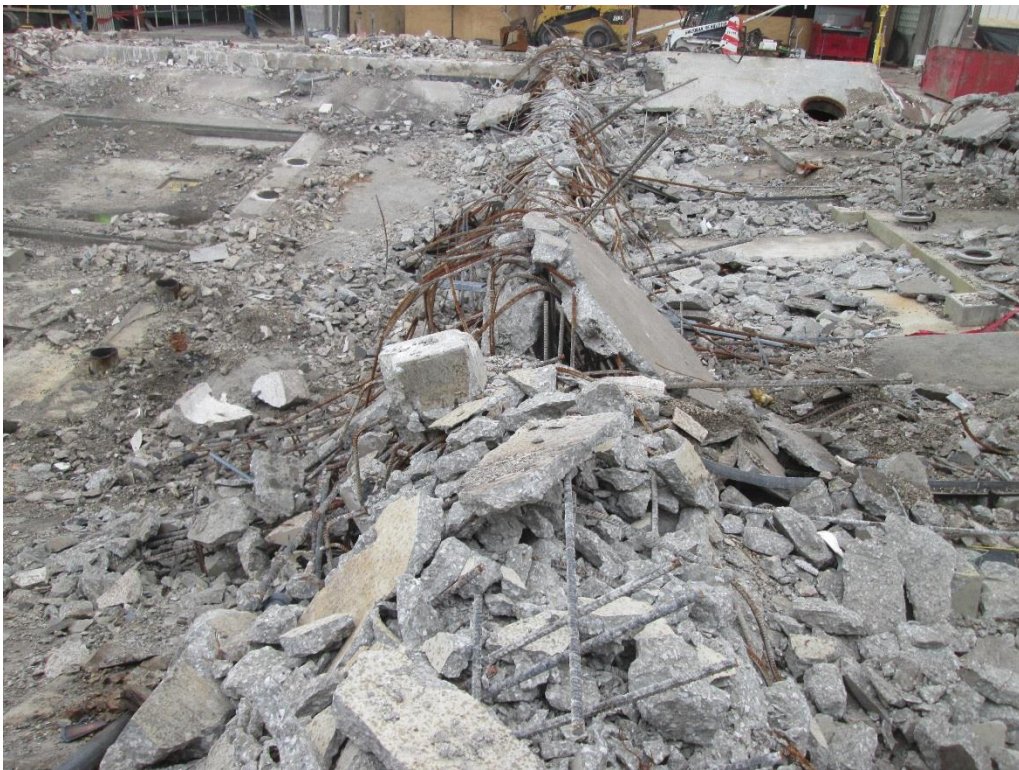
3. At the interior tank wall separating the east tank from the center tank, the slab was severely damaged with only the reinforcing bars remaining over the top of the wall, and on both sides of the wall (see Figure 21). At the east side of the wall, the width of this damaged area ranged from 2 1/2 feet at the south GBT equipment to 4 1/2 feet at the north end of the slab (see Figure 22). At the west side of the wall, the severely damaged portion of the slab with only the reinforcing bars remaining extended from 2 to 5 feet from the wall. Many of these reinforcing bars were damaged allowing the slab to drop on the west side of this interior wall. Portions of Beams B-12 and B-13, which are oriented parallel to the interior tank wall in this area were also severely damaged. An overall view of this damage is shown in Figure 23.

Figure 21. Damaged floor slab over interior wall between east and center tanks
