CALUMET WATER RECLAMATION PLANT Investigation of Explosion and Structural Collapse in Gravity Belt Thickener Room

Final Report

November 16, 2018

Metropolitan Water Reclamation District of Greater Chicago

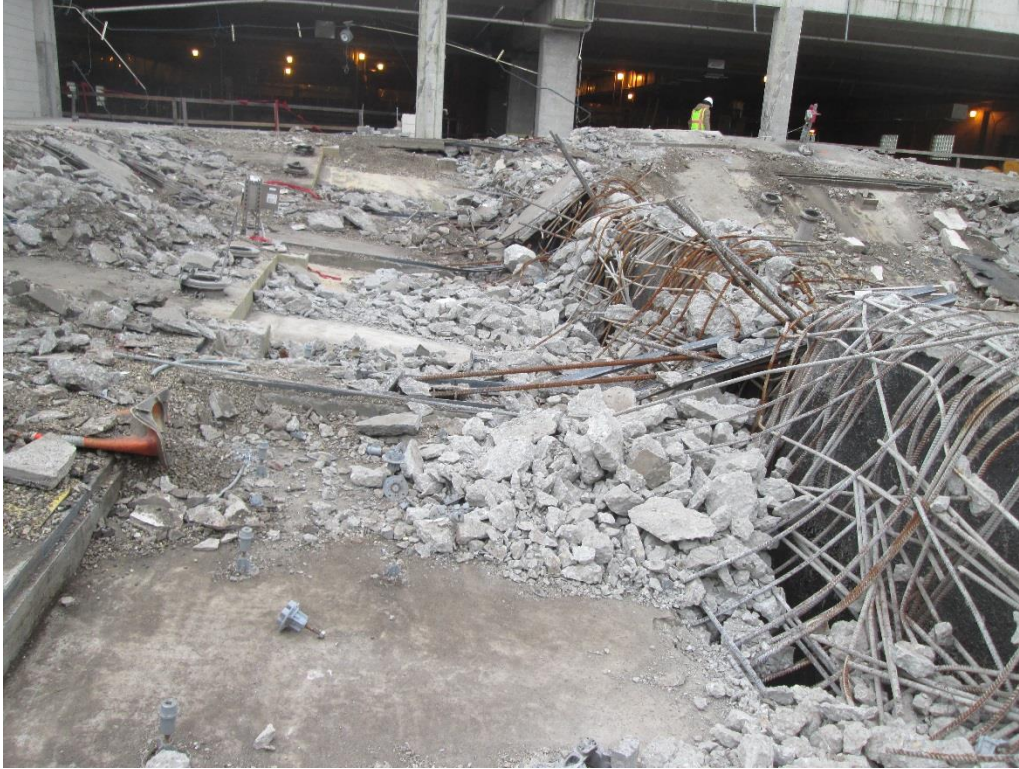
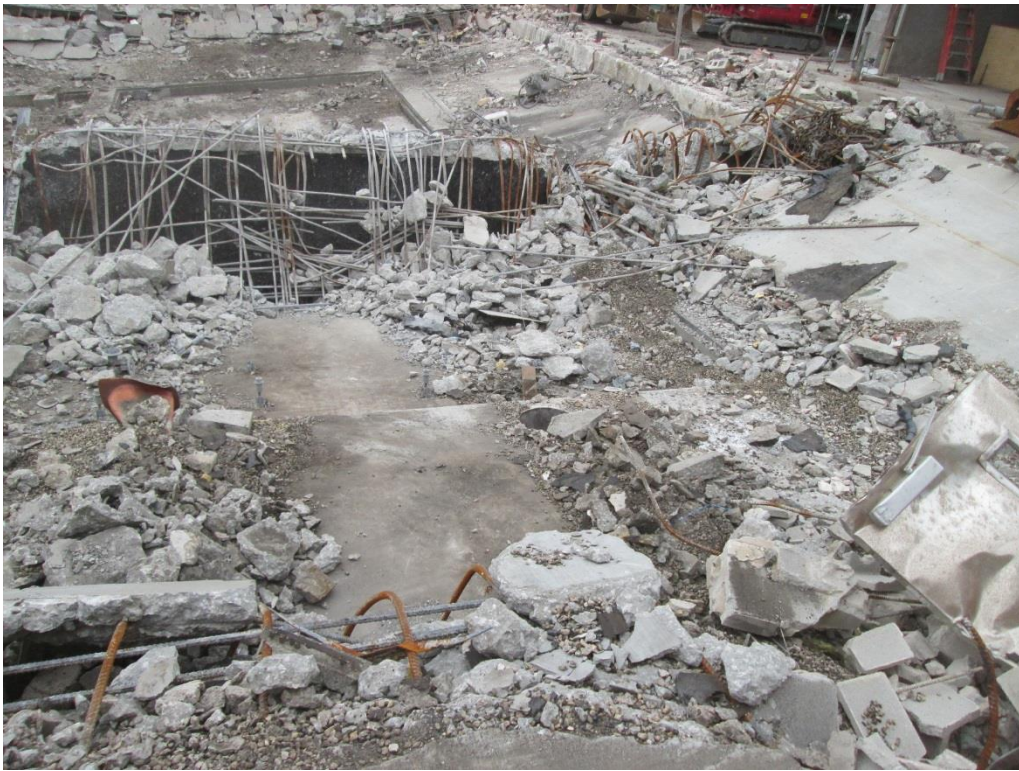
Figure 22. Damaged GBT Room floor slab over east tank at east side of wall separating the east and center tanks

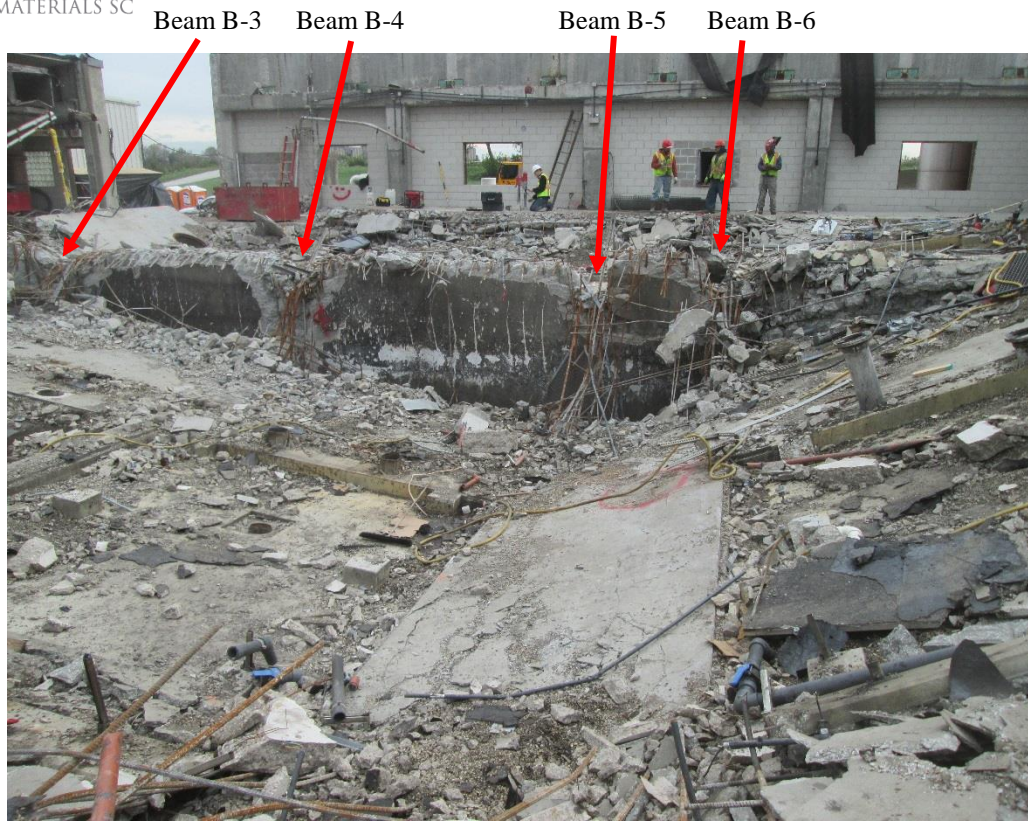
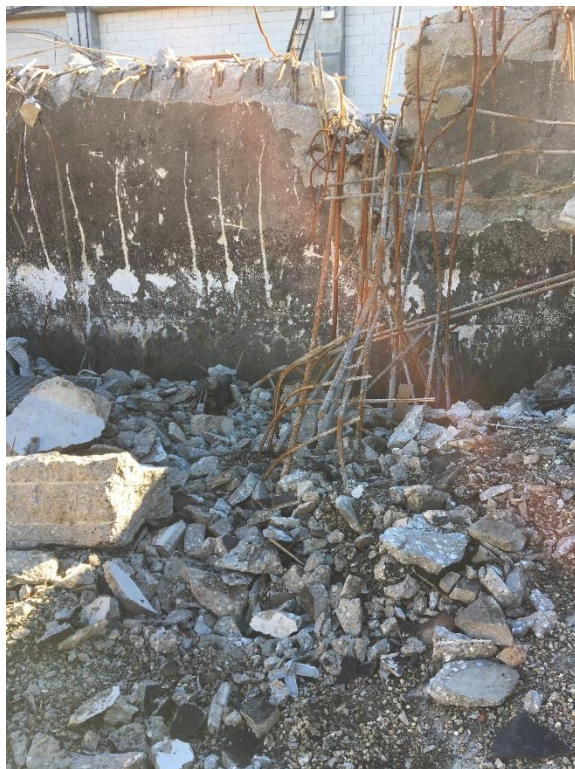
3. At the interior tank wall separating the east tank from the center tank, the slab was severely damaged with only the reinforcing bars remaining over the top of the wall, and on both sides of the wall (see Figure 21). At the east side of the wall, the width of this damaged area ranged from 2 1/2 feet at the south GBT equipment to 4 1/2 feet at the north end of the slab (see Figure 22). At the west side of the wall, the severely damaged portion of the slab with only the reinforcing bars remaining extended from 2 to 5 feet from the wall. Many of these reinforcing bars were damaged allowing the slab to drop on the west side of this interior wall. Portions of Beams B-12 and B-13, which are oriented parallel to the interior tank wall in this area were also severely damaged. An overall view of this damage is shown in Figure 23.

Figure 23. Damaged GBT Room floor slab and beams over the center tank on the west side of interior wall between the east and center tanks

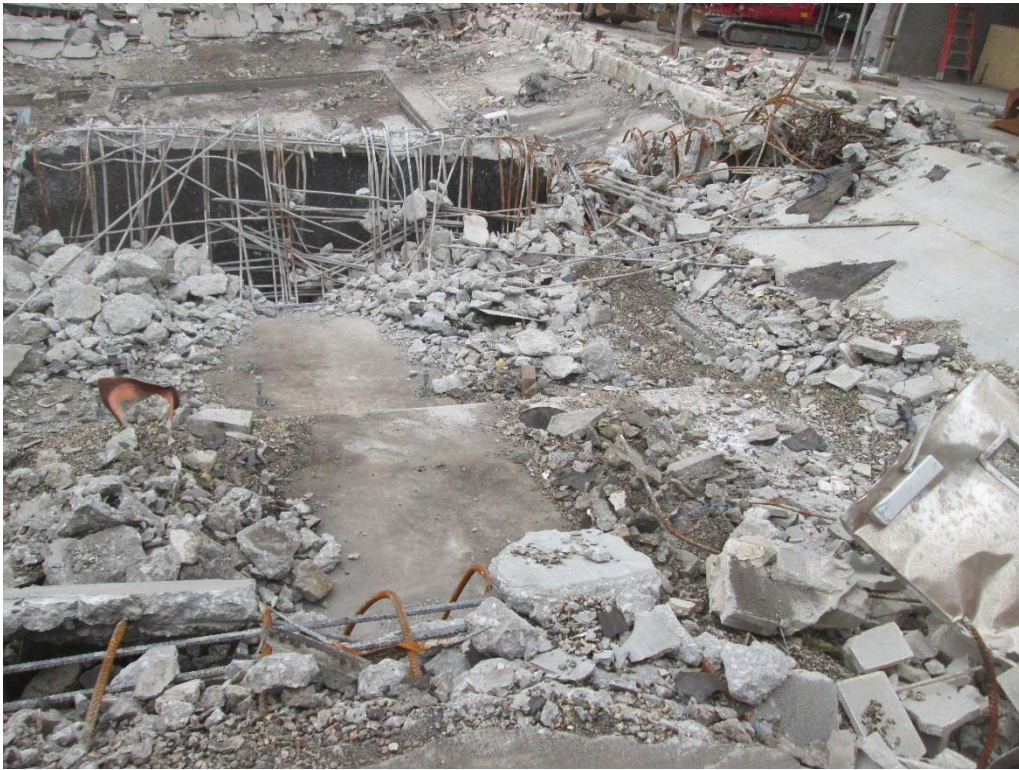
4. The floor slab area between the distress at the east tank wall (described in item 2 above) and the distress at the interior tank separation wall between the east and center tanks (described in item 3 above) was intact, sloping downward from the east toward the west with no significant damage to the top slab surface (see Figure 24).

Figure 24. Intact floor slab over center portion of east tank looking west

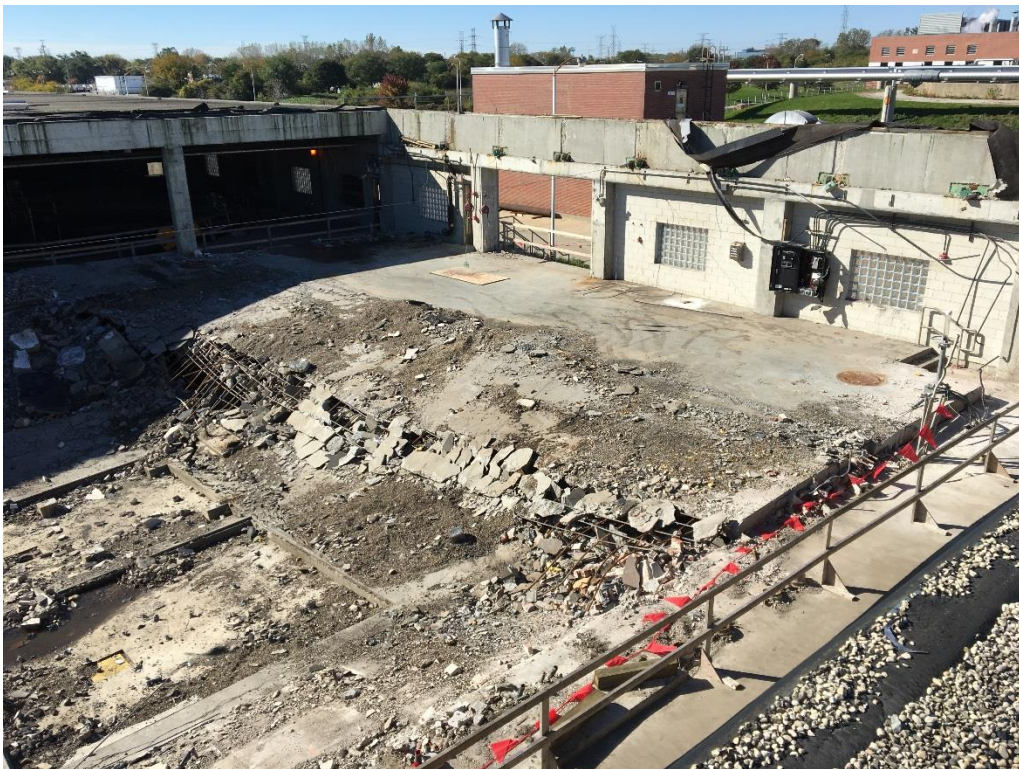
Figure 25. West side of GBT Room floor slab

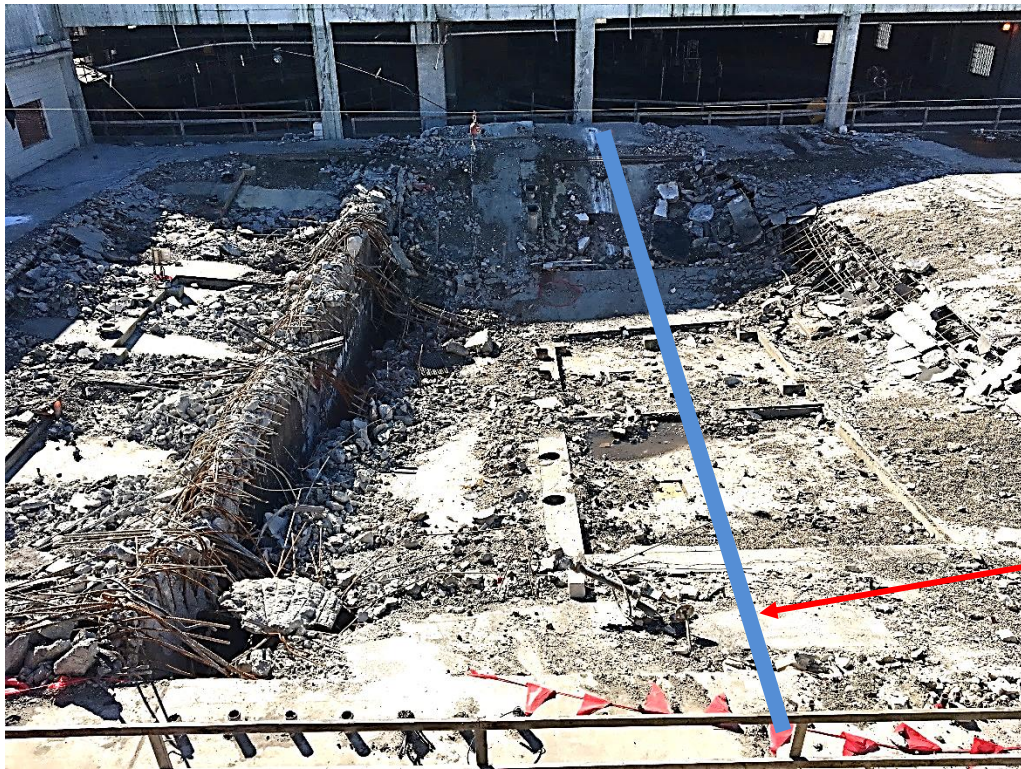
5. The floor slab at the west side of the GBT Room was flat and generally appeared to be intact for approximately 20 feet east of the west exterior building wall. At 20 feet east of the west exterior wall, the slab was cracked along Beam B-1, which was oriented in the north-south direction. East of this crack along Beam B-1, the slab sloped downward toward the east at a moderate slope to Beam B-2 where the slab is severely damaged with only the reinforcing bars remaining at most locations (see Figure 25). Through the severely damaged areas of the slab along Beam B-2, we could observe that portions of Beam B-2 were damaged and the two southernmost square columns supporting this beam were pushed over toward the southwest. East of Beam B-2, the downward slope of the slab toward the east increases until it reaches a low point between the east and west GBT equipment. From this low point of the remaining slab, the exposed reinforcing bars steeply sloped upward toward the interior tank wall separating the east tank from the center tank. The slab was found to be intact between the severe damage over Beam B-2 and the damage (see item 3 above) on the west side of the wall separating the center tank from the east tank (see Figure 26).

Figure 26. GBT Room floor slab over center and west tanks

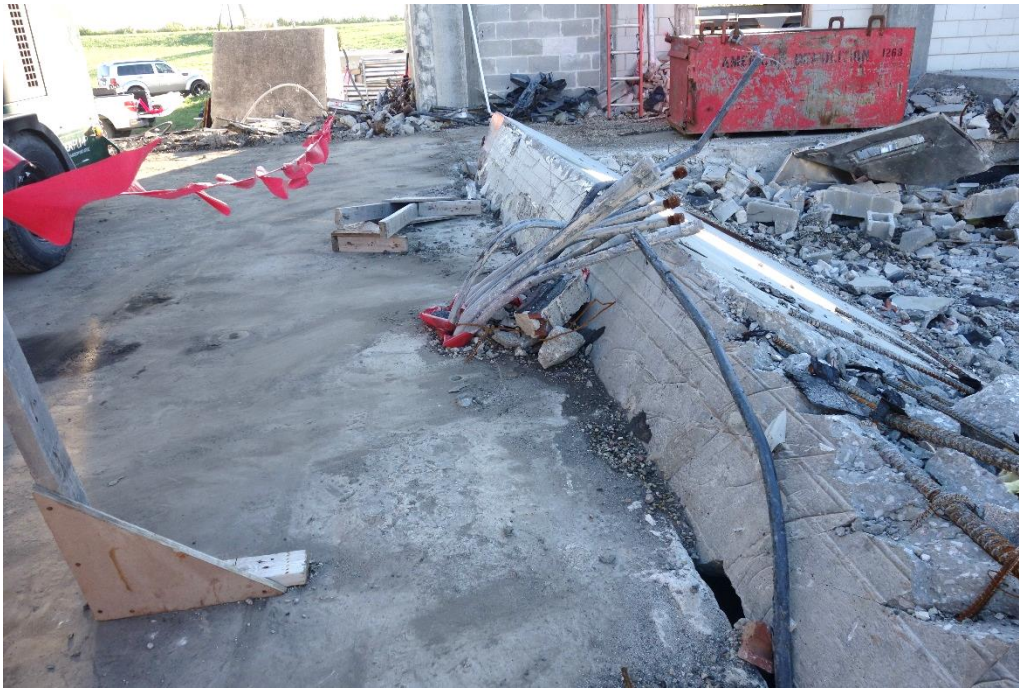
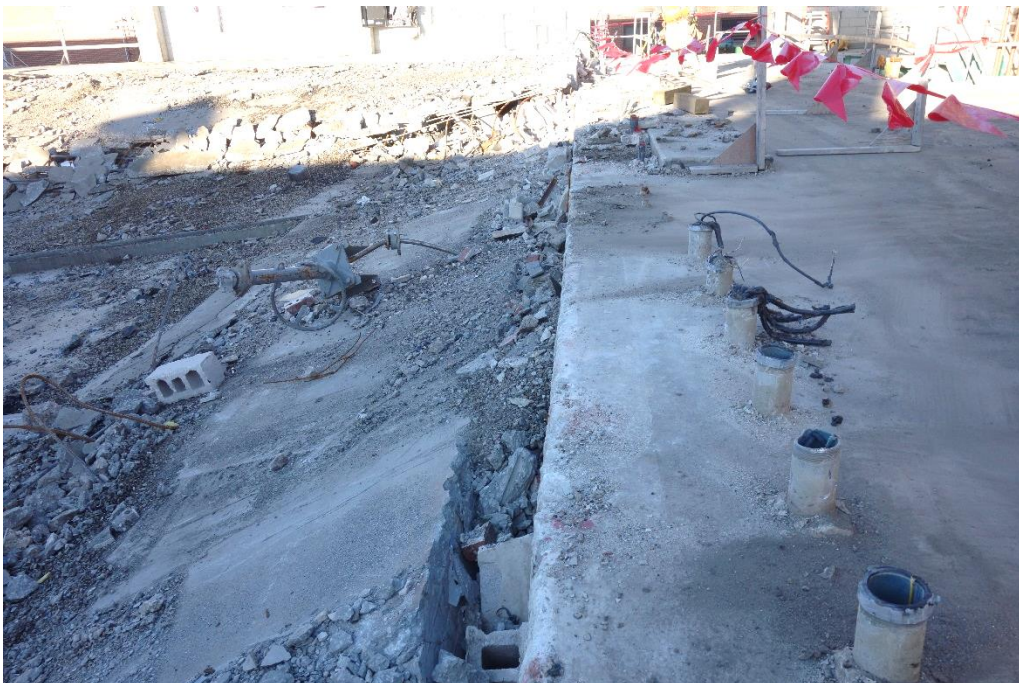
Figure 27. North GBT Room floor slab over east and center tanks

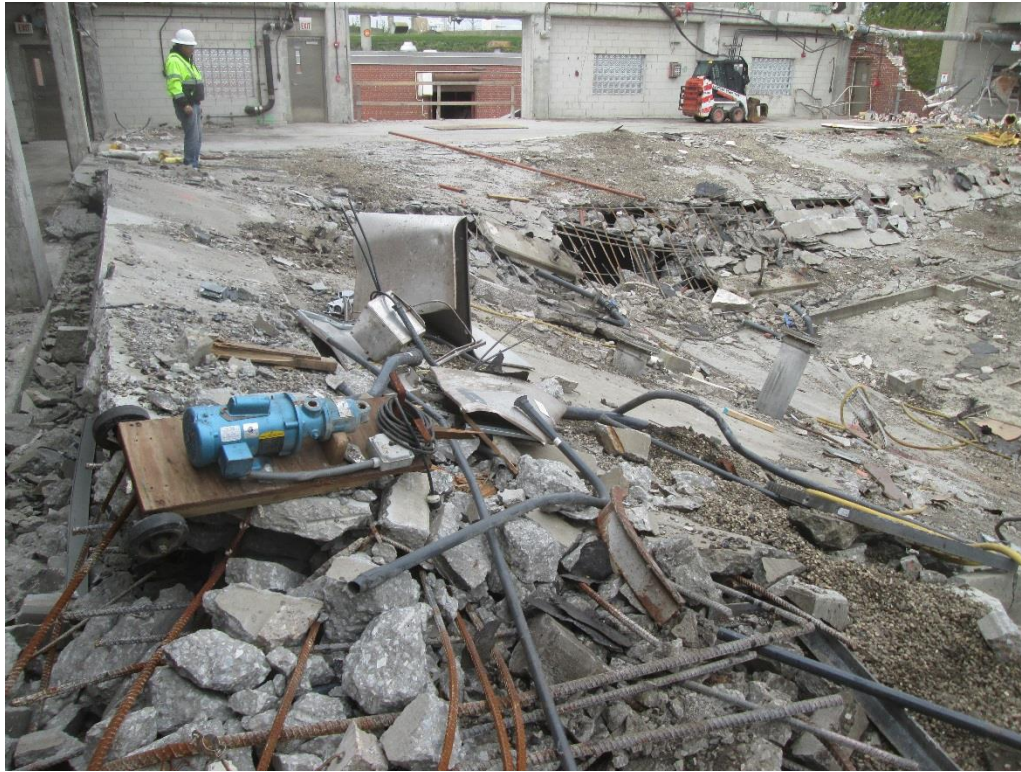
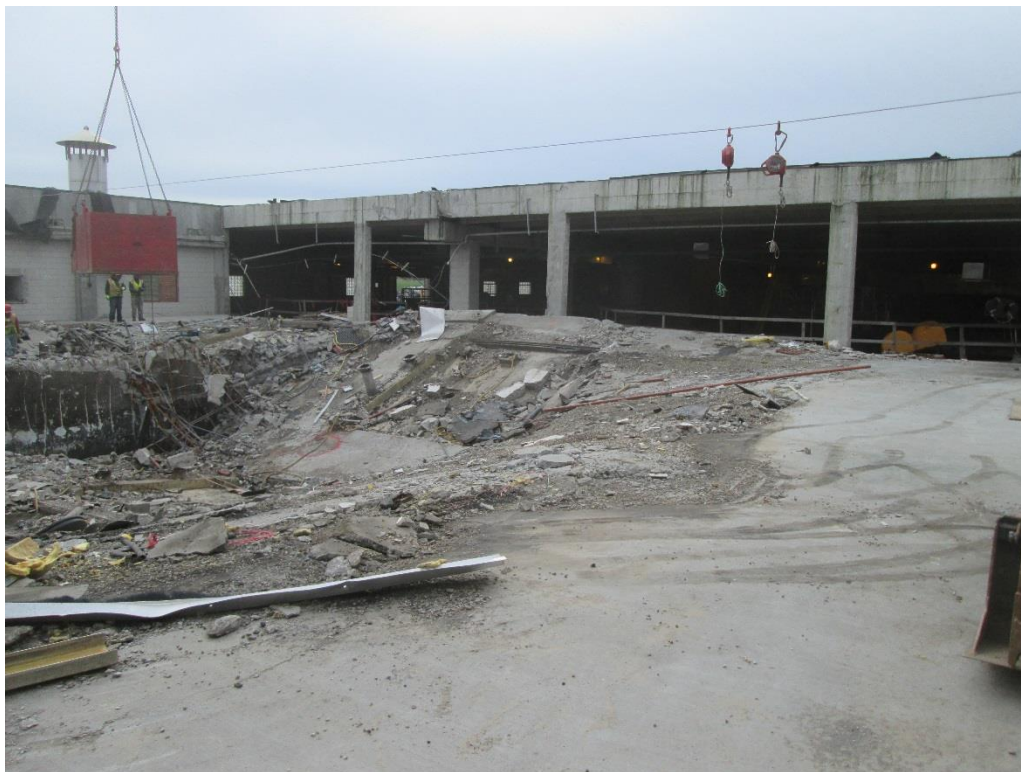
Figure 28. Center section of floor slab at south wall of GBT Room

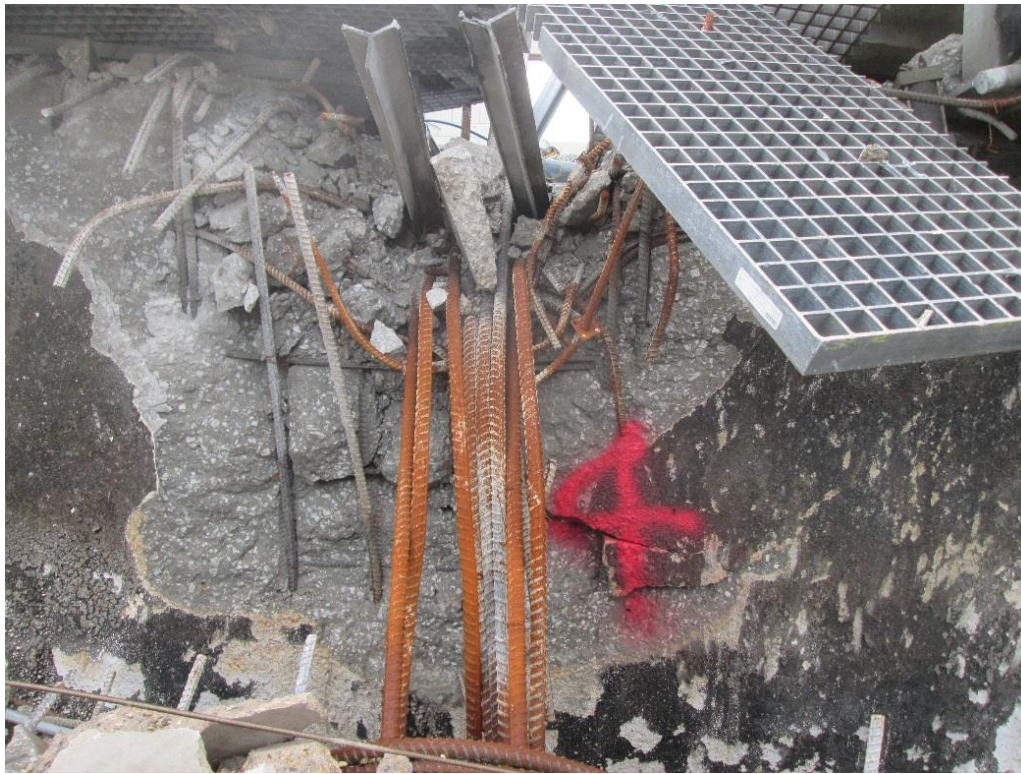
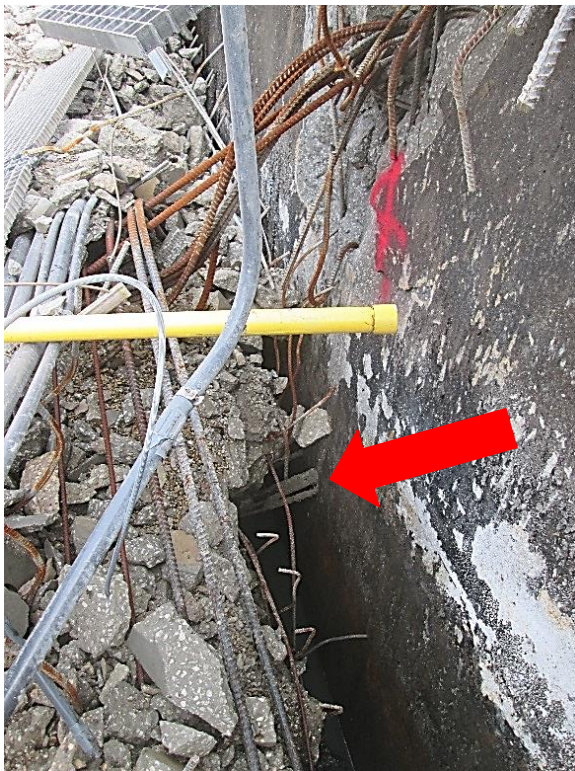
8. Beams B-3, B-4, B-5, and B-6 were all damaged on both sides of the interior wall separating the center tank from the east tank. The bottom reinforcing bars, which were not continuous through the interior tank wall, had dropped below their original elevation on the west side of the wall. The top reinforcing bars that were continuous over the tank wall had broken the concrete cover on both sides of the wall and were exposed for a majority of their length (see Figure 29).

Figure 29. Beam B-4 at interior wall between east tank and center tank

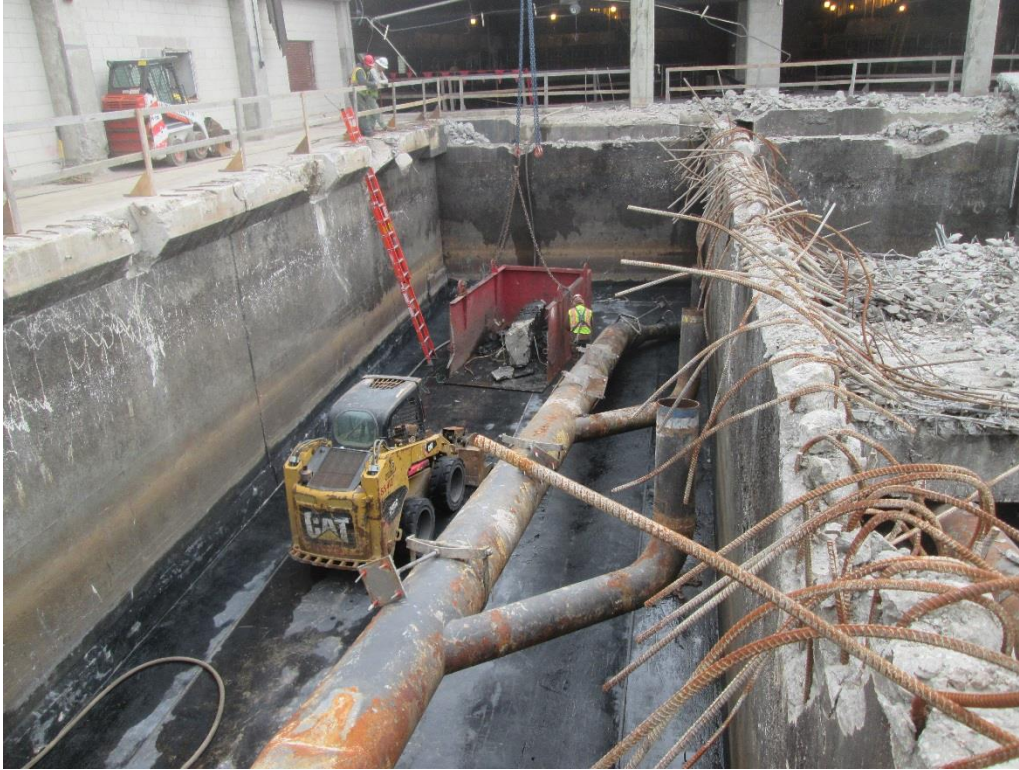
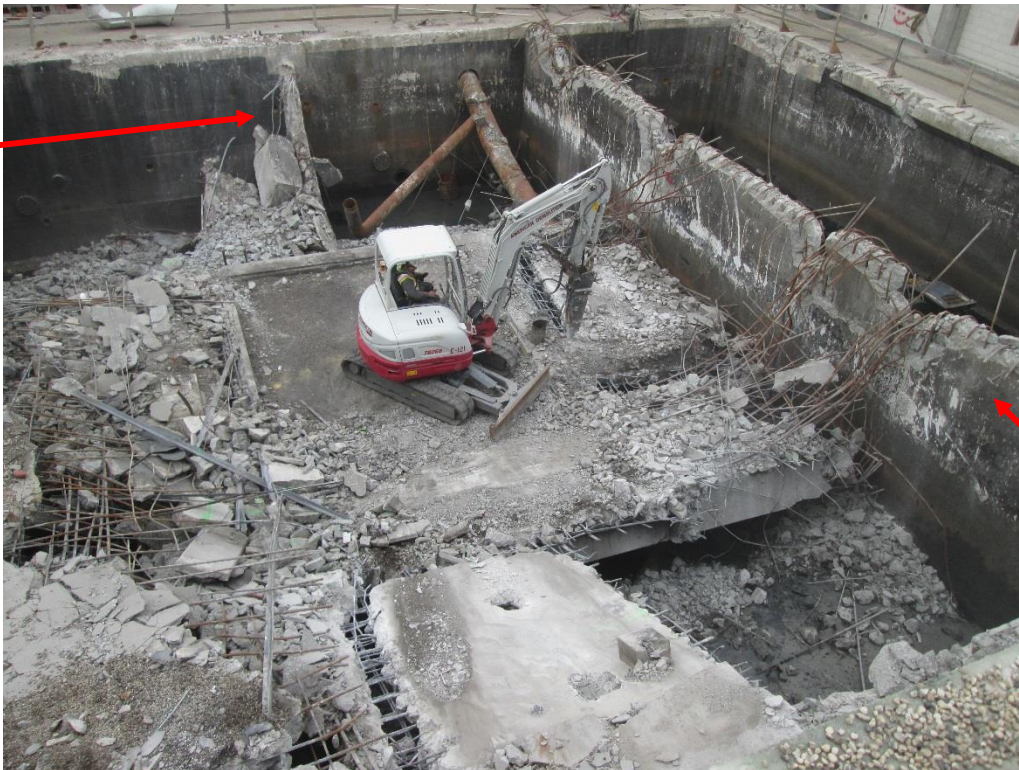
Interior Wall between East and Center Tanks - The interior wall between the east and center tanks was still in its original vertical orientation. Crushing was only observed at the top of the wall and at the beam pockets where the existing slab and integral beams failed over the top of this wall. Also, there were numerous scrapes on the wall surface from the reinforcing bars in the beams that collapsed (see Figure 30).

Figure 30. Interior wall between east tank and center tank

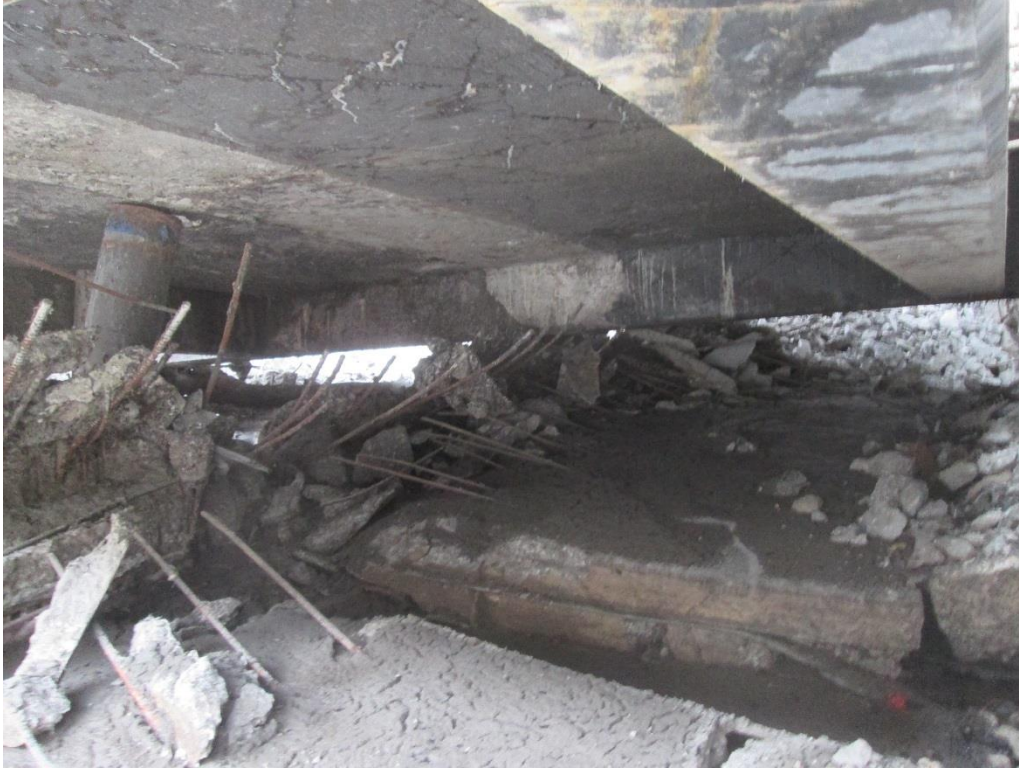
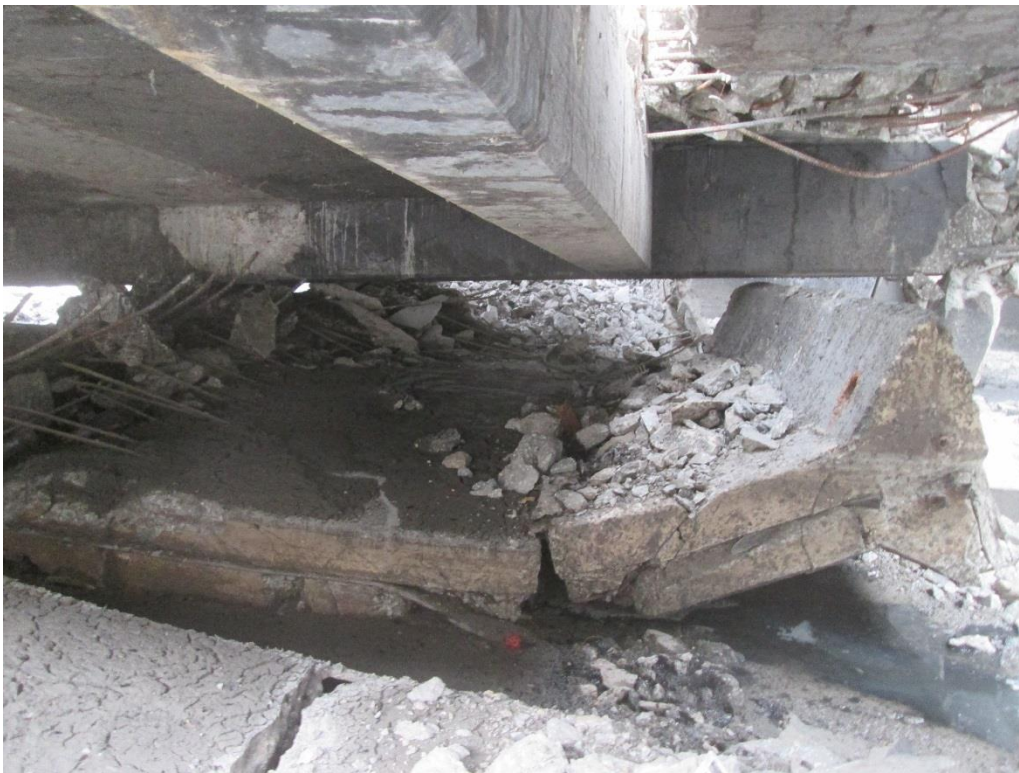
Interior Wall between Center and West Tanks - The interior wall that separates the center tank from the west tank had broken at approximately 3 feet above the bottom of the tank (at the center portions of the tank away from the north and south walls). The upper section of the wall was displaced westward and was lying flat on the tank slab west of the wall location between this center wall and the column row to the west (see Figure 31). At several locations, the top of the 3 foot 8 inch wide double corbel at the top of this wall could be observed. There were no indications that epoxy grouted dowels had been installed in the top of the wall to connect the wall to the floor slab (see Figure 32). It appeared that although the slab was cast on top of this wall it was not mechanically anchored to the wall.

During our site visits, we observed that the tank wall that was part of the original construction and located between the center and west tanks had generally collapsed toward the west, indicating that it was loaded on its east face. In reviewing the debris, we observed locations where the wall laid on the tank floor slab mostly intact, with a break occurring near the base of the wall. This would suggest that the wall acted as a cantilever structure at these locations. We also observed that the top of the wall was not doweled to the concrete floor slab that was supported on it. Therefore, for the first failure scenario, we considered the slab deflected upward from the blast pressure as the wall was laterally loaded from the blast pressure. With the slab deflected upward, the wall would not have had a lateral support at its top end, and would act as a cantilevered wall for the lateral loads.

Figure 31. Collapsed interior wall between center tank and west tank. The top of the wall is to the right (west).

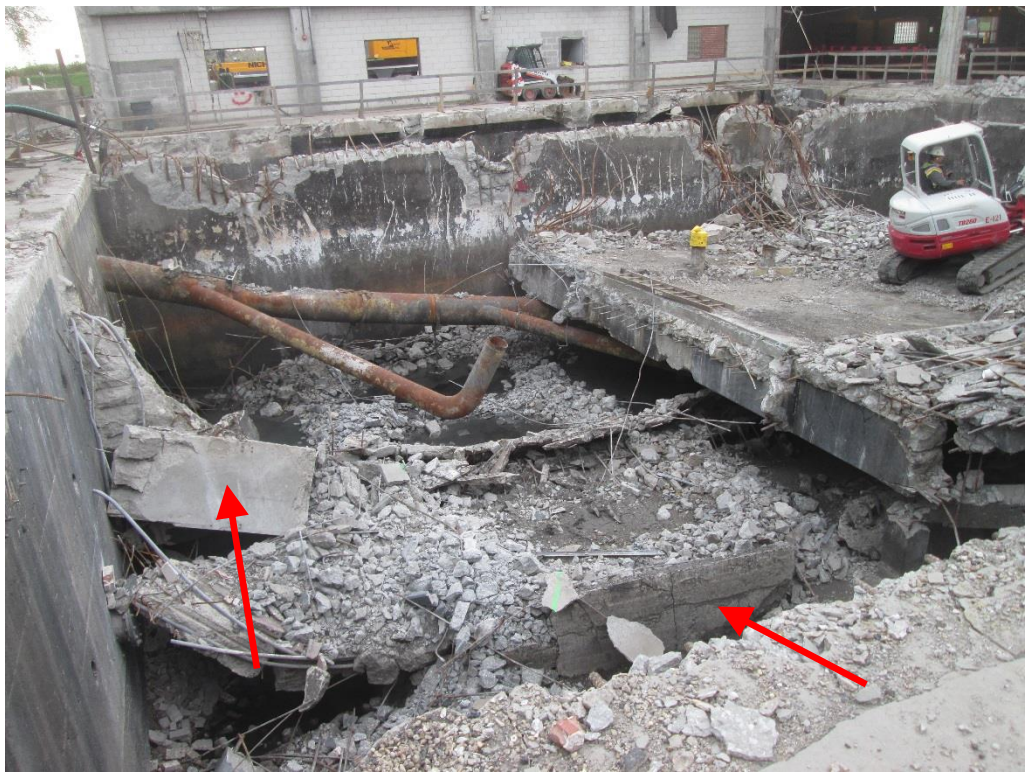
Figure 32. Top of wall separating west tank from center tank with no epoxy grouted dowels present

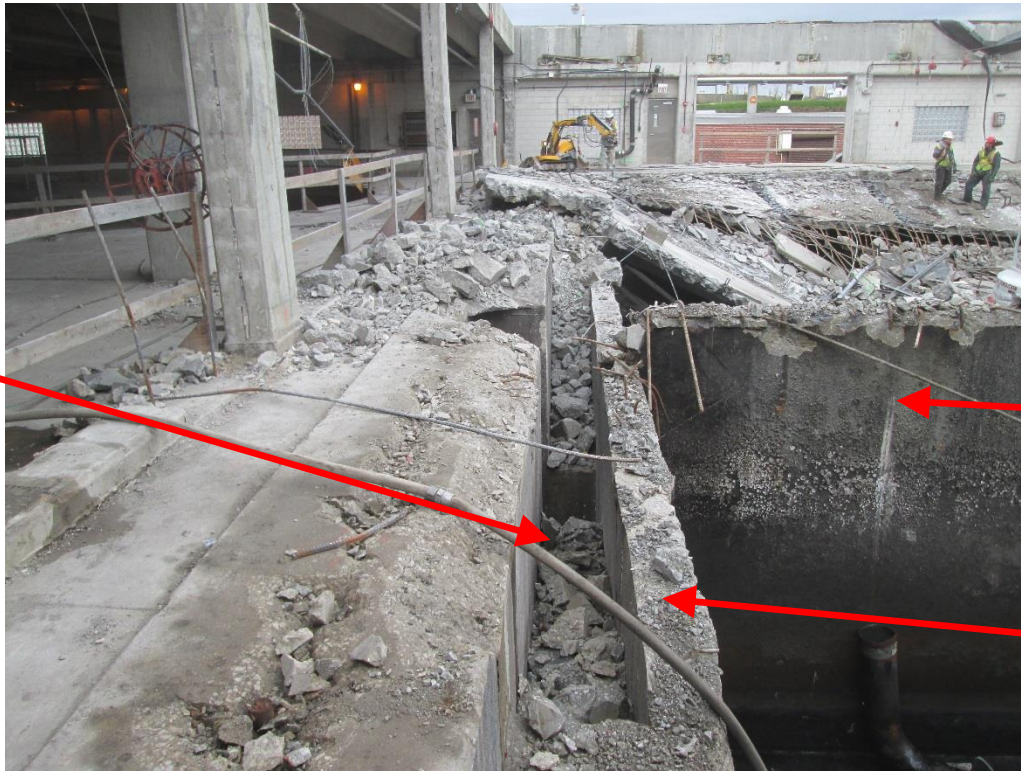
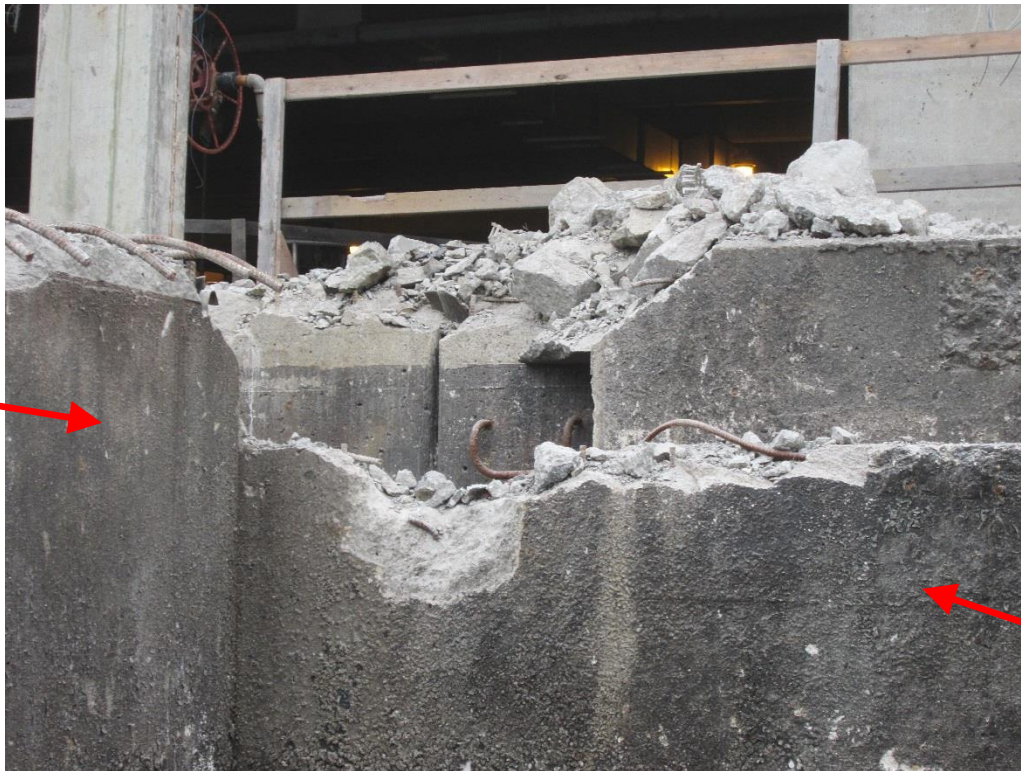
Figure 33. South wall of tank between tank and overflow trough

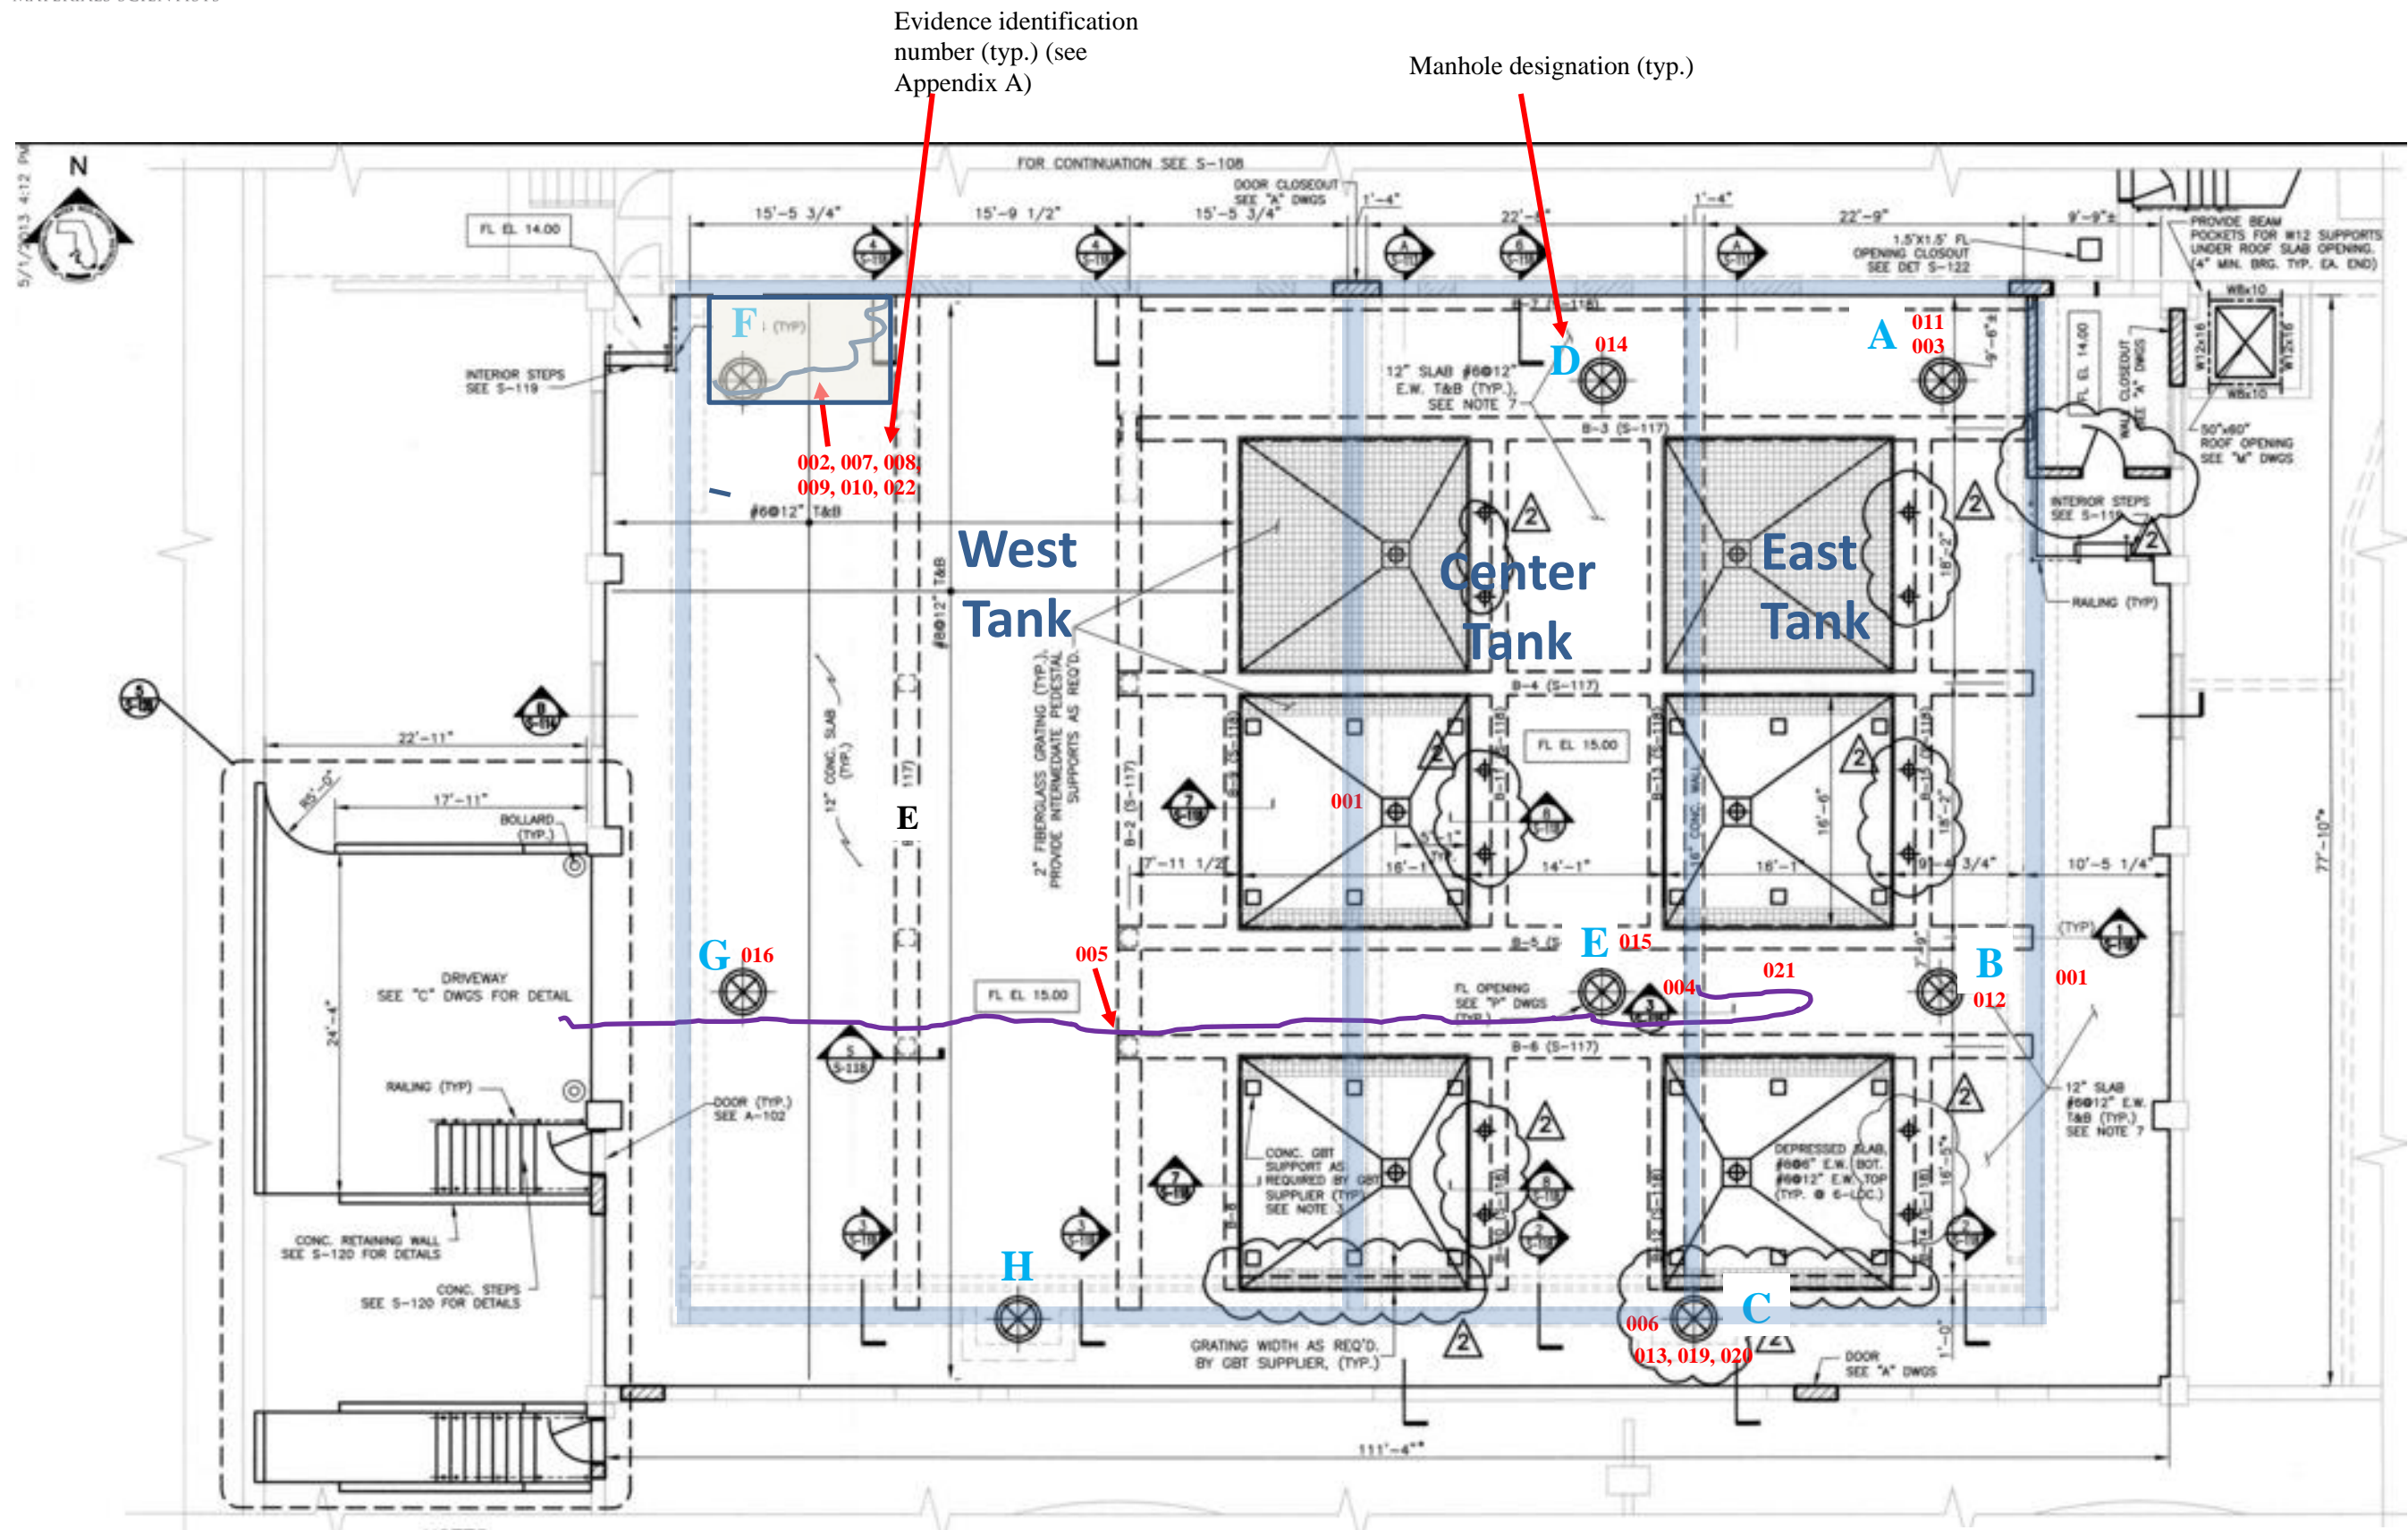
Workers started work that day at about 8:00 a.m. At about 8:30 a.m., a manhole was opened in the southeast portion of the room, Manhole C¹⁵. (refer to Figure 34 for manhole locations.) That manhole was opened using a battery-powered impact wrench, and reportedly closed after observations were taken; though bolts were left off. A coffee break was taken at 10:30 a.m. The next manhole that was planned to be opened was the manhole north of that (i.e. assumed to be Manhole B). At about 10:50 a.m., an explosion occurred. Given the flint striker, oxy-acetylene cutting torch, hammer, and chisel found in that immediate area, and flame cut bolts and flame cutting marks observed at the Manhole B cover, it is clear that such equipment was being used to open that manhole.

Figure 34. Evidence locations in GBT Room (See Appendix A for evidence list)

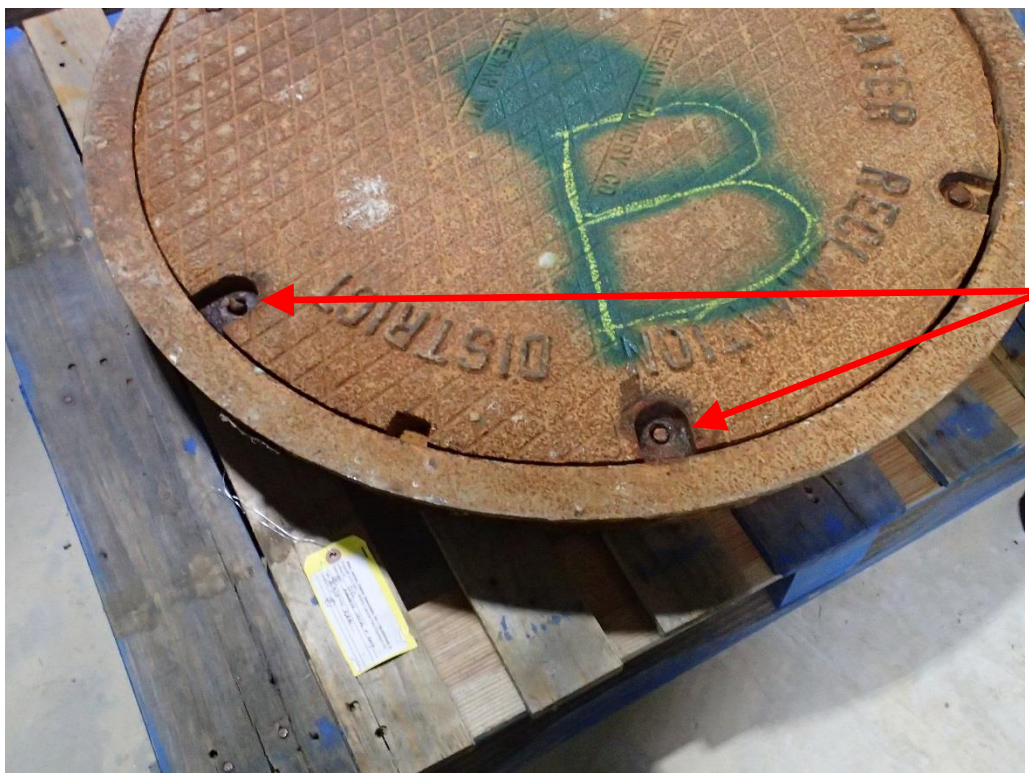
- Manhole B – the cover and ring were found nearby to the east and upside down; two bolt heads were removed by flame cutting (see discussion in later report sections)
- Manhole C – found without bolts, the cover was broken in many pieces and moved to the southeast several feet, the ring was also broken with the ring pieces found in several nearby locations
- Manhole D – the cover and ring were found upside down, broken and located several feet to the southwest from its original location
- Manhole E – the cover and ring were found upside down and moved about 16 feet to the west
- Manhole F – was found undisturbed
- Manhole G – the cover and ring were found upside down, and located several feet to the west
- Manhole H – was found undisturbed

Figure 37. Manhole B with two flame cut bolts
