***REPORT NO. 17-14***

***HANOVER PARK WATER RECLAMATION PLANT***

***FISCHER FARM MONITORING REPORT FOR***

***FIRST QUARTER 2017***

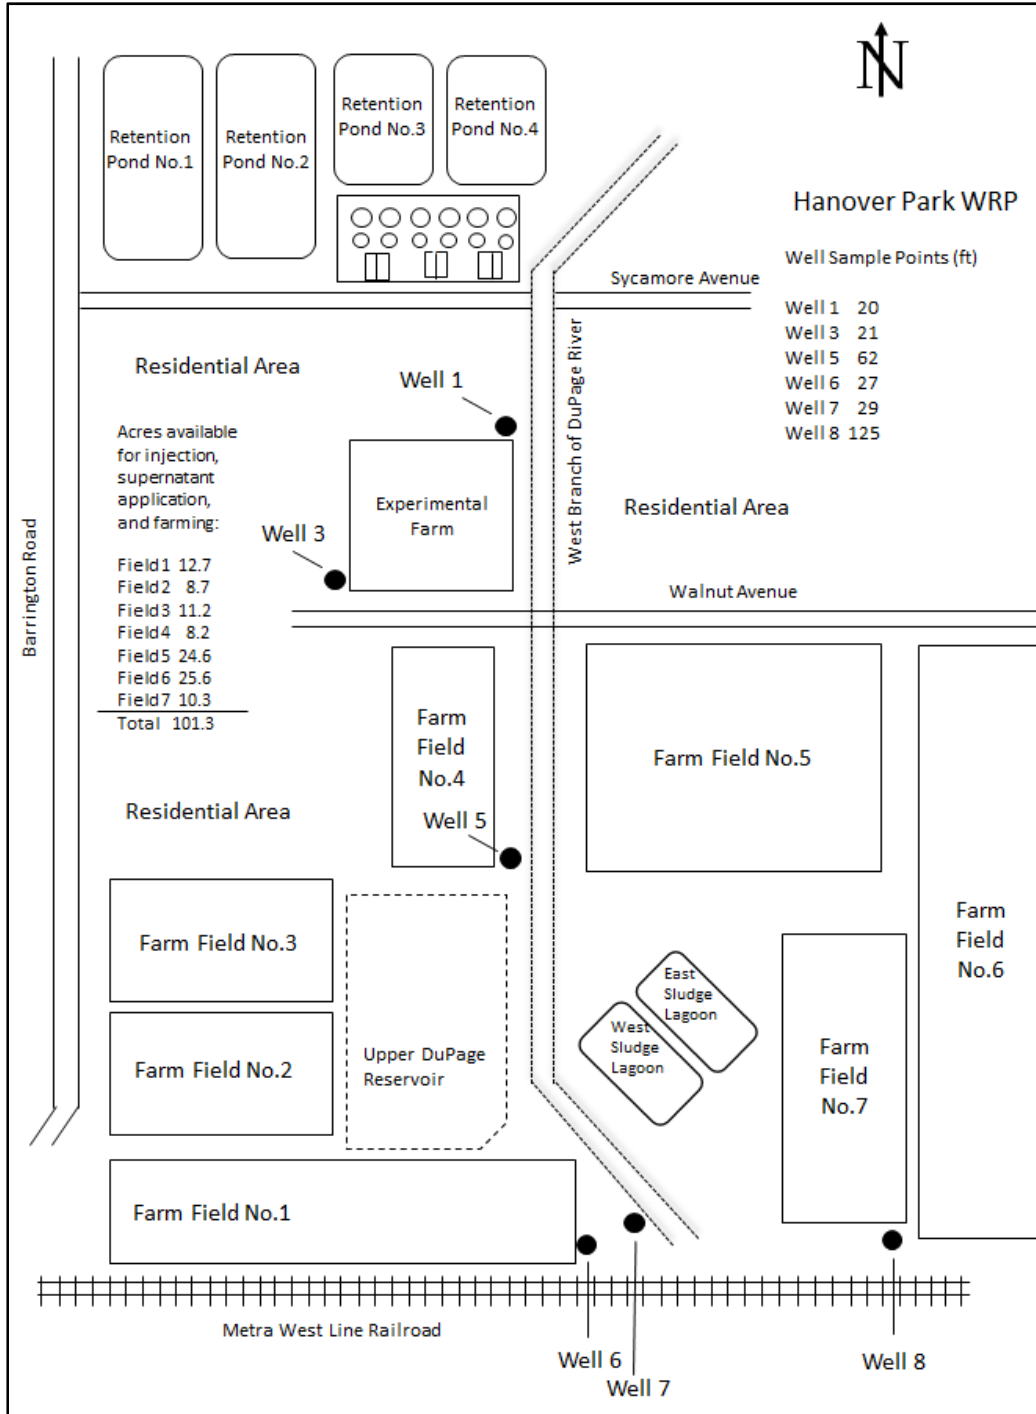
FIGURE 1 MAP OF FIELDS AND WELLS AT THE HANOVER PARK FISCHER FARM SITE OF THE METROPOLITAN WATER RECLAMATION DISTRICT OF GREATER CHICAGO

Drainage water (combined surface and subsurface) returned to the Hanover Park WRP from the farm fields was sampled in January, February, and March 2017, and data for these samples are presented in [Table 2](#). The volumes of drainage water returned to the WRP during the first quarter were estimated as 2.2, 8.6, and 7.8 million gallons in January, February, and March, respectively. No lagoon supernatant or liquid biosolids were applied to Fischer Farm fields in January, February, or March. Field and water monitoring locations are presented in [Figure 1](#).
