*REPORT NO. 18-14*

*HANOVER PARK WATER RECLAMATION PLANT*

*FISCHER FARM MONITORING REPORT FOR*

*FIRST QUARTER 2018*

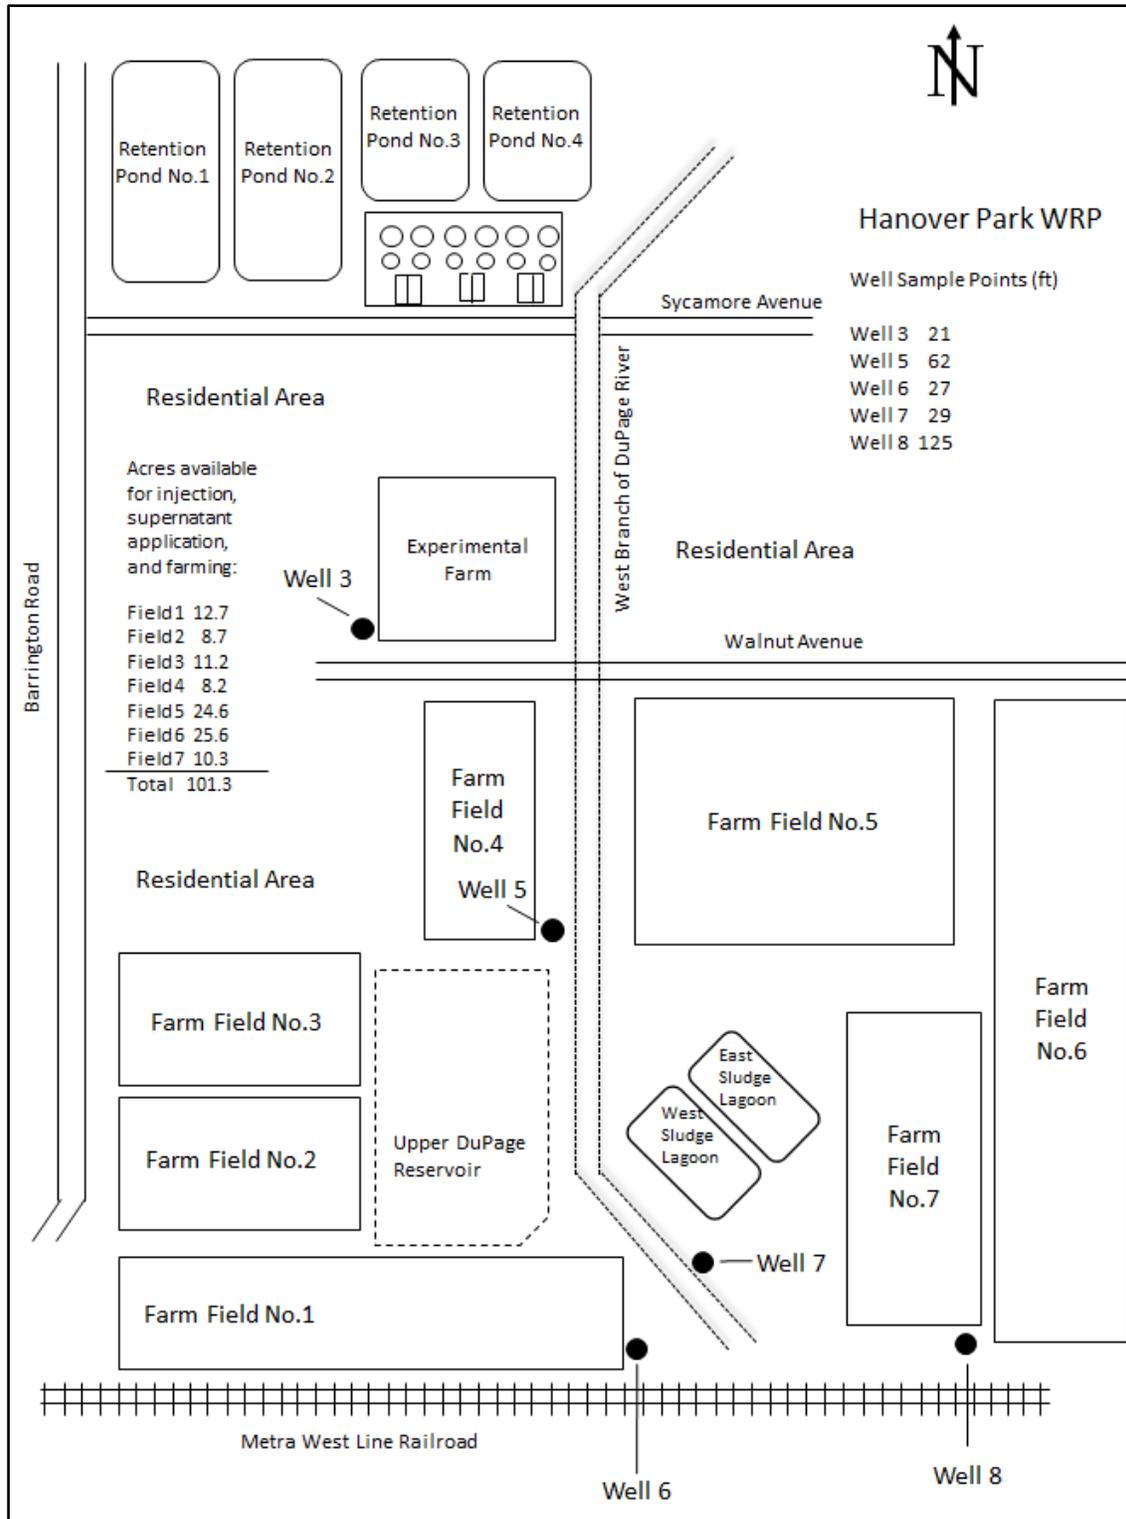
FIGURE 1 MAP OF FIELDS AND WELLS AT THE HANOVER PARK FISCHER FARM SITE OF THE METROPOLITAN WATER RECLAMATION DISTRICT OF GREATER CHICAGO

Drainage water (combined surface and subsurface) returned to the Hanover Park WRP from the farm fields was sampled in January, February, and March 2018, and data for these samples are presented in Table 2. The volumes of drainage water returned to the WRP during the first quarter were estimated as 7.8, 5.2, and 15 million gallons in January, February, and March, respectively. No lagoon supernatant or biosolids were applied to Fischer Farm fields in January, February, or March. Field and water monitoring locations are presented in Figure 1.
