METROPOLITAN WATER RECLAMATION DISTRICT
OF GREATER CHICAGO

SUBJECT: **Investigatory Report of the August 30, 2018 Roof Collapse at the Calumet Plant Conducted by Human Resources Safety Staff**

SUBJECT: Review of the Investigatory Report of the August 30, 2018 Roof Collapse at the Calumet Plant Conducted by Human Resources Safety Staff.

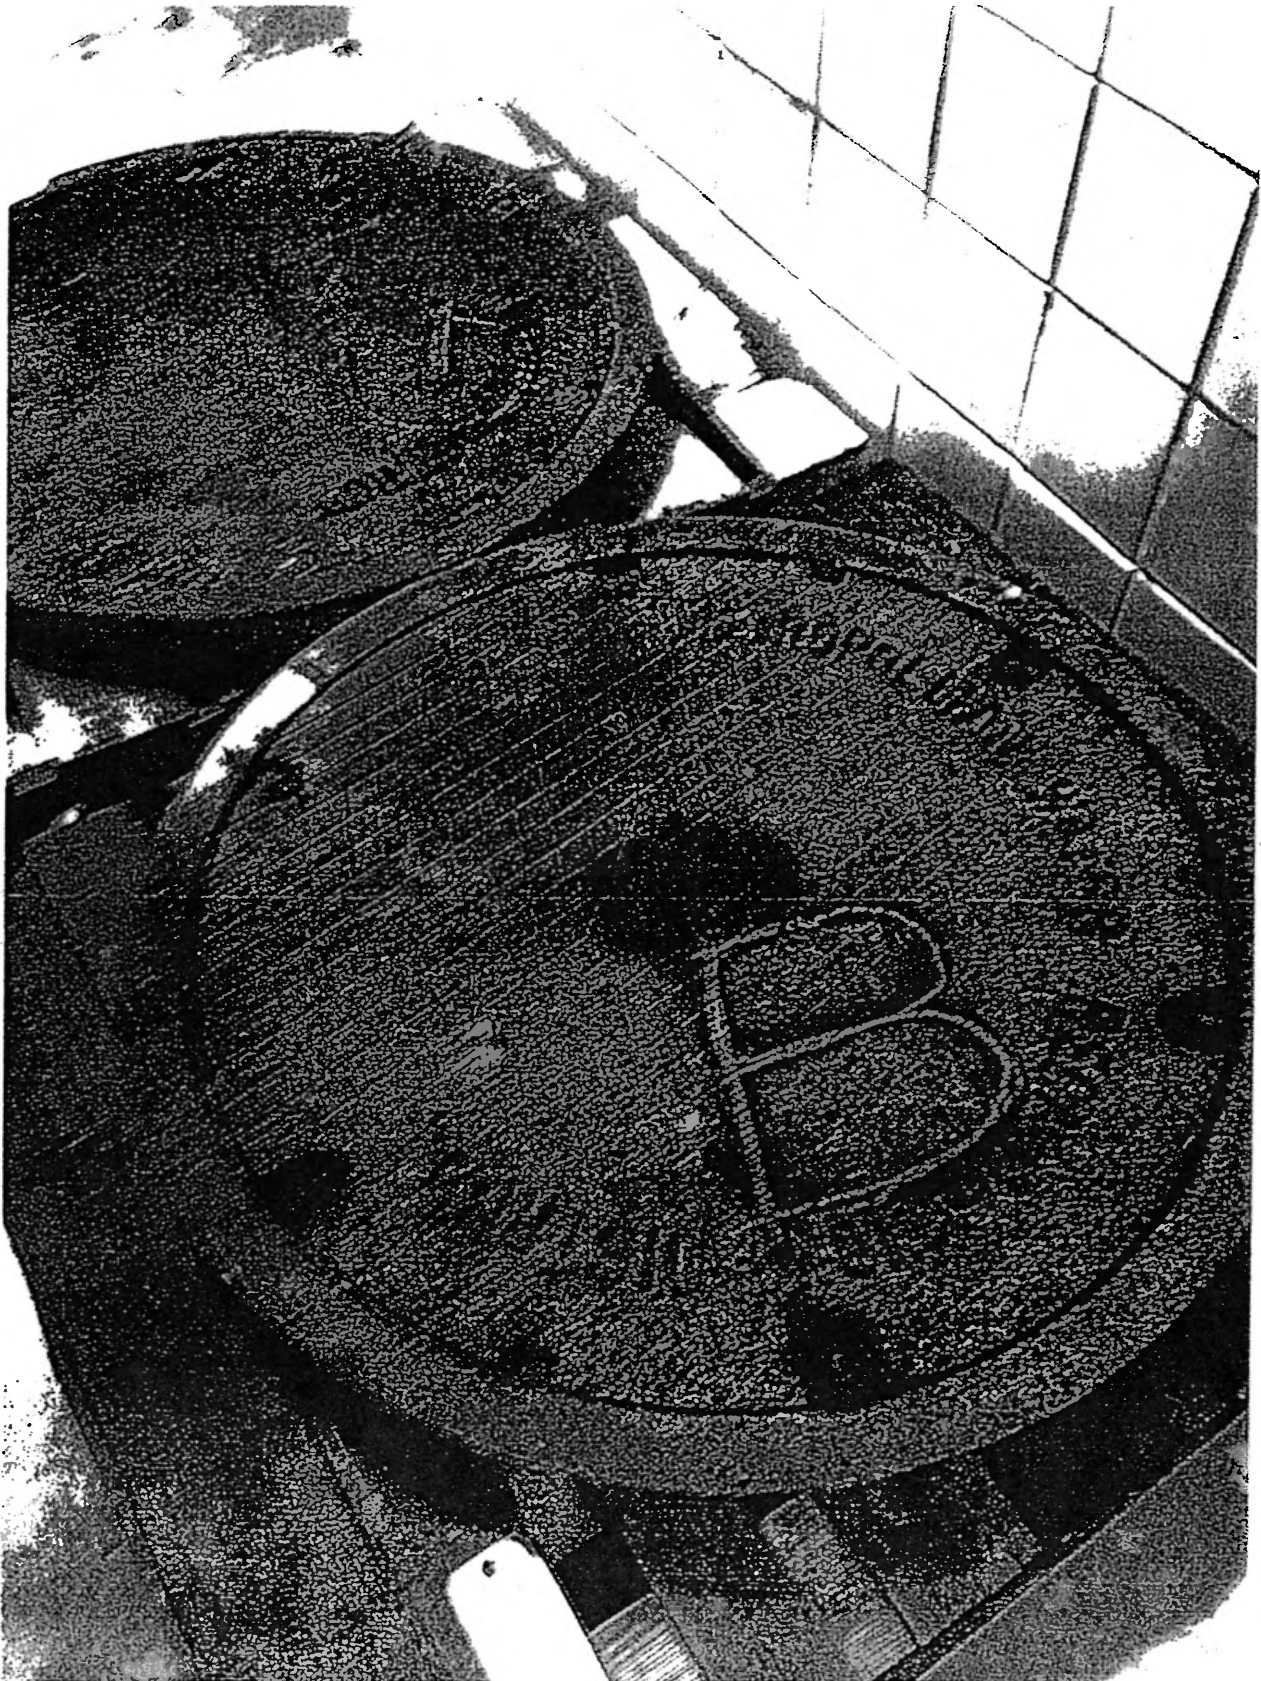
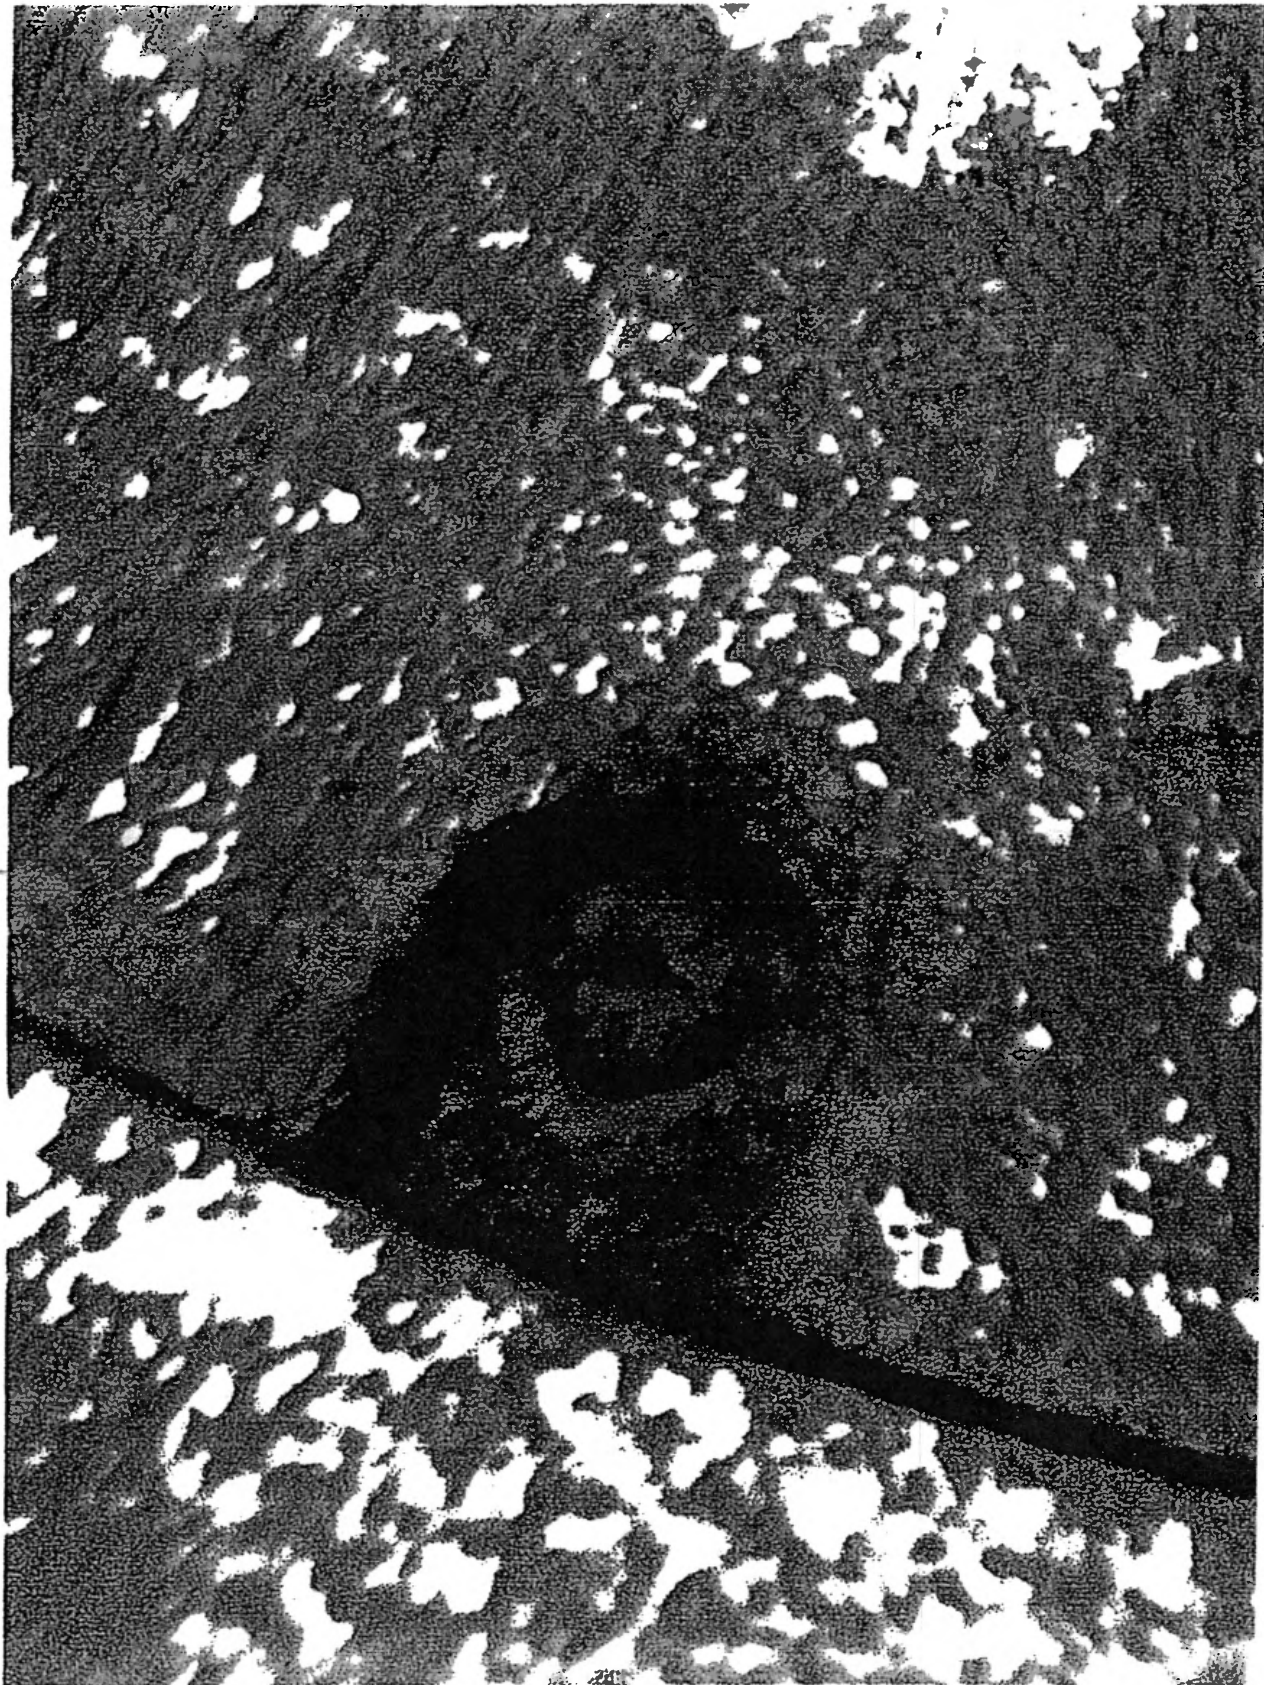
Attachment 2
Manhole Cover Photos

On August 30, 2018 before the 10:00 am coffee break, Malinowski had removed the first manhole cover near the south wall with a battery powered pneumatic impact driver. However, when O'Connor, and Malinowski looked at the area below the manhole cover it appeared to be an overflow area rather than the holding tank that needed to be inspected. Malinowski began working on the removal of another bolted on manhole cover. The bolts were seized due to rust on this manhole cover, so Malinowski applied a penetrating oil to the bolts of this and another manhole cover and then informed O'Connor that he would return after coffee break with a larger drive tool. This occurred around 10:00am and Malinowski went to break.
