**CHICAGO AREA WATERWAY SYSTEM HABITAT EVALUATION  
AND IMPROVEMENT STUDY:**

**HABITAT IMPROVEMENT REPORT**

Prepared for the Metropolitan Water Reclamation District of Greater Chicago

Prepared by LimnoTech

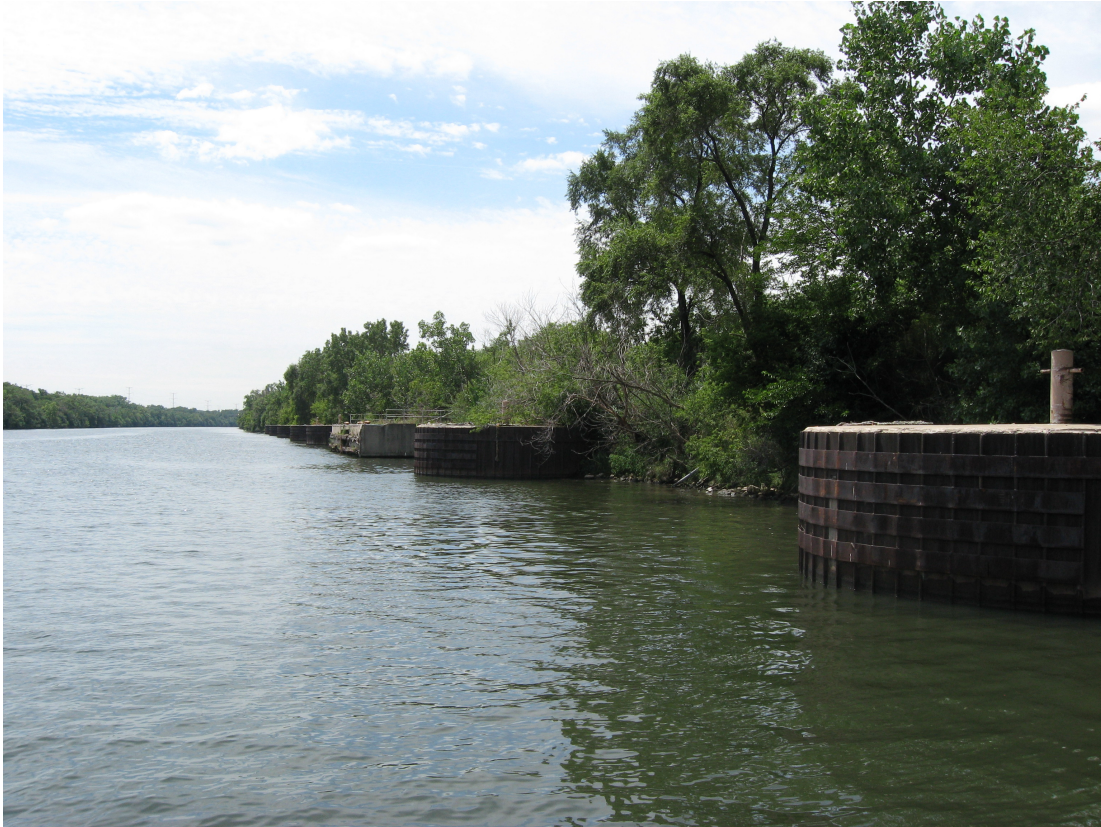
**Figure 2-2: Examples of Dolphin Structures on the Chicago Sanitary and Ship Canal near AWQM 41.**

- Manmade structures – The presence of manmade structures in the channel (bridge abutments, dolphins, piers) in the channel was found to be an important habitat variable, in a negative sense. An example of these structures is shown in Figure 2-2. It is not clear why these structures are negatively associated with fisheries in the CAWS, but it is likely that it is the

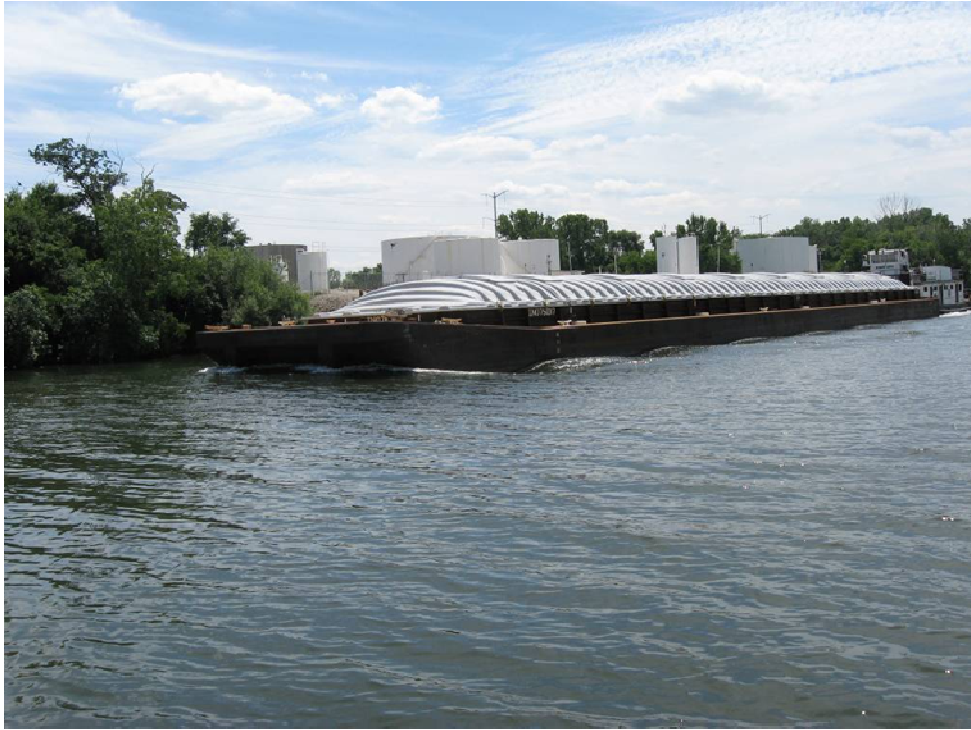
**Figure 2-3: Barge and Tug on the Chicago Sanitary and Ship Canal. Many CAWS Reaches are Deep Draft Waters (photo taken near AWQM 41, 2008).**

Deep water reaches in the CAWS can be greater than 20 feet deep to maintain adequate depth for commercial ship traffic (Figure 2-3) and to maintain storage volume for flood flows. These depths are maintained in many parts of the CAWS through dredging by the U.S. Army Corps of Engineers.

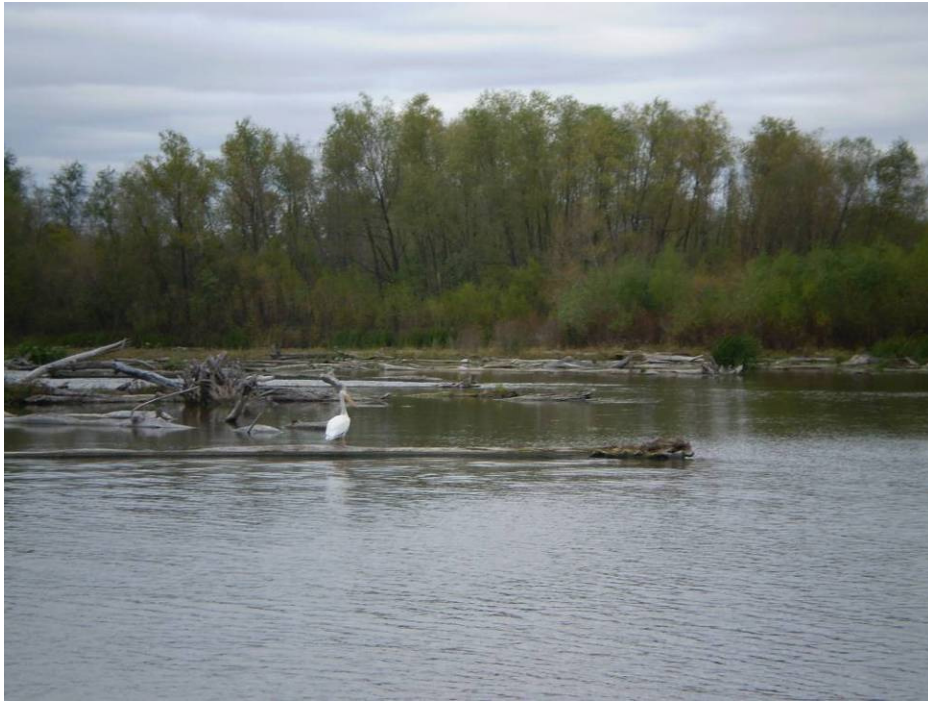
**Figure 2-4: Example of Off Channel Refuge Found in Natural Rivers, absent from the CAWS (photo taken in Lake Pepin, on the Mississippi River, 2007).**

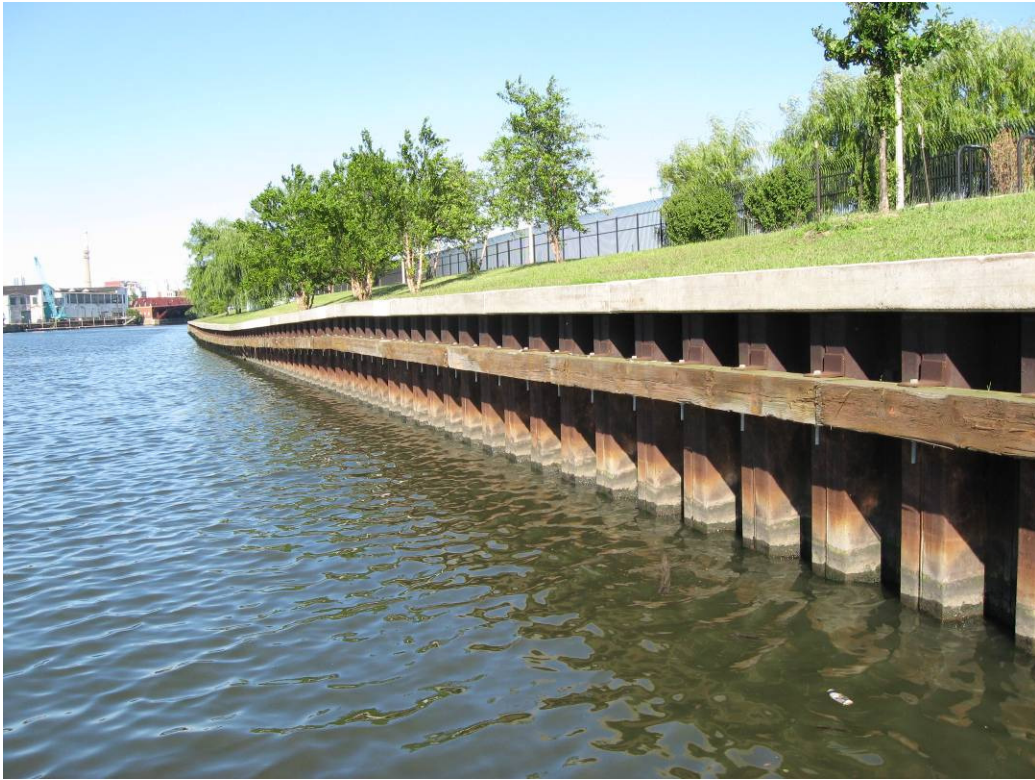
**Figure 2-5: Vertical Wall Banks are found throughout the CAWS (photo taken in South Branch Chicago River, near AWQM 40, 2008).**

The CAWS reaches evaluated in this Study have approximately 65 miles of vertical walled banks, which is about 42% of the banks in the Study area. These vertical walls consist of steel sheet piling (Figure 2-5), stone, and in some cases, wooden walls. The condition reflects the constructed nature of the CAWS and the primary functions of the system for support of effluent disposal, commercial navigation, and flood control. It goes without saying that these vertical wall banks do not resemble natural banks. They reflect the general absence of a littoral zone, disconnection from riparian areas, deep water, reduced in-stream aquatic vegetation and, in many cases, riparian development right to the water's edge.

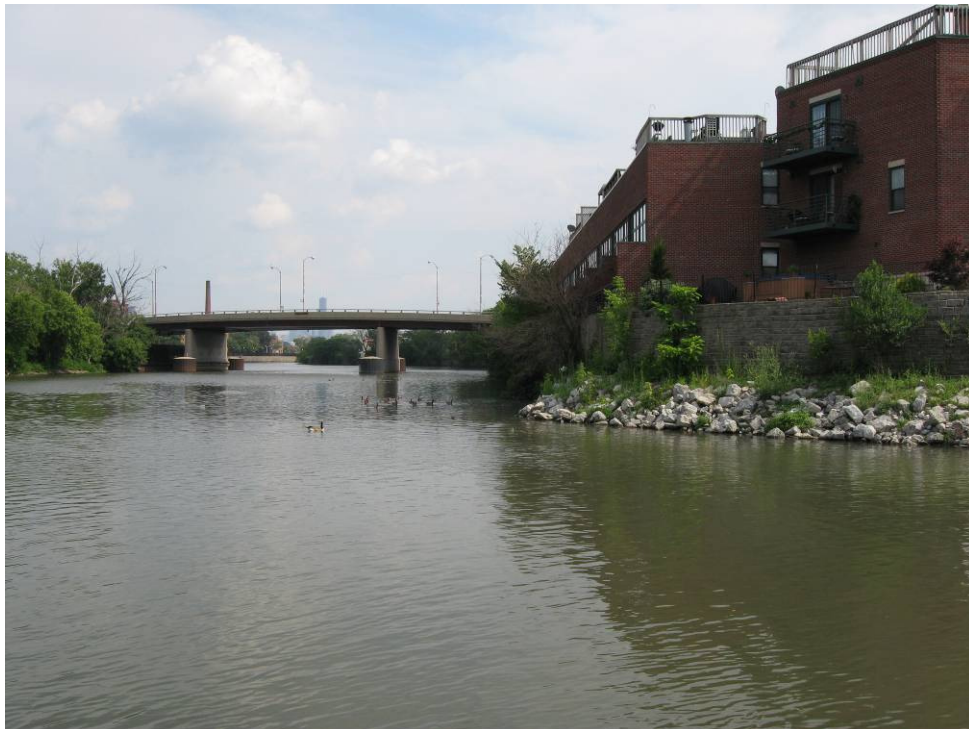
**Figure 2-6: Riprap Banks in the North Branch Chicago River (photo taken near AWQM 73, 2008).**

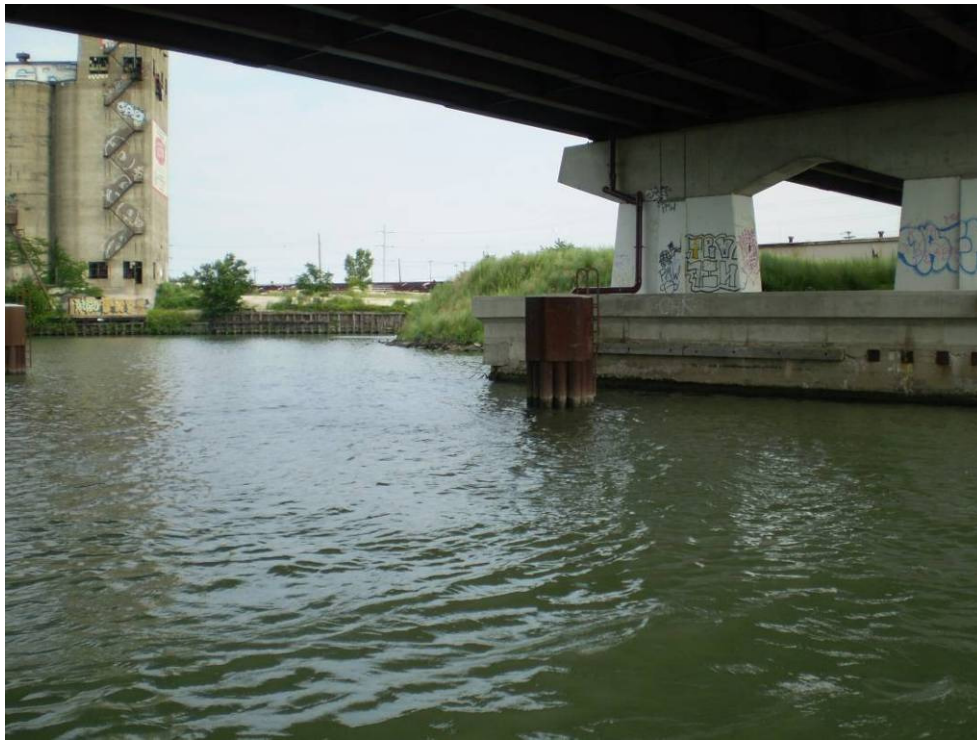
**Figure 2-7: Manmade Structure Such as Shown Here Were Negatively Correlated with Fish in the CAWS (photo taken in South Branch Chicago River at AWQM 40, 2008).**

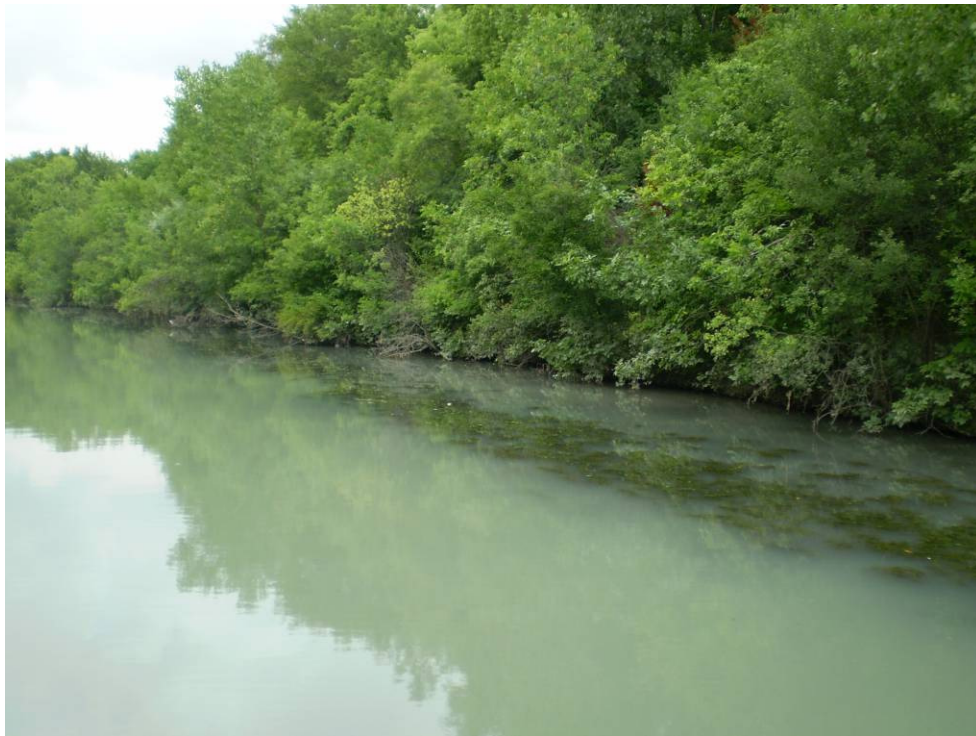
**Figure 2-8: Near-Shore Macrophyte Cover in the North Shore Channel (photo taken near AWQM 35, 2008)**

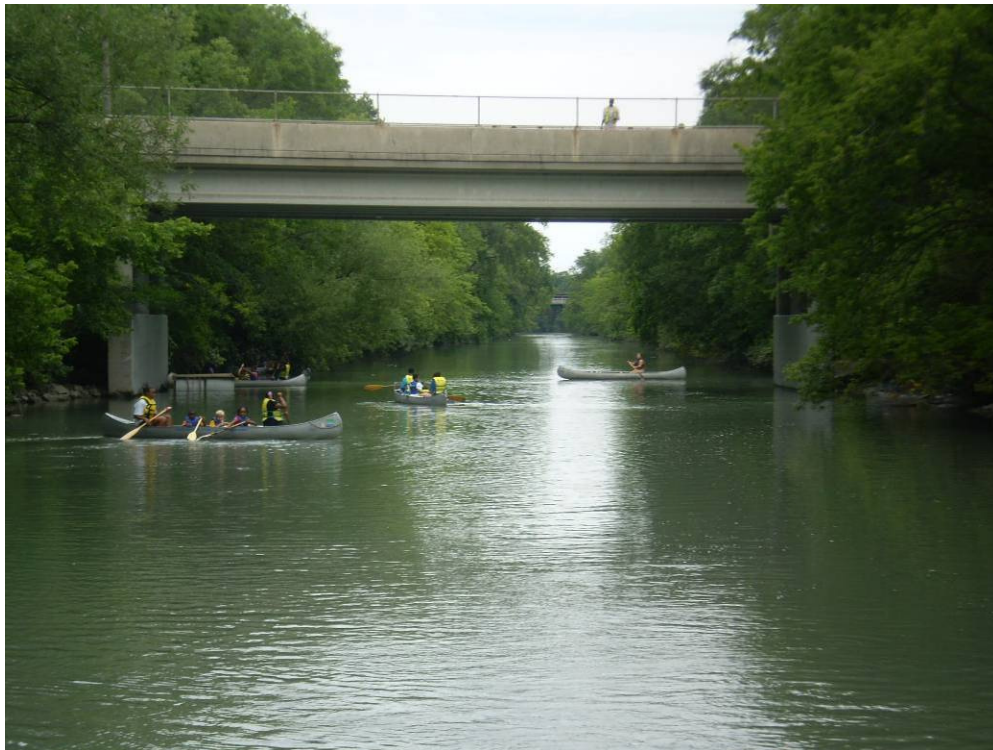
**Figure 2-9: Relatively High Overhanging Vegetative Cover in the North Shore Channel (photo taken upstream of AWQM 102, 2008).**

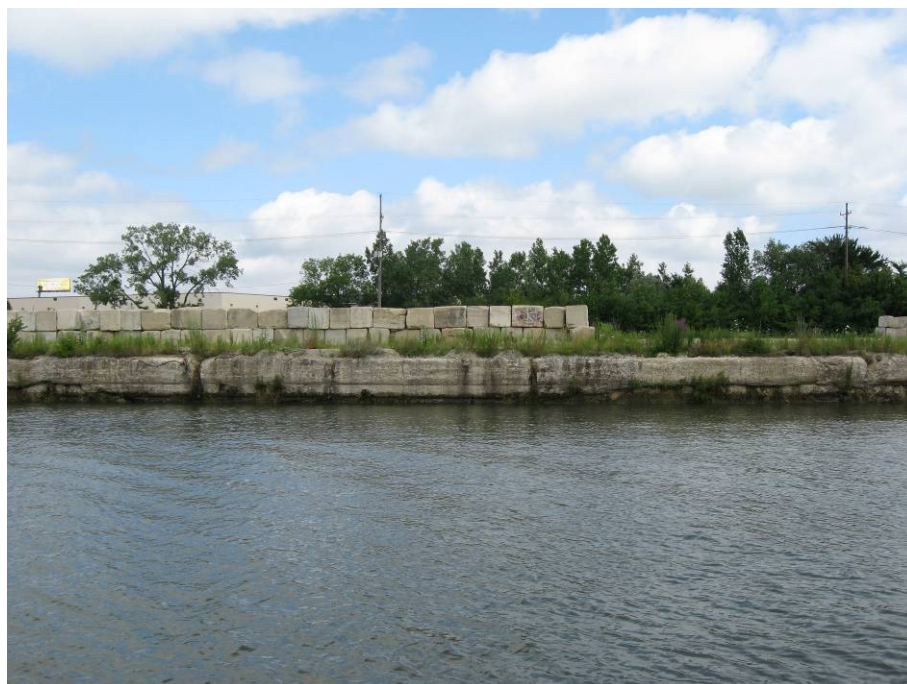
**Figure 2-10: Low Overhanging Vegetative Cover in the Lower Cal-Sag Channel (photo taken near AWQM 48, 2008)**

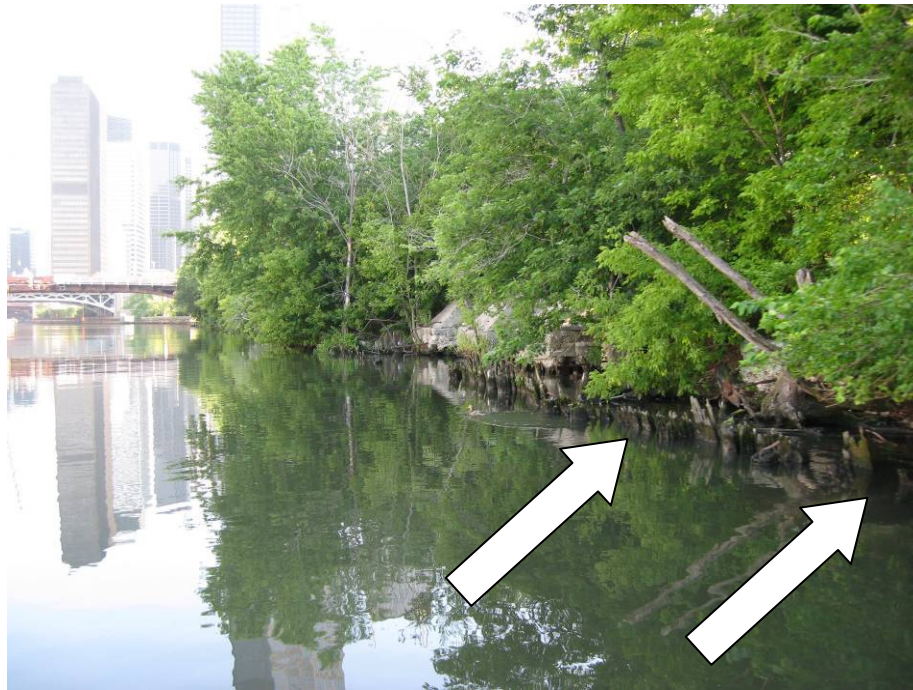
**Figure 2-11: Bank Pocket Areas (indicated by white arrows) Created by a Decaying Wooden Seawall on the South Branch Chicago River (photo taken downstream of AWQM 39, 2008).**

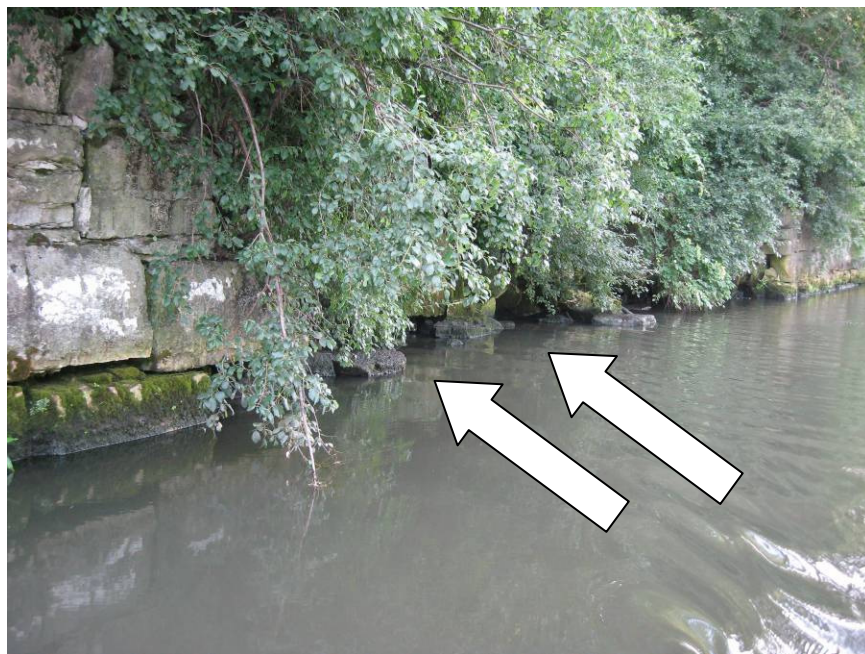
**Figure 2-12: Bank Pocket Areas (indicated by white arrows) Created by a Gaps in Limestone Walls on the Chicago Sanitary and Ship Canal (photo taken downstream of AWQM 41, 2008).**

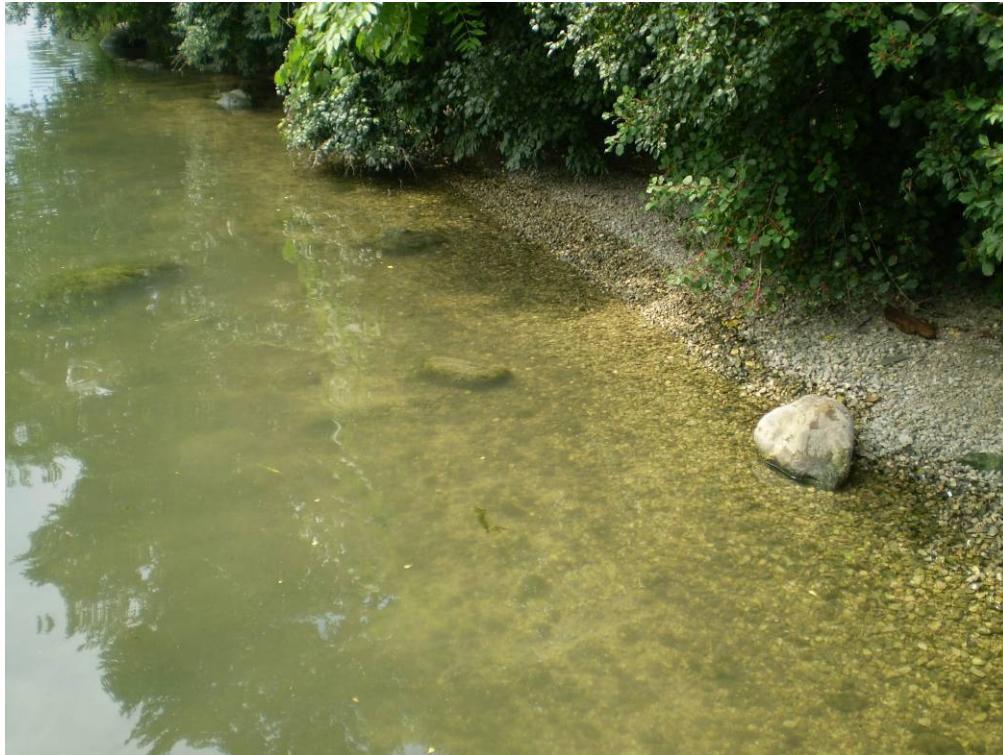
**Figure 2-13: Large Substrate, Consisting of Gravel, Cobbles, and Boulders, is relatively Uncommon in the CAWS (photo taken in CSSC, downstream of AWQM 41, 2008).**

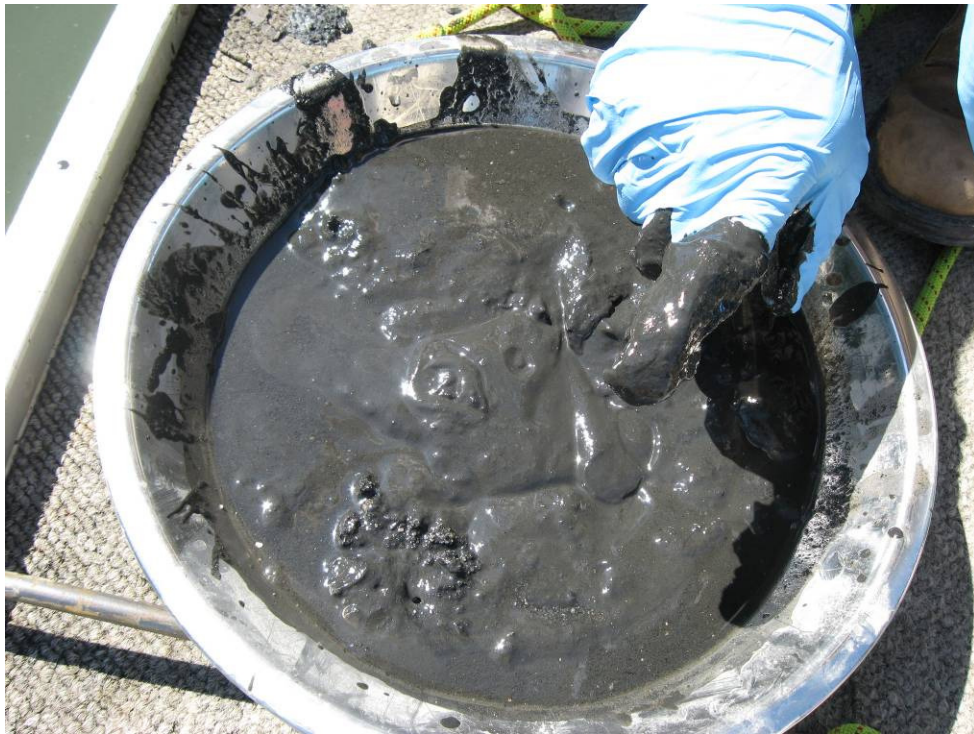
**Figure 2-14: Organic Sludge is Present in a Number of CAWS Reaches, Such as in This Picture from Bubbly Creek (photo taken at AWQM 99, 2008).**

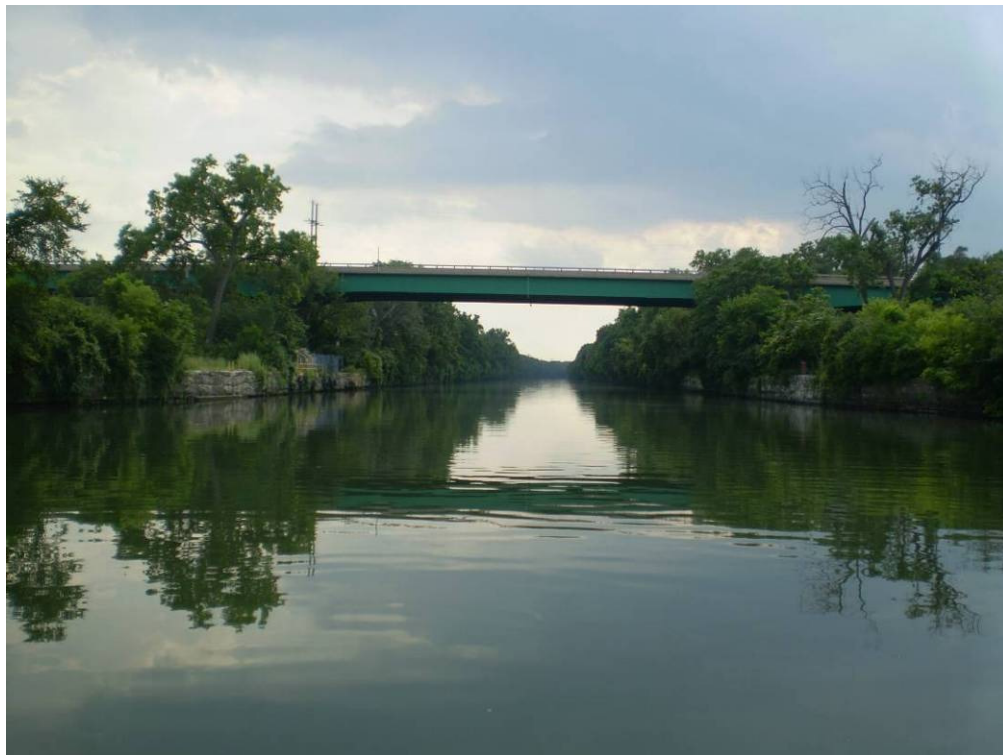
**Figure 2-15: Most of the CAWS Waterways Were Constructed Without Floodplains, Like This Middle Portion of the Chicago Sanitary and Ship Canal (photo taken downstream of AWQM 41, 2008).**

Floodplains never existed for the 75% of the CAWS that were excavated where channels did not previously exist (Figure 2-15), such as in the Cal-Sag Channel and the Chicago Sanitary and Ship Canal. In the CAWS reaches that were once natural waterways, or partially so, channelization has eliminated floodplain connectivity almost entirely. In addition to the absence of floodplains and floodplain connectivity, the entire system is actively managed to prevent flooding. For these reasons, there is no potential for improving this habitat impairment.

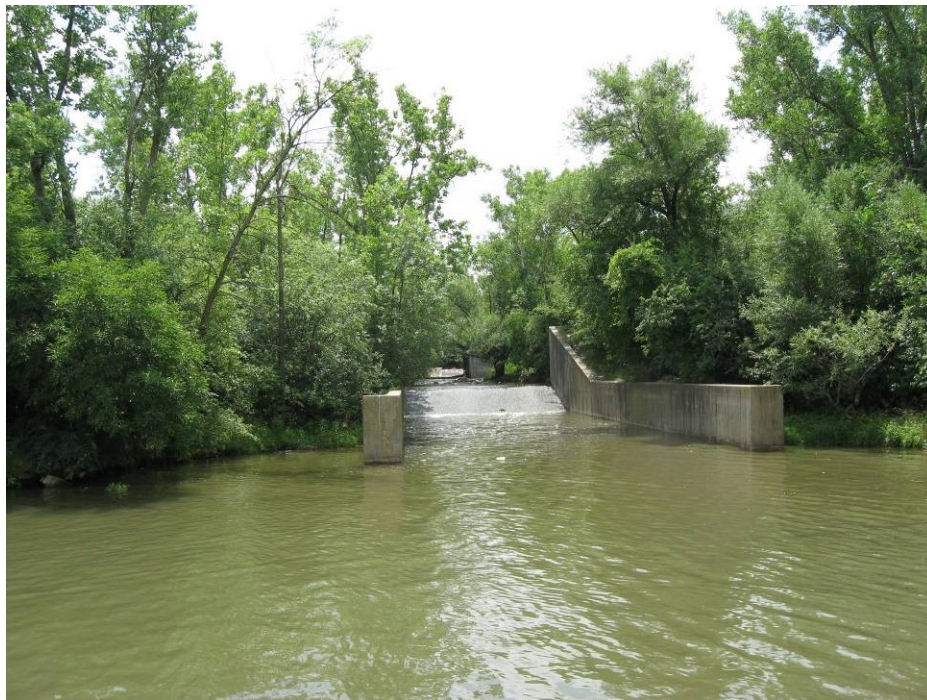
**Figure 2-16: Tributary Access Blocked by a Concrete Structure at the Mouth of Tinley Creek on the Cal-Sag Channel (photo taken 2008).**

A few tributaries are connected to the CAWS, but in many cases, structures have been built across tributary mouths (Figure 2-16). These structures can effectively block fish passage.

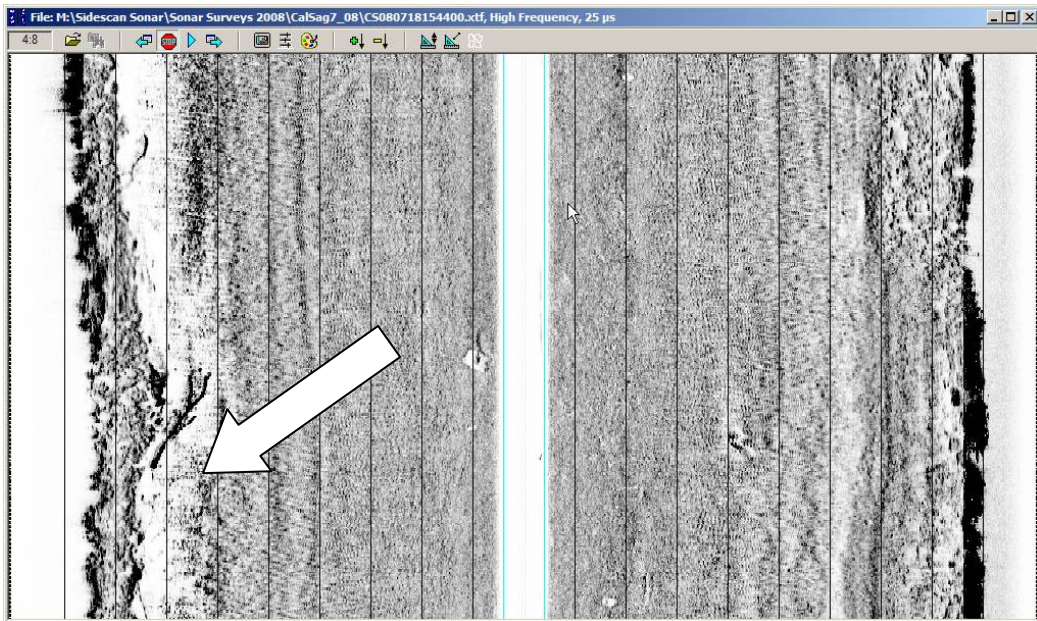
**Figure 2-17: Limited In-Channel Structure Exists in the CAWS, Such as the Apparent Tree Trunk Visible on the Left Side of This Side Scan Sonar Image (white arrow) from the Cal-Sag Channel (near AWQM 59, 2008).**

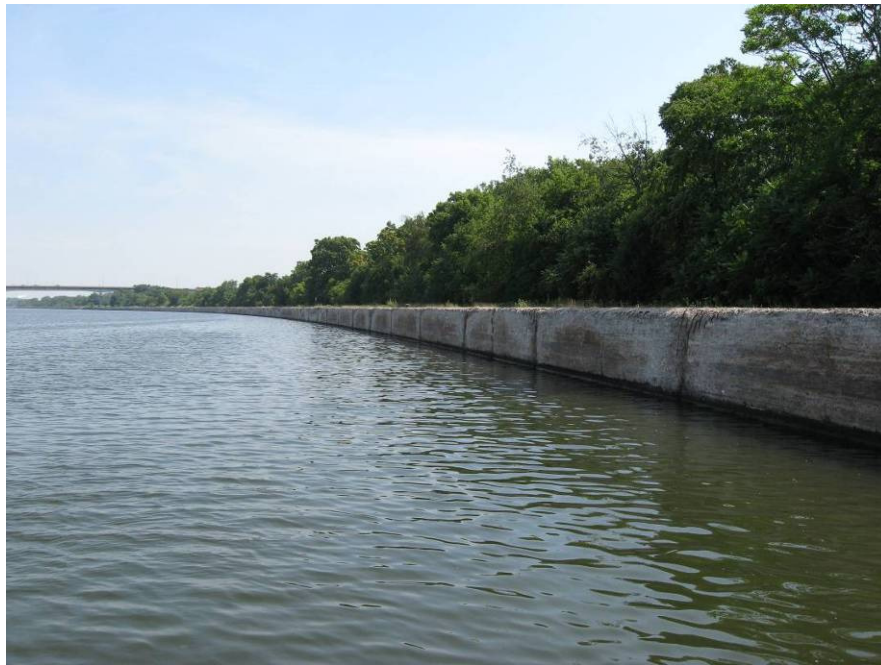
**Figure 2-18: Many of the CAWS Reaches Completely Lack Littoral Zones by Design, Such as Seen Here in the Chicago Sanitary and Ship Canal (photo taken downstream of AWQM 48, 2008).**

In the CAWS, large portions of the system were constructed without littoral zones, such as the Chicago Sanitary and Ship Canal, most of which was excavated into bedrock with vertical sides (Figure 2-18). Other reaches in the CAWS have had their littoral zones replaced with vertical sheet pile walls or other vertical revetments. This is the case in the entire Chicago River, as well as portions of the North and South Branches of the Chicago River, and Bubbly Creek. In total, approximately 65 miles of

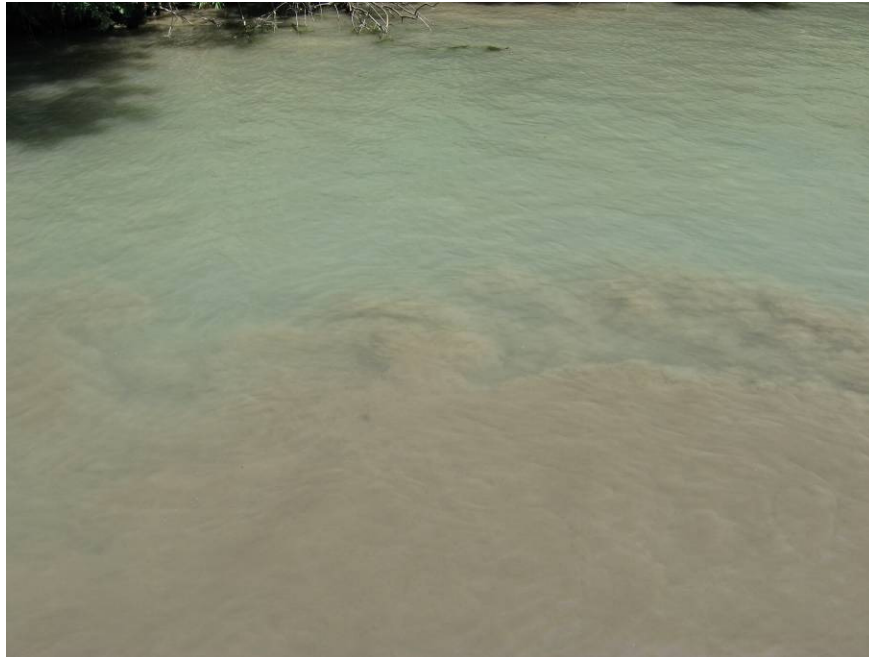
**Figure 2-19: Reduced Water Clarity in the North Shore Channel (photo taken near AWQM 102, 2008)**

Water clarity, as measured by Secchi depth, is generally poor throughout the CAWS (Figure 2-19). Some reaches, particularly those closest to Lake Michigan, have generally better water clarity, likely due to the inflow of clearer water from the lake. This effect is particularly noticeable in the Chicago River, which has the highest water clarity by far. It is noticeable to a much lesser degree in the upper North Shore Channel, which receives pumped water from Lake Michigan. Throughout the rest of the system, water clarity is almost uniformly poor.

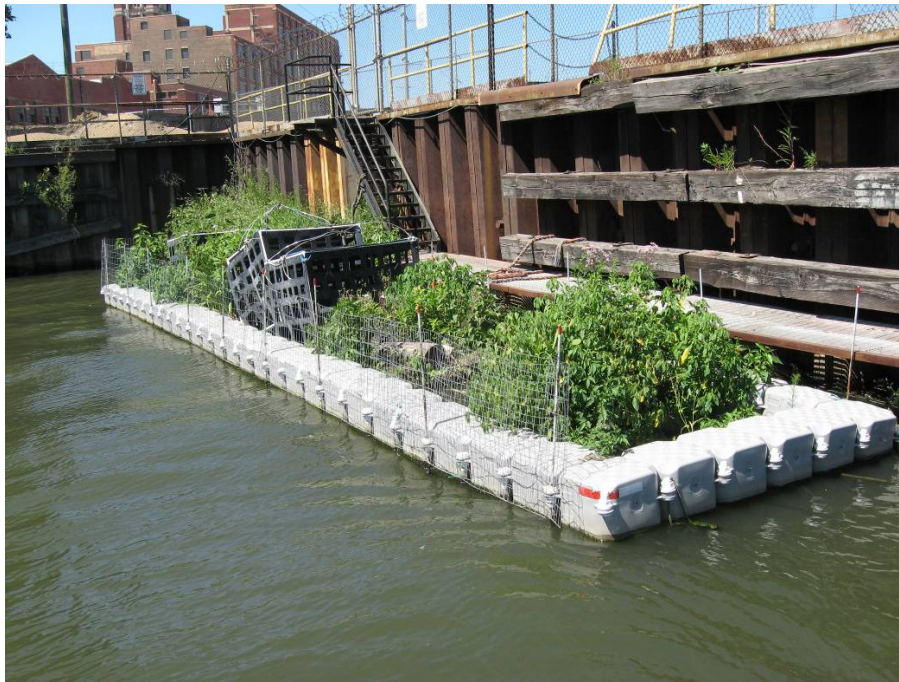
**Figure 3-1: Fish Hotel, South Branch Chicago River, 2008**

The friends of the Chicago River have implemented a habitat improvement project on the Chicago River that they refer to as the “fish hotel”, a floating island design that is intended to provide shelter, forage, and reproduction habitat for fish. A similar structure was observed on the South Branch Chicago River during field surveys in 2008 (Figure 3-1).

Based on a telephone inquiry to the Friends of the Chicago River, it is known that one fish hotel structure is currently deployed in the Chicago River and although periodic visual observations are made to identify fish, no biotic sampling has been conducted to quantify the benefit of the structure.
