CALUMET WATER RECLAMATION PLANT Investigation of Explosion and Structural Collapse in Gravity Belt Thickener Room

Final Report

November 16, 2018

Metropolitan Water Reclamation District of Greater Chicago

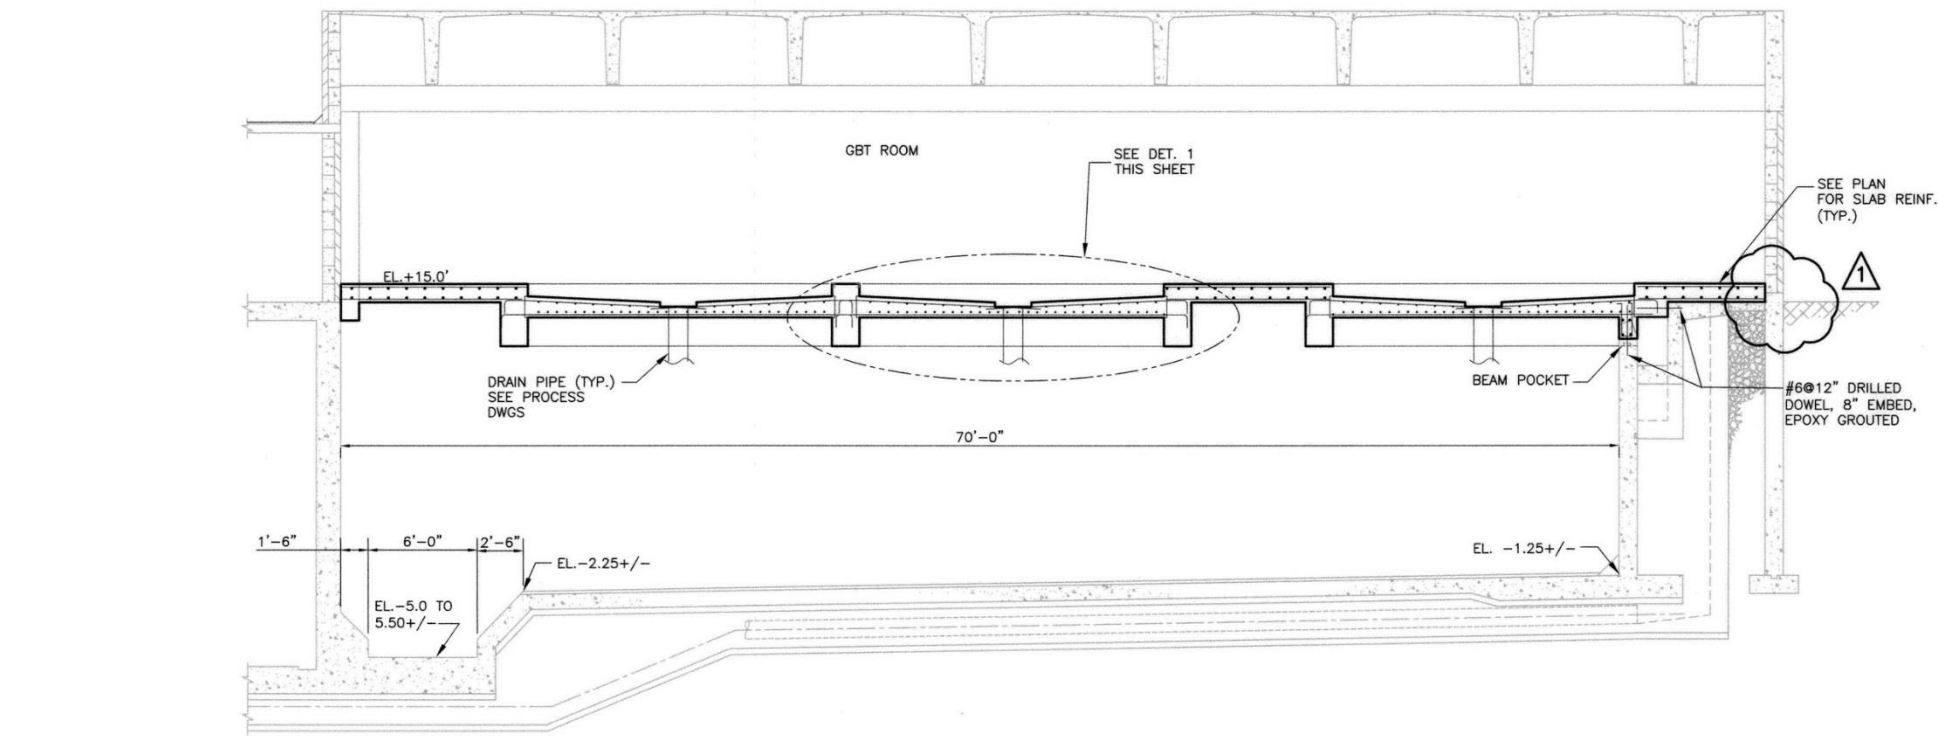
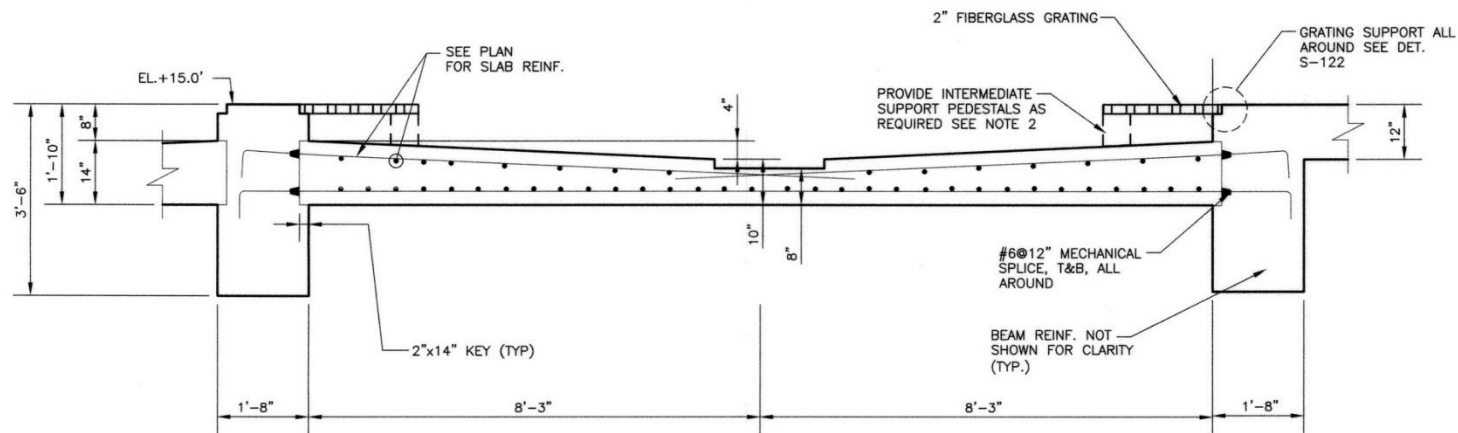
Sheet Number:
S-113
Page Number: 55

modified to become the GBT Room. In the GBT Room, the modifications included removing some internal tank walls, installing new internal tank walls, and installing a new cast-in-place reinforced concrete beam-supported slab over the top of the tanks. In addition to serving as a cover over the existing below-grade tanks, this reinforced concrete slab also served as the floor of the new GBT Room and supported the gravity belt thickener equipment. Figure 3 reproduces the structural drawing (S-109) from Contract 96-251-2P showing the new floor structure in the GBT Room. Figure 4 reproduces Drawing S-114 (Contract 96-251-2P) showing a section view through the GBT Room looking north, and Figure 5 reproduces Drawing S-113 (Contract 96-251-2P) showing a section view through the GBT Room looking east.

Figure 5. Section view through GBT Room looking east - Drawing S-113

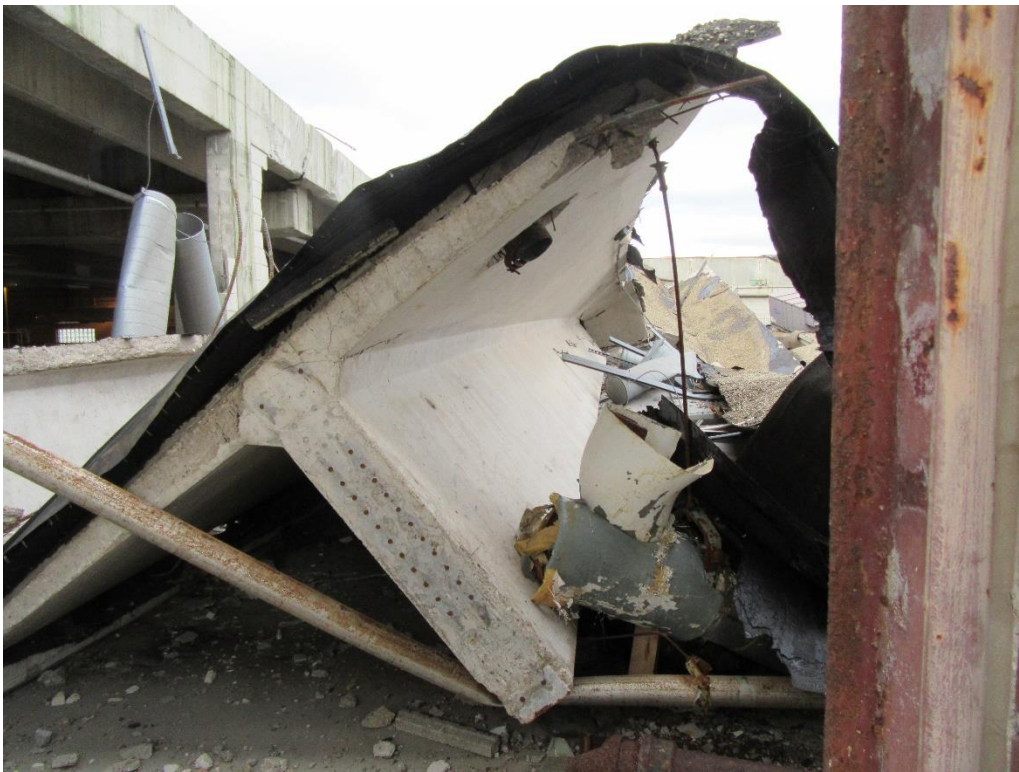
The roof structure over the GBT Room was separated from the adjacent areas (Operating Gallery roof and Gravity Concentration roof) by expansion joints. The GBT Room roof structure consisted of precast prestressed concrete single tee beams spanning 110 feet between the east and west exterior walls of the building. The single tee beams consisted of a 4 foot deep by 8 inch wide stem with a 10 foot wide flange. The flange thickness varied from 5 1/2 inches at the stem to 1 1/2 inches at the outer tip. Figure 6 shows an end view of one single tee beam. The stems of the single tee roof beams were supported on a cast-in-place reinforced concrete frame at the east wall and at the west wall. At the west wall, the stem of each single tee roof beam was attached with a single 1 inch diameter bolt to double angles welded to an embedded steel plate in the west girder (Figure 7). At the east wall, the single tee roof beams were set between but not bolted to the double angles (Figure 8). The roof structure of the GBT Room consisted of a total of eight single tee beams. The beams were connected to each other with flange connectors consisting of steel plates welded to plates embedded in the beam flanges.

Figure 6. End view of precast prestressed single tee roof beam

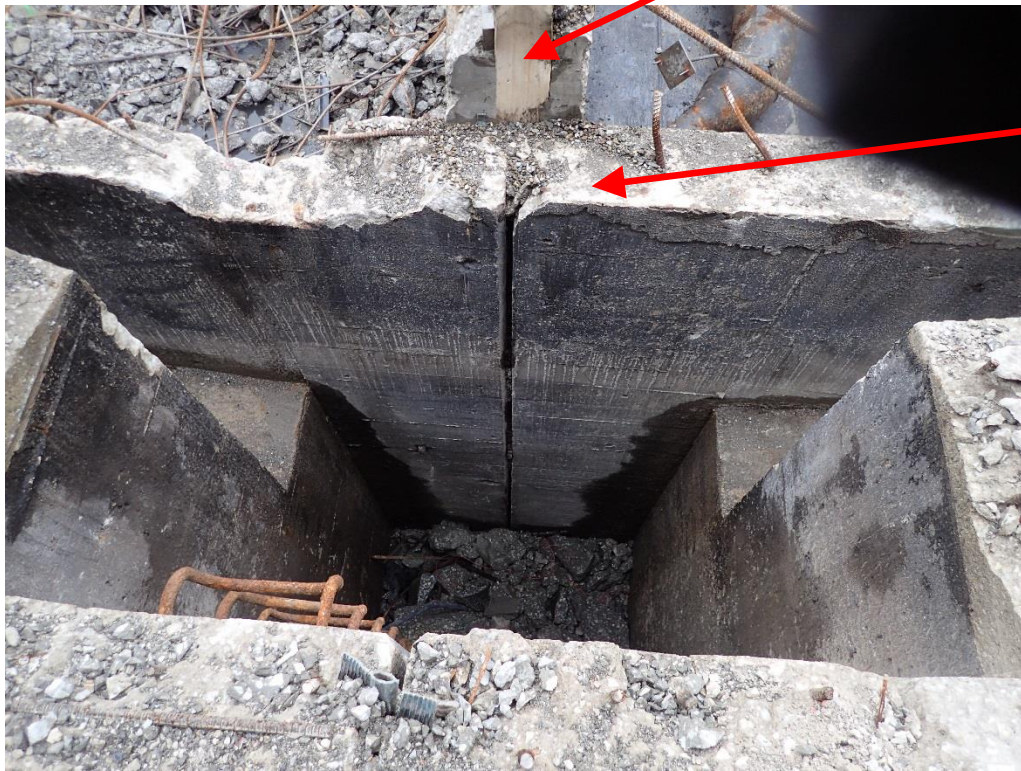
Interior tank wall between east tank and center tank

South wall of tank

Figure 35. Blending tank common overflow facilities
