Perspectives on Private Sector Infiltration/Inflow Identification and Rehabilitation

Prepared by
Alan J. Hollenbeck, P.E., BCEE
President/CEO
RJN Group, Inc.

2012 – Original 1980's ICAP “Revisited”

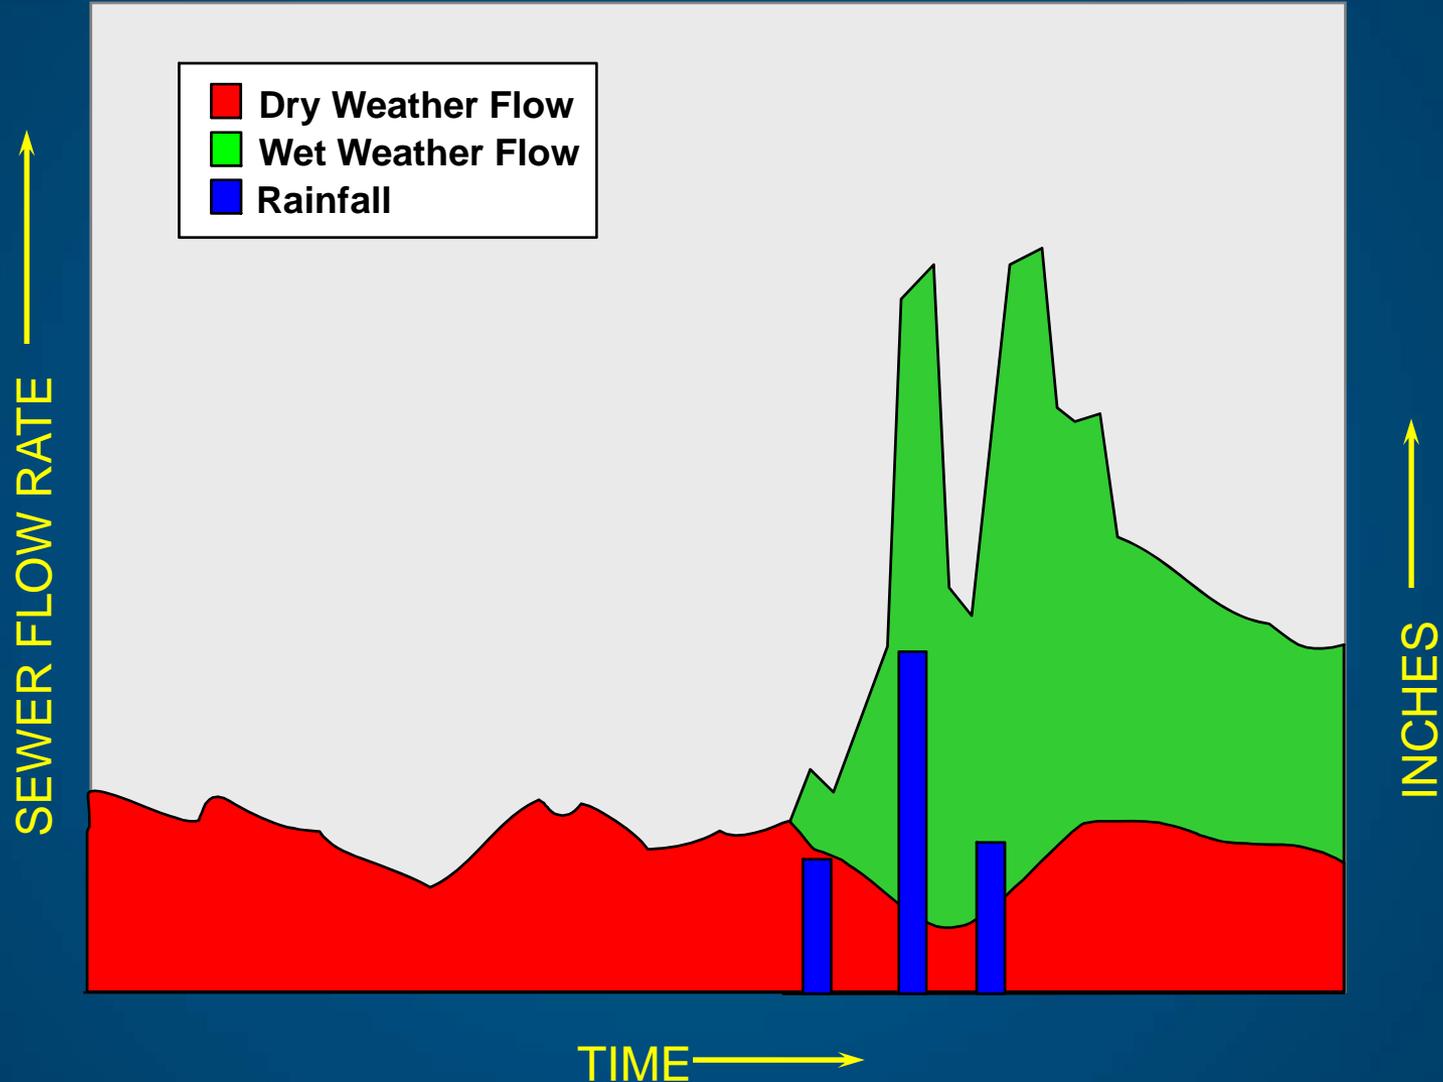
Typical Sewer Flow Hydrograph

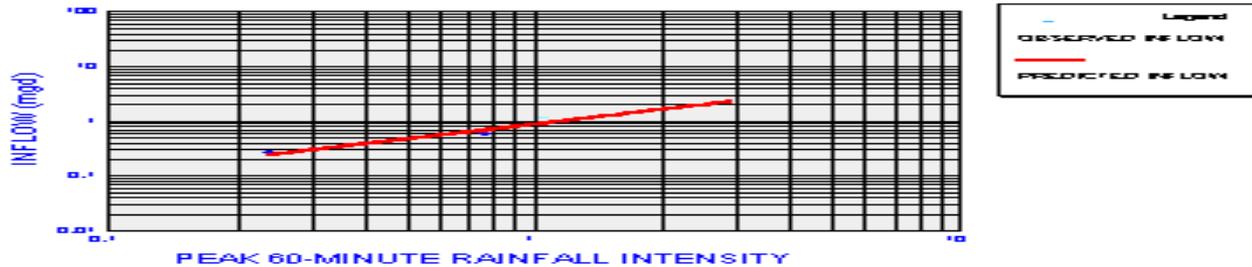
Rainfall Intensity & Inflow Relationship
Basin 02

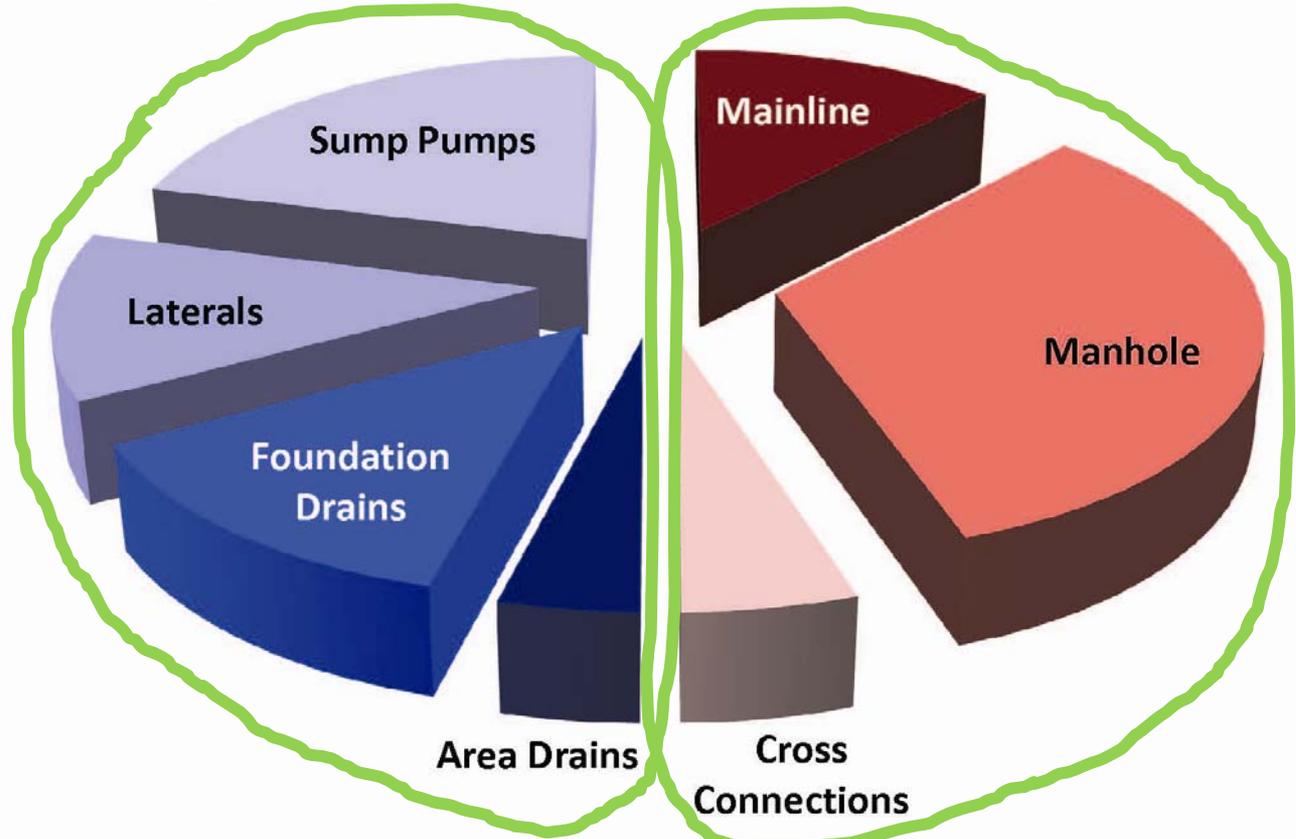
Pre-ICAP 1985 - Typical Inflow Distribution in Chicago Area

Typical Inflow Source Distribution - Illinois

Public Sector = 50%

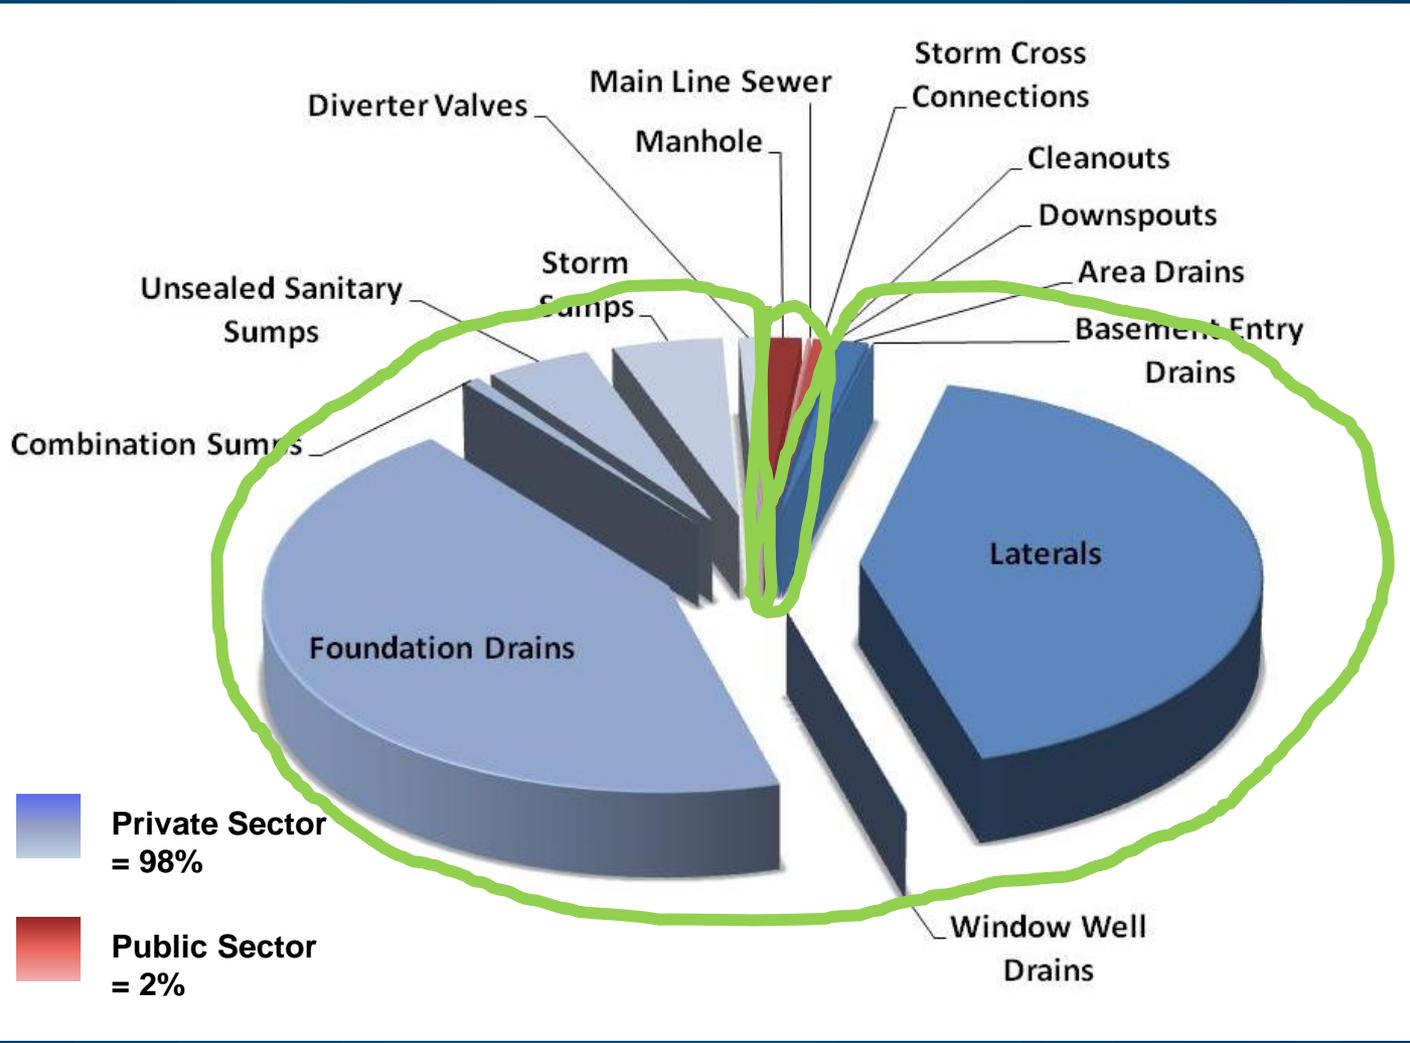
Inflow Source Distribution - Basin 4

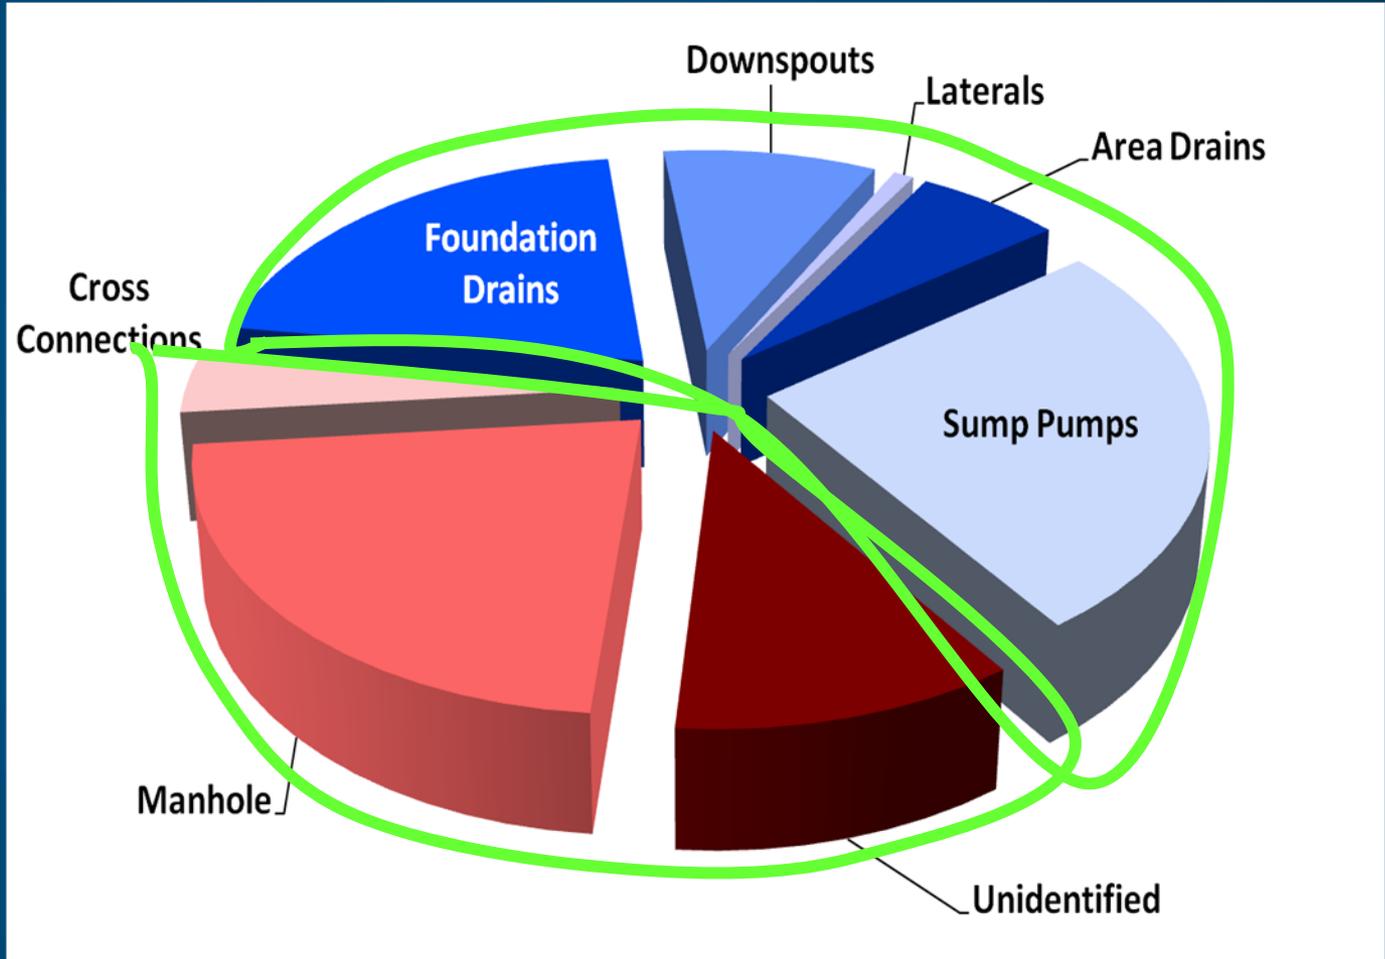
Elmhurst Inflow Distribution in 1987

Private Sector = 63%

Public Sector = 37%

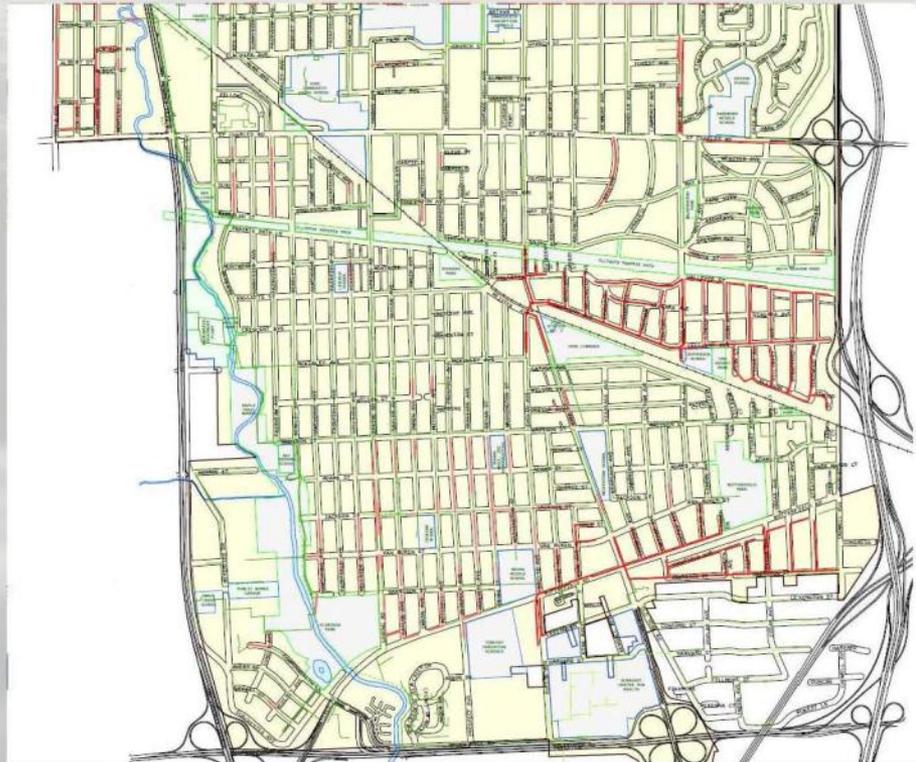
CIPP Lining Program- South Elmhurst

Sanitary Sewer Lining Projects South Elmhurst (since 1993)

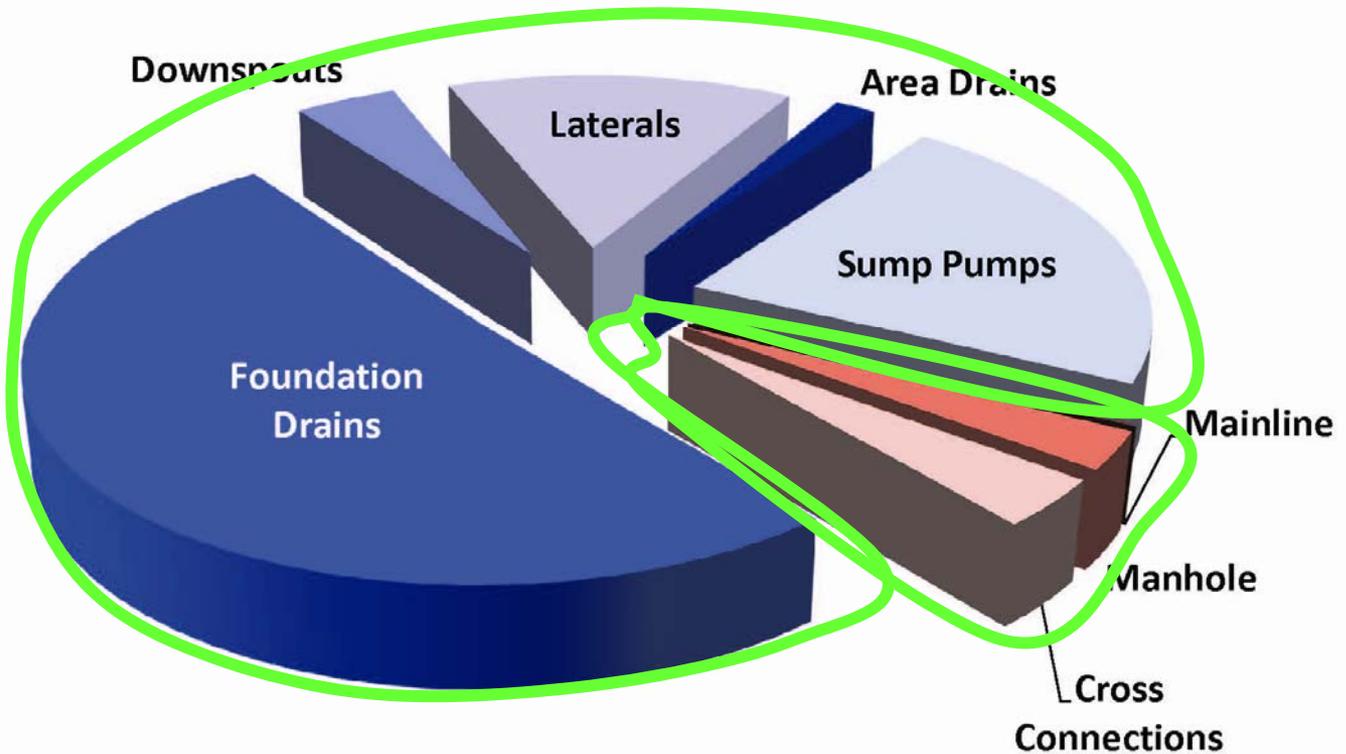
Elmhurst Citywide Distribution in 2011

City-Wide Inflow Distribution

Public Sector = 7%

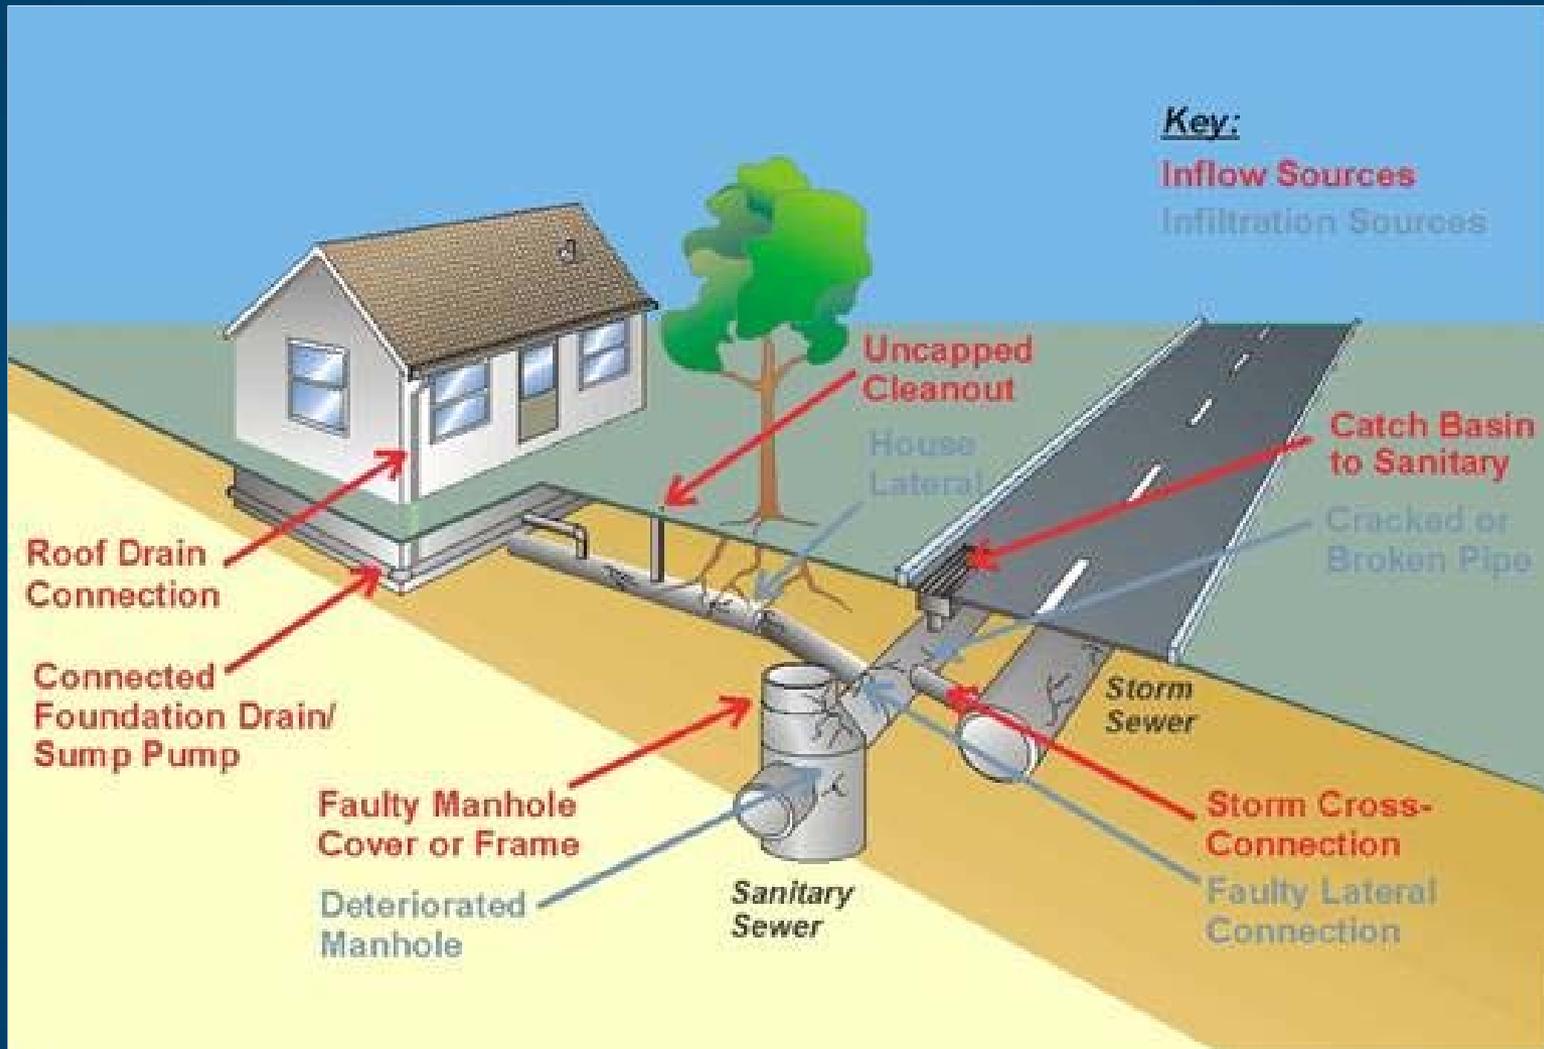
Public Sector Infiltration/Inflow – Main Line

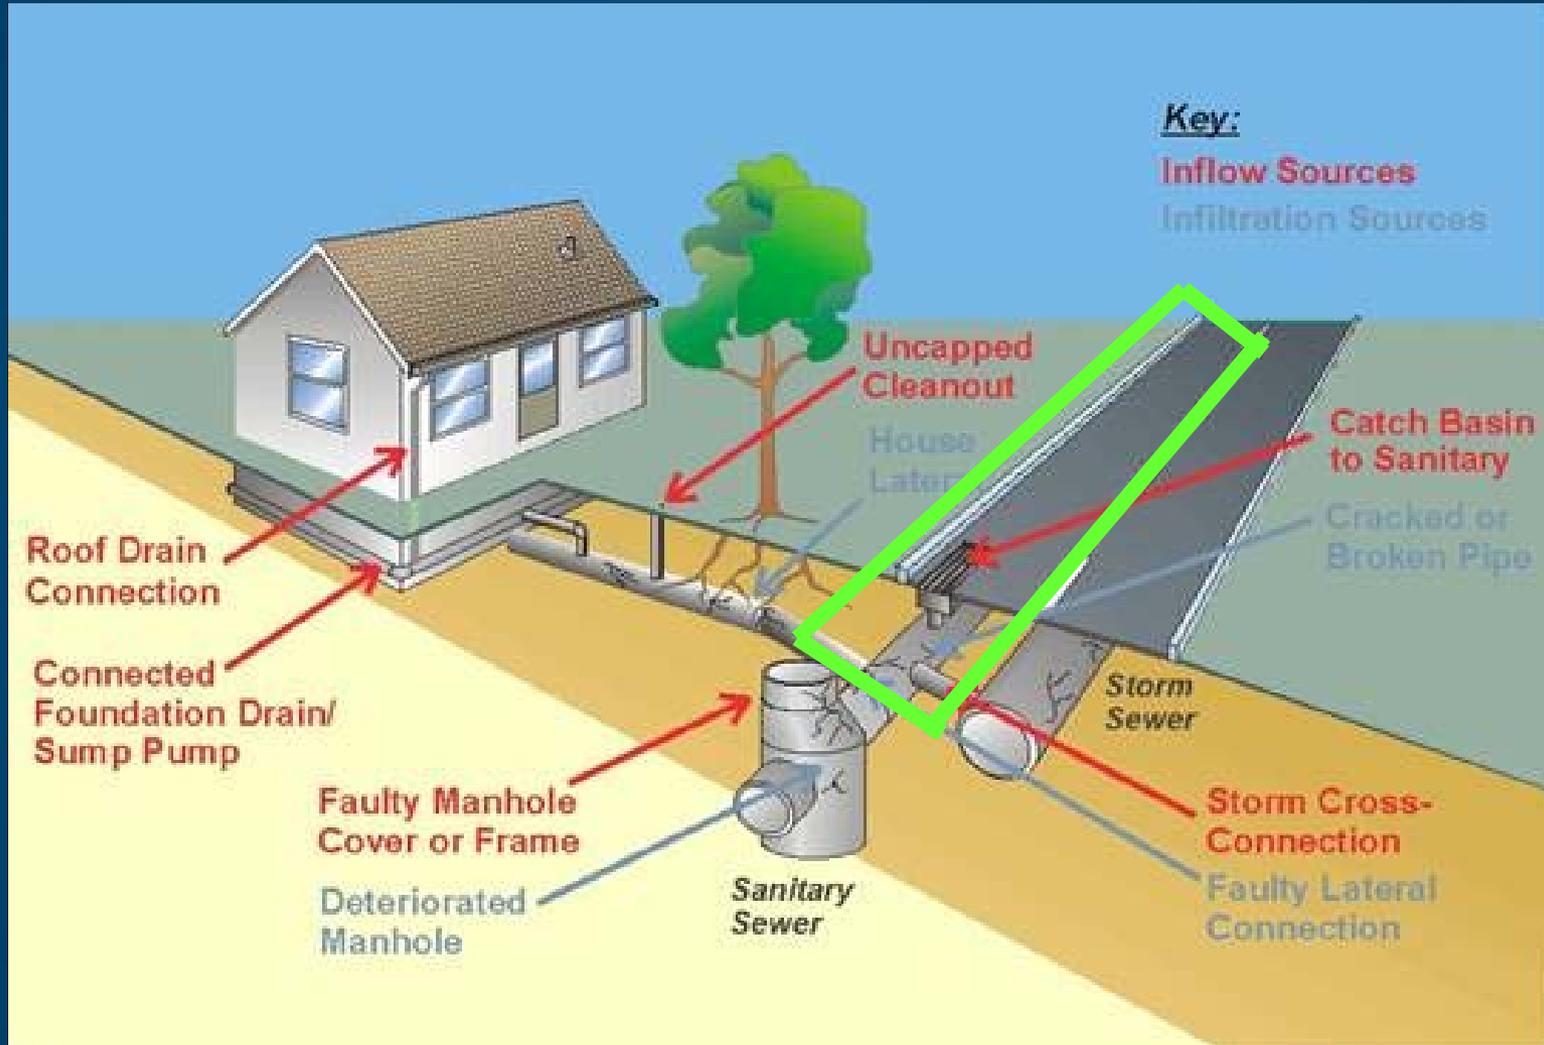
Public Sector Infiltration/Inflow – Main Line

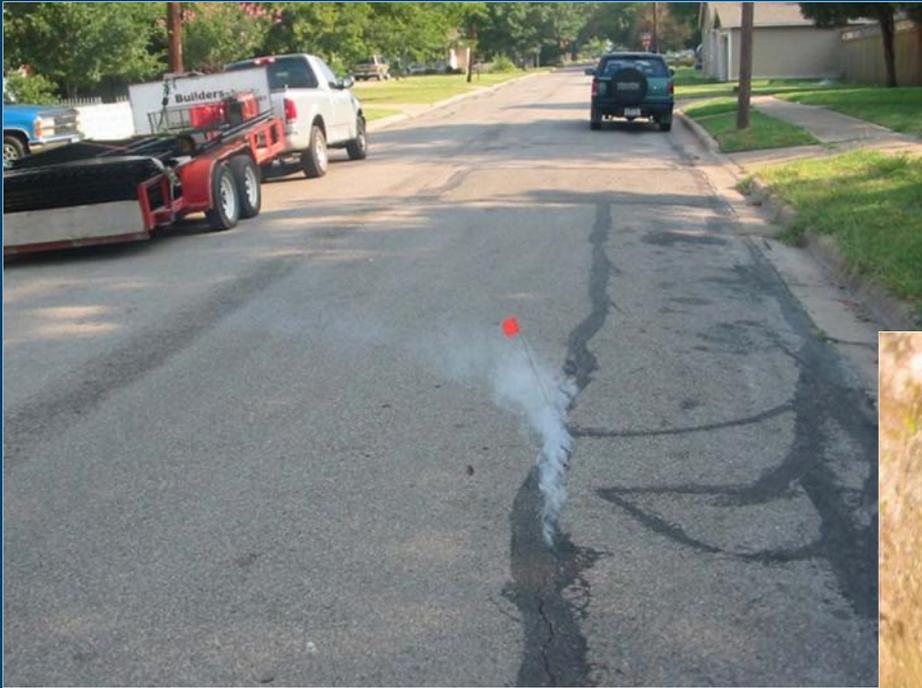
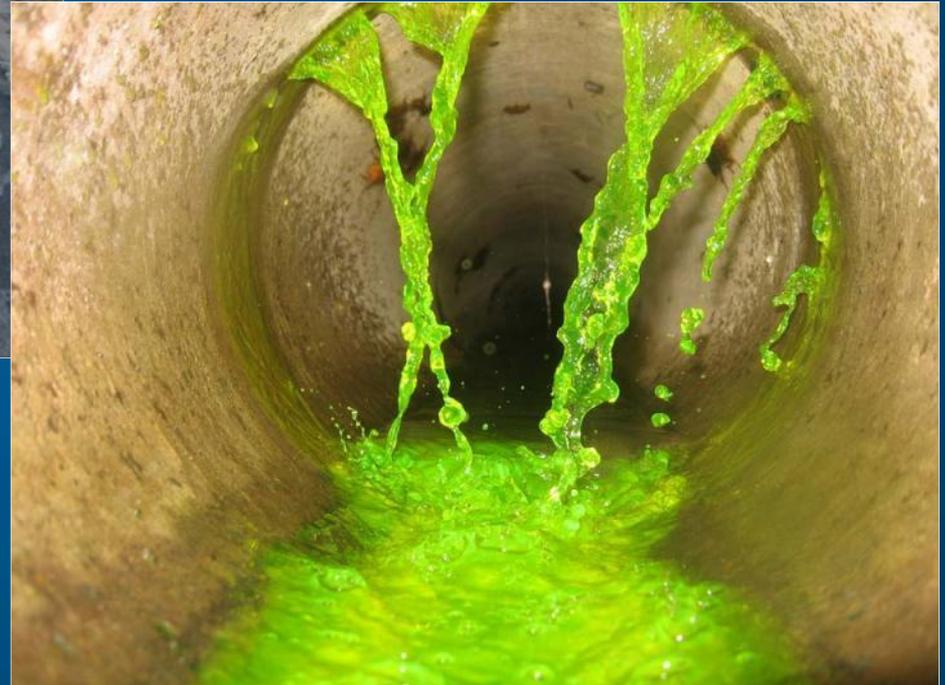
Main Sewer Defects

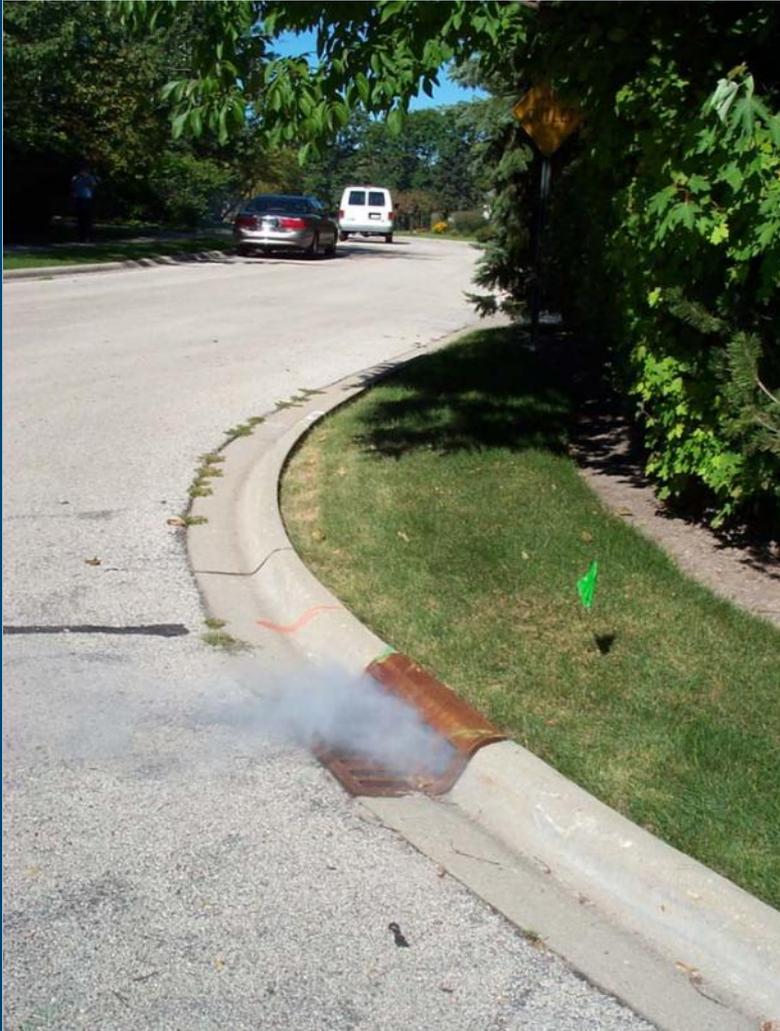
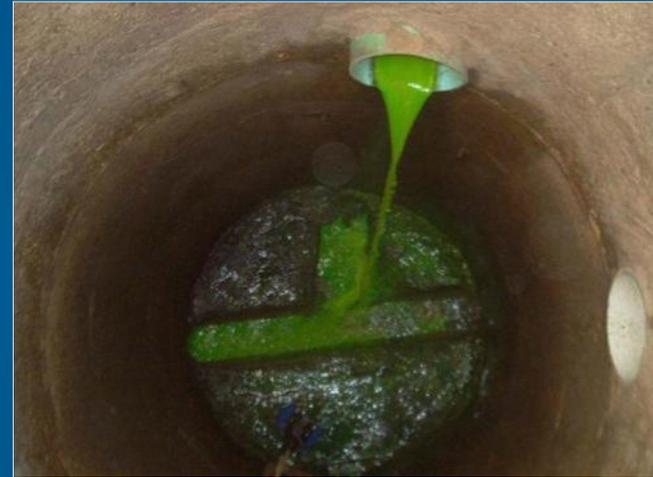
Indirect Cross Connections

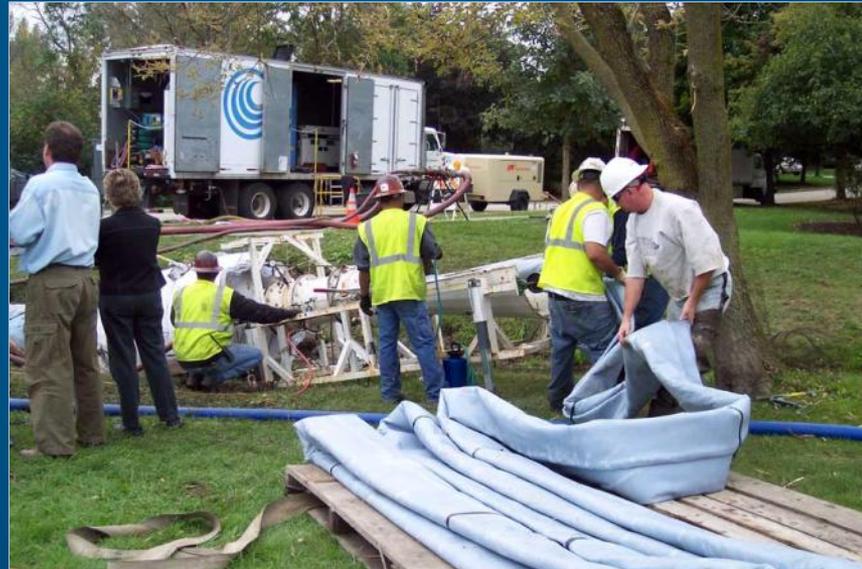
Main Line Sewer Rehabilitation

- Rehabilitate from Manhole to Manhole
- Excavation Not Required Using “Trenchless Technology”
- Most Common in Illinois - Cured In Place Pipe (CIPP)

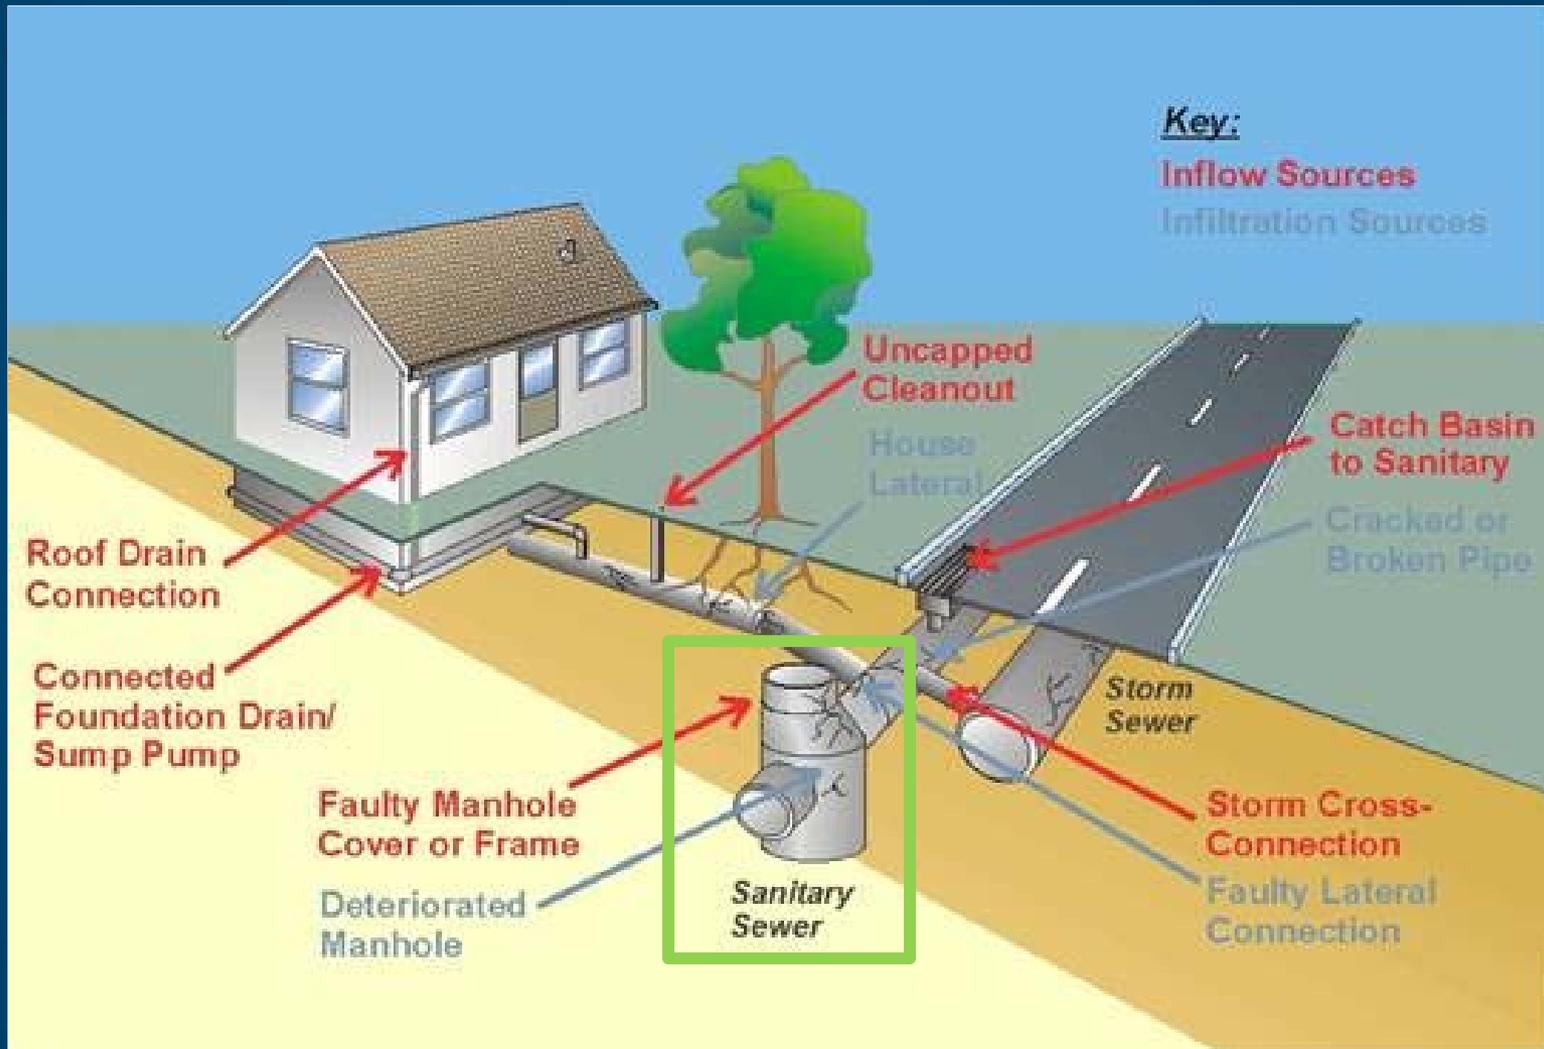
Public Sector Infiltration/Inflow - Manholes

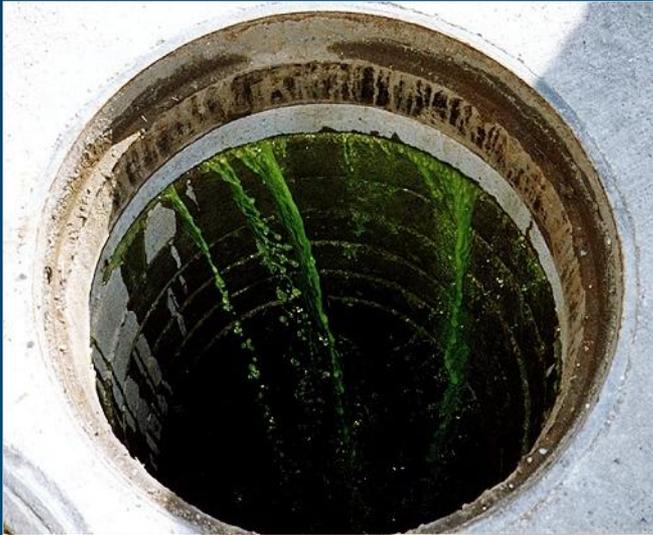
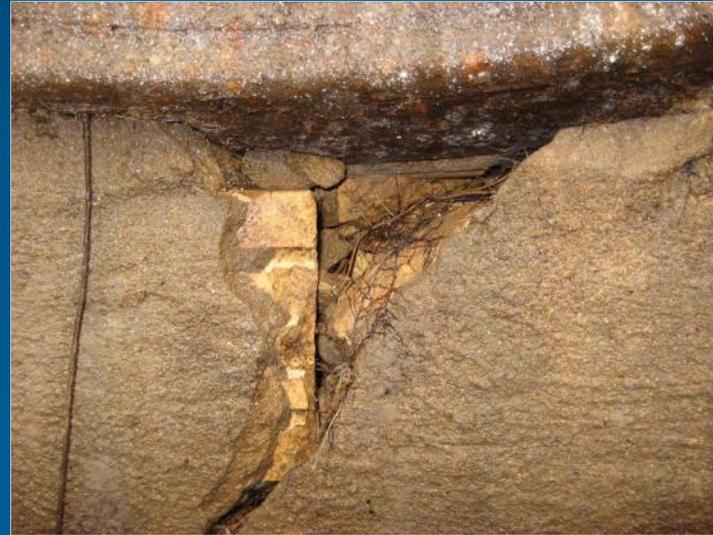
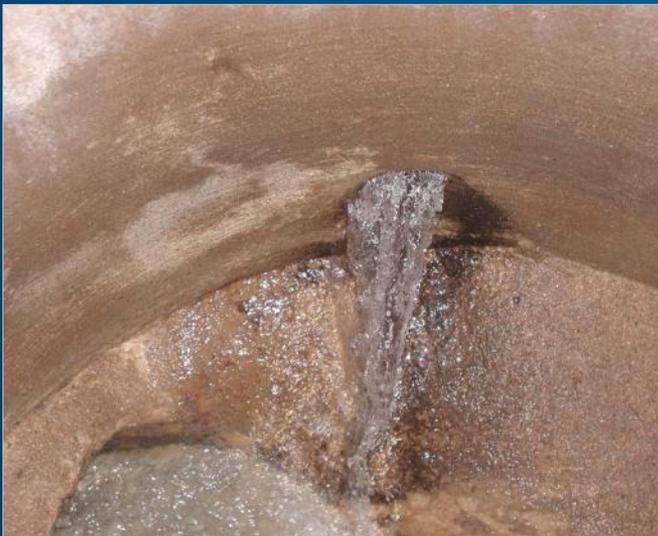
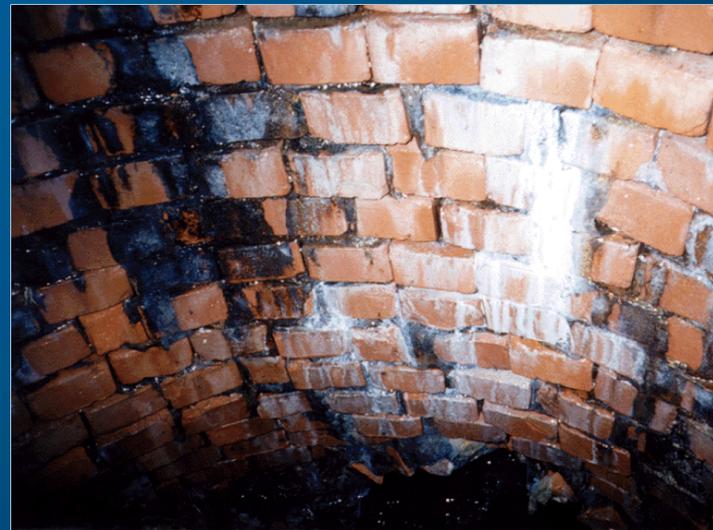
Manhole Infiltration/Inflow Defects

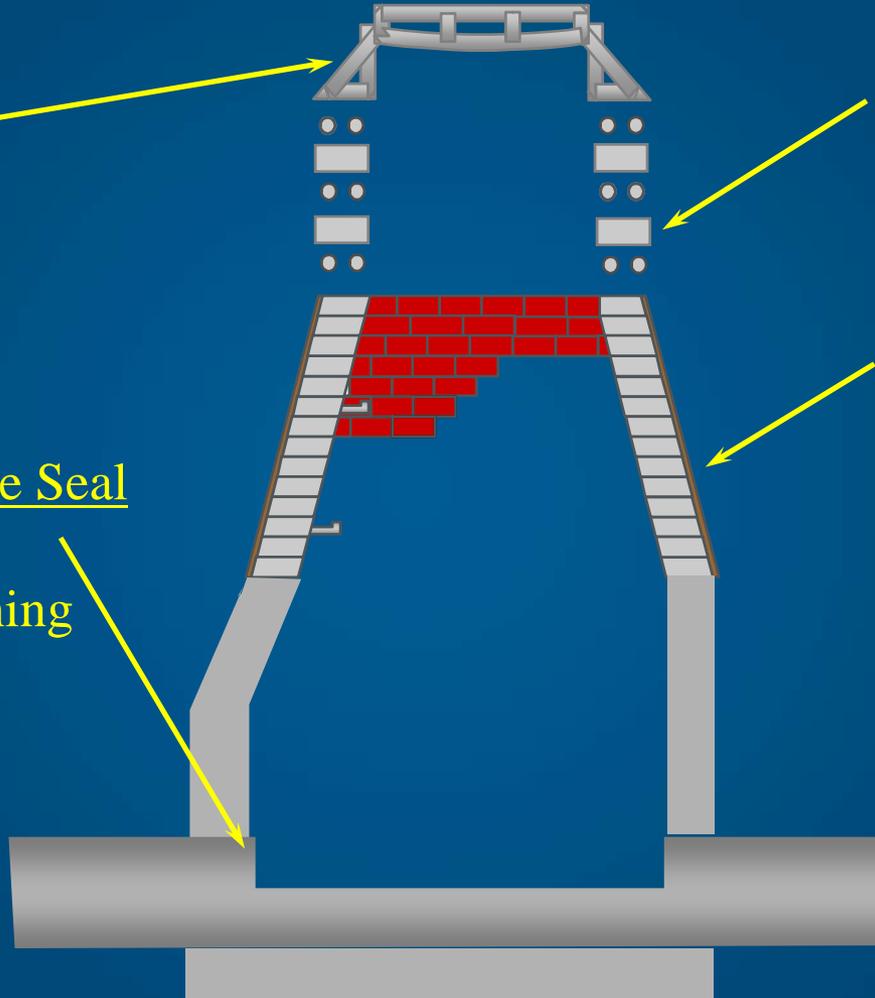
Manhole Walls

- chemical grouting
- cement linings
- epoxy coatings
- CIP systems
- oakum rope

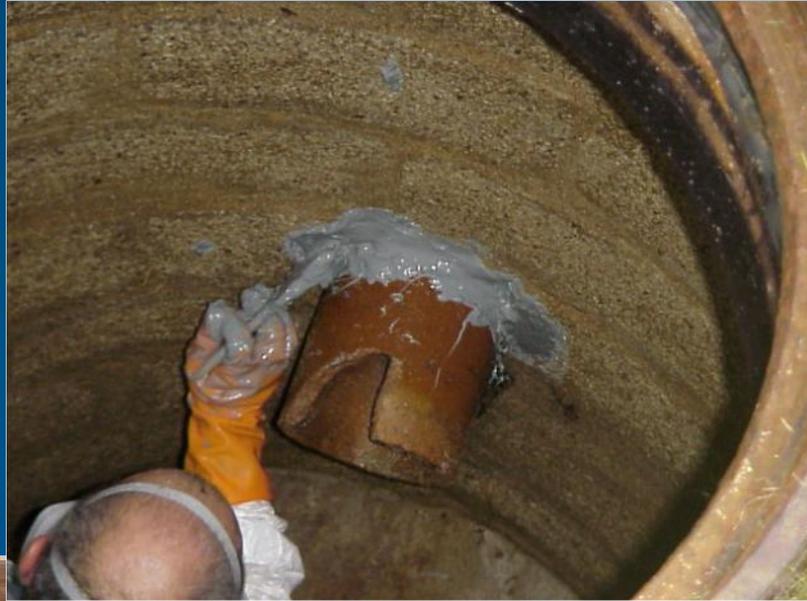
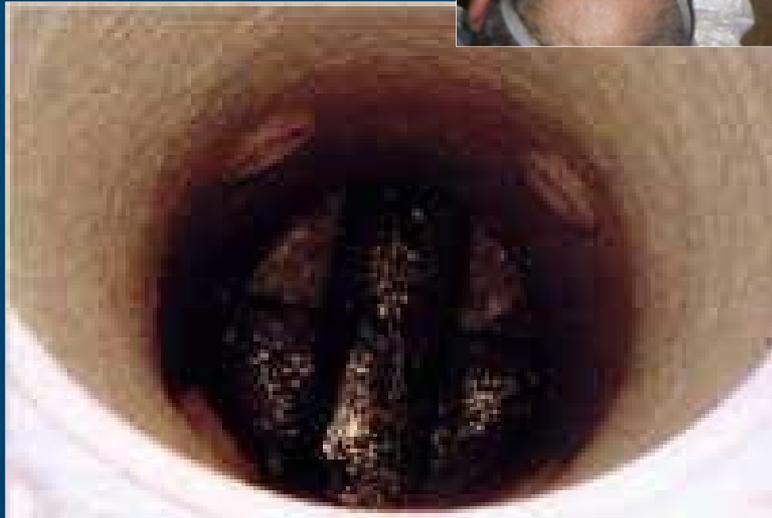
Manhole Rehabilitation

“Permacast”

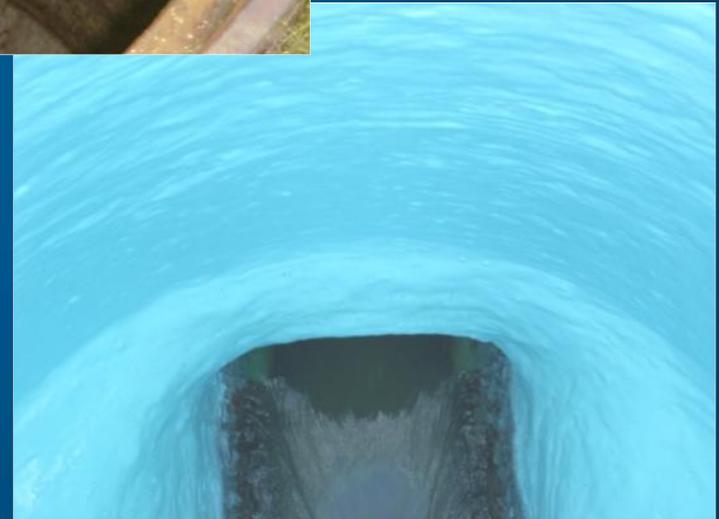
“Raven 405”

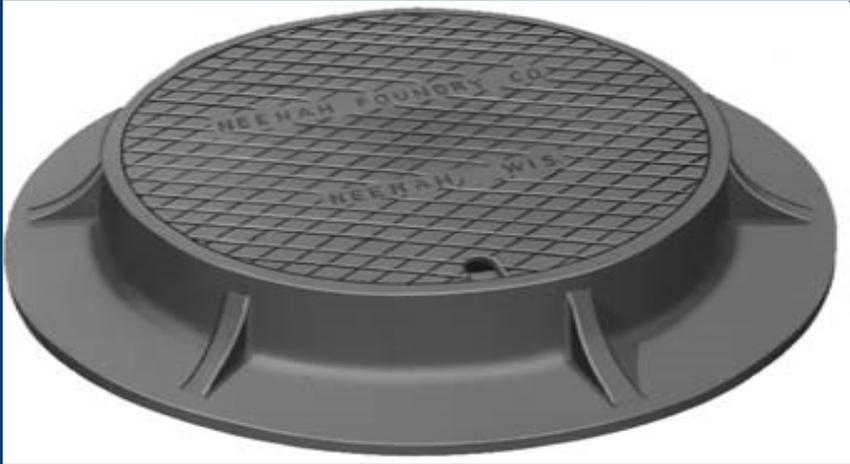
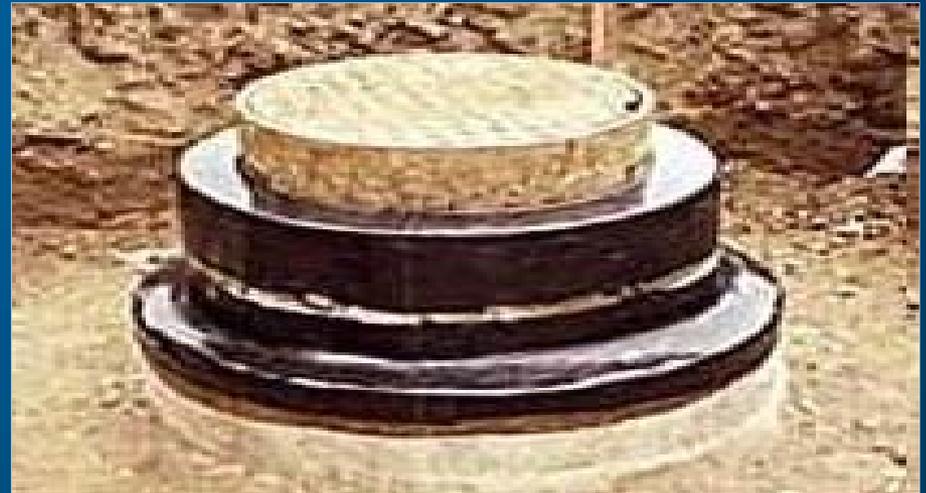
Manhole Rehabilitation

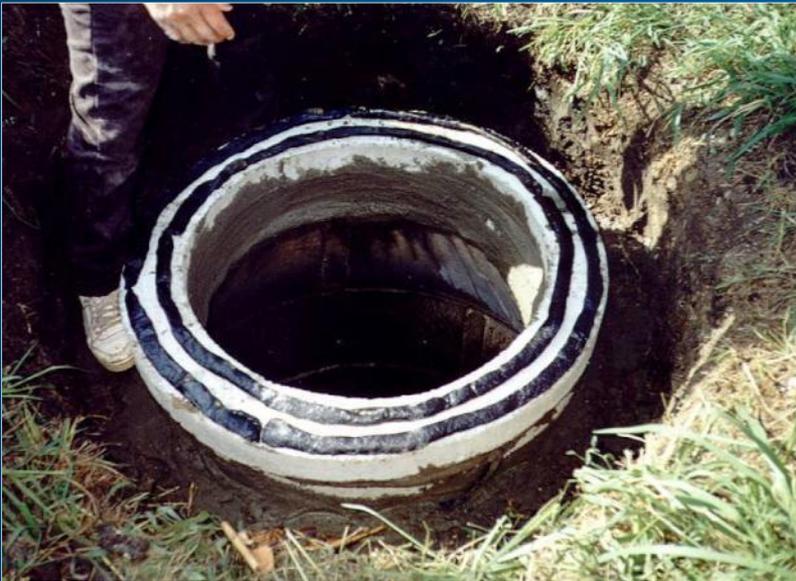
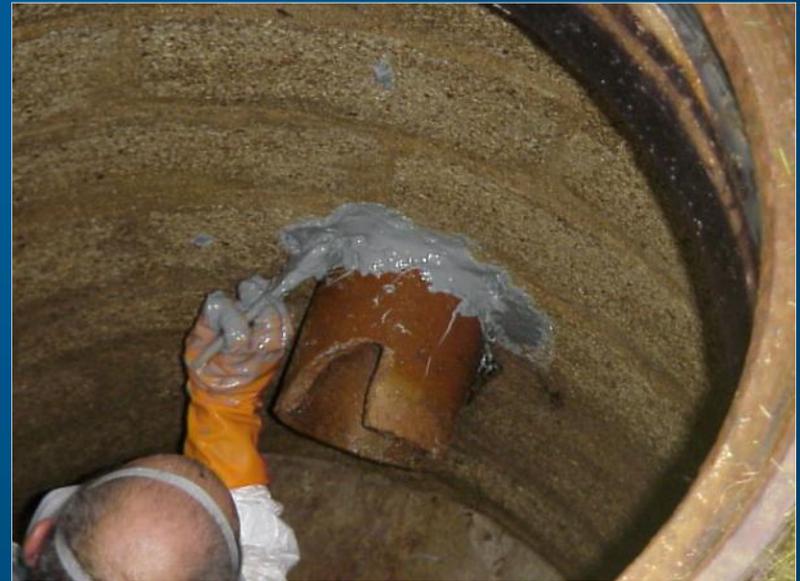
Sample Manhole Inspection – Spring 2011

- Inspected 76 Manholes Rehabilitated in 1987
- Locations Near Creek, with Main Sewer Lining, Various Ages
- Result – Limited Defects
1987 Rehabilitation Work Still Generally Sound

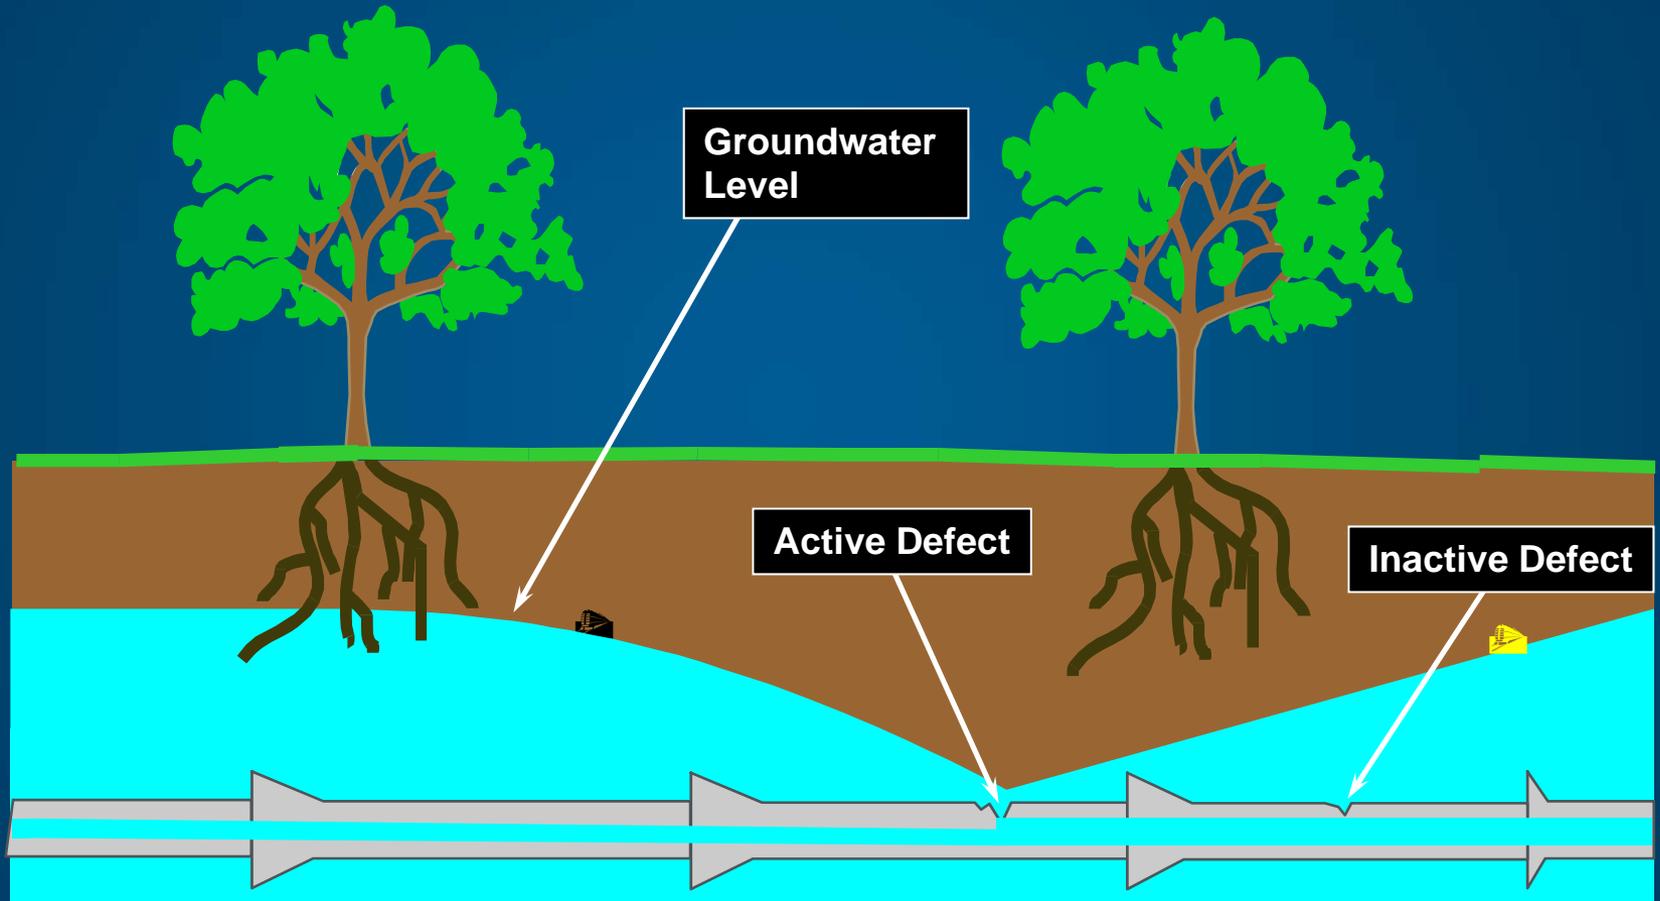
Migration Along Pipe Trench

BEFORE Rehabilitation

I/I Migration to Service Laterals

- Manhole to Manhole Lining
 - Structural integrity
 - Eliminate I/I within main sewer
- Groundwater Migration “Up” to Service Laterals
 - Water in sewer trench moves “up” to service laterals
 - Net “reduction” in I/I often limited
