Perspectives on Private Sector Infiltration/Inflow Identification and Rehabilitation

Prepared by
Alan J. Hollenbeck, P.E., BCEE
President/CEO
RJN Group, Inc.

2012 – Original 1980's ICAP “Revisited”

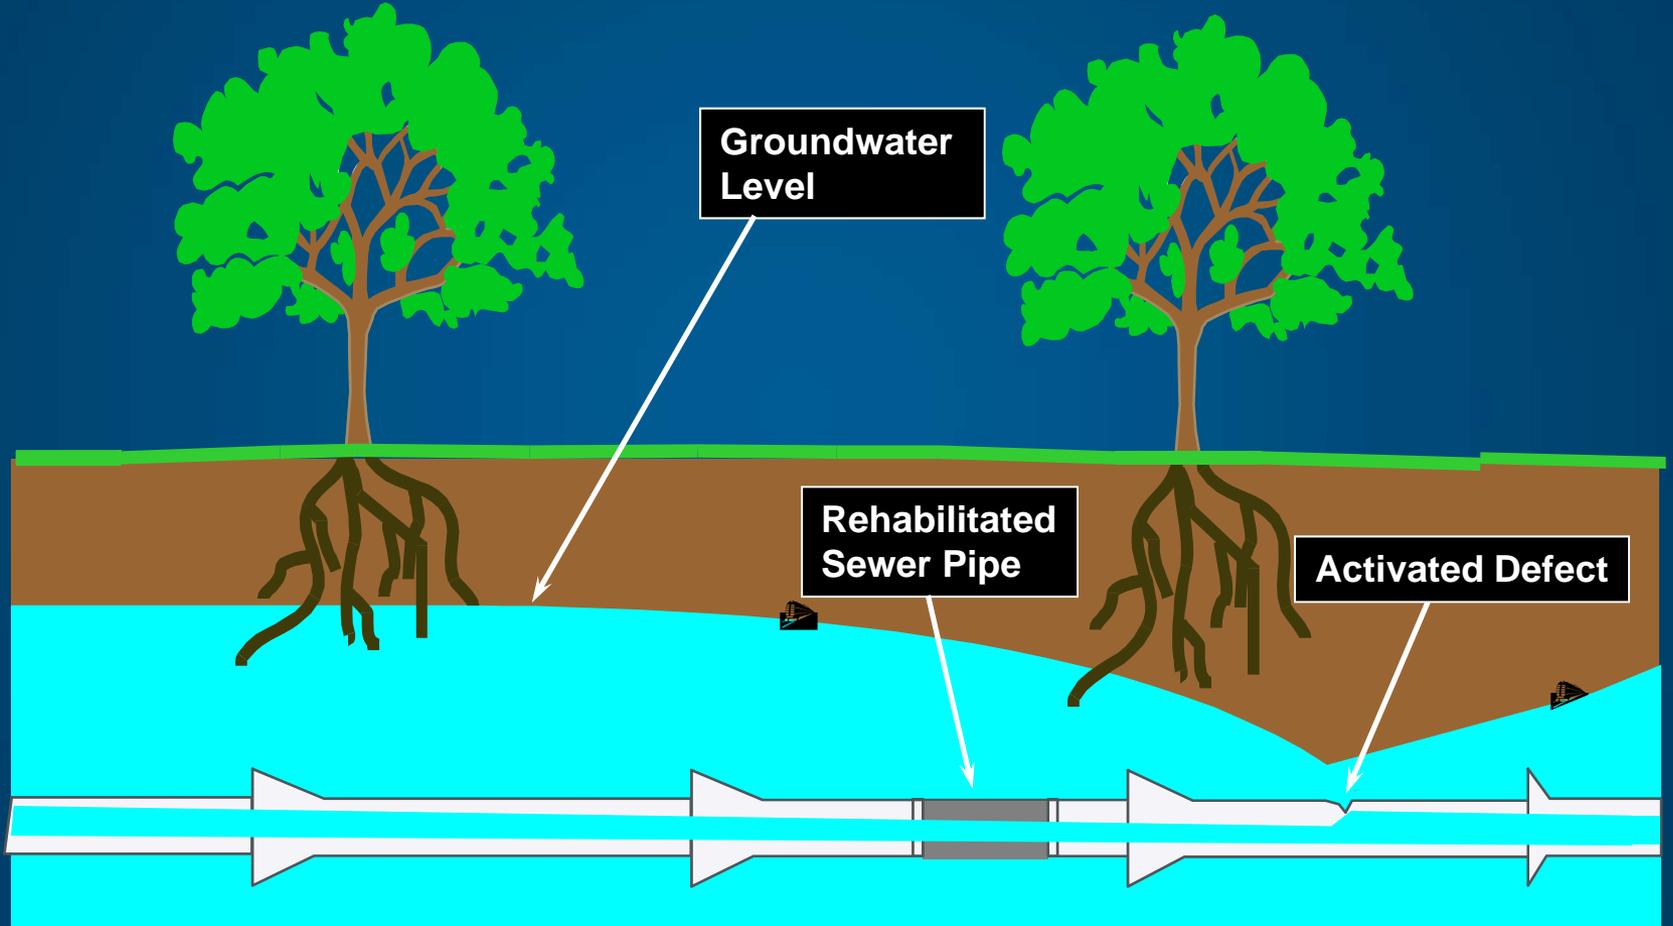
Migration Along Pipe Trench

AFTER Rehabilitation

- Manhole to Manhole Lining
 - Structural integrity
 - Eliminate I/I within main sewer
- Groundwater Migration “Up” to Service Laterals
 - Water in sewer trench moves “up” to service laterals
 - Net “reduction” in I/I often limited

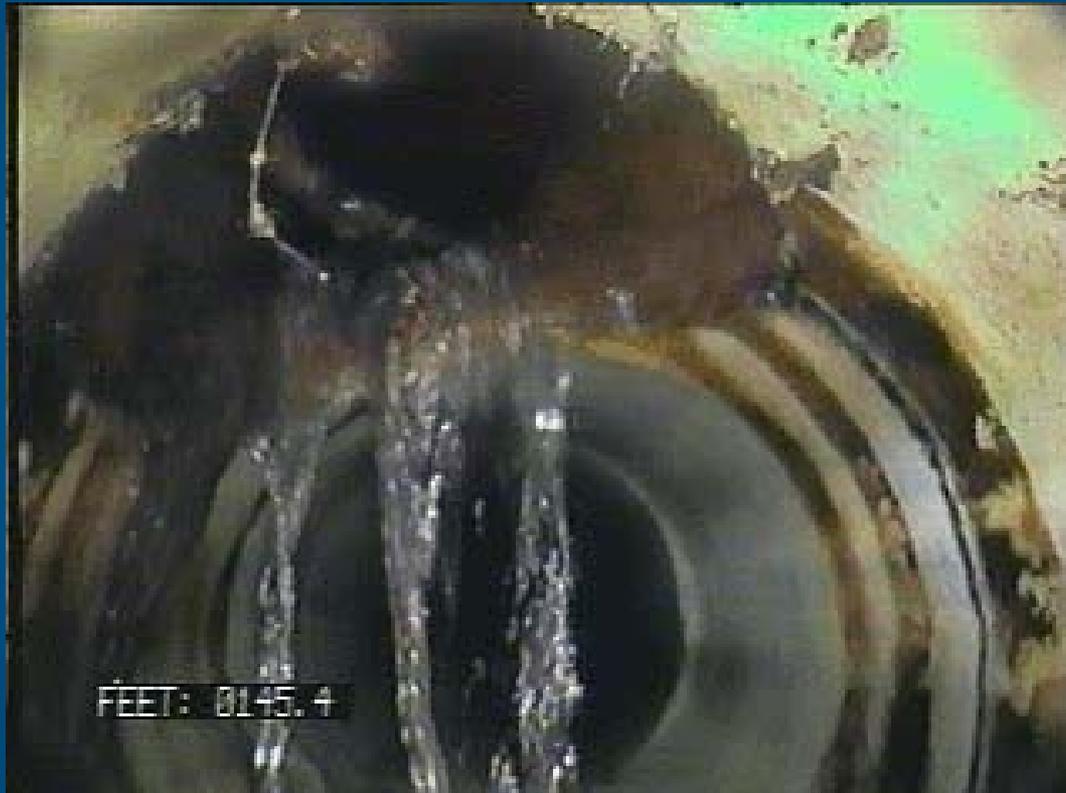
Leaking Service Lateral Video

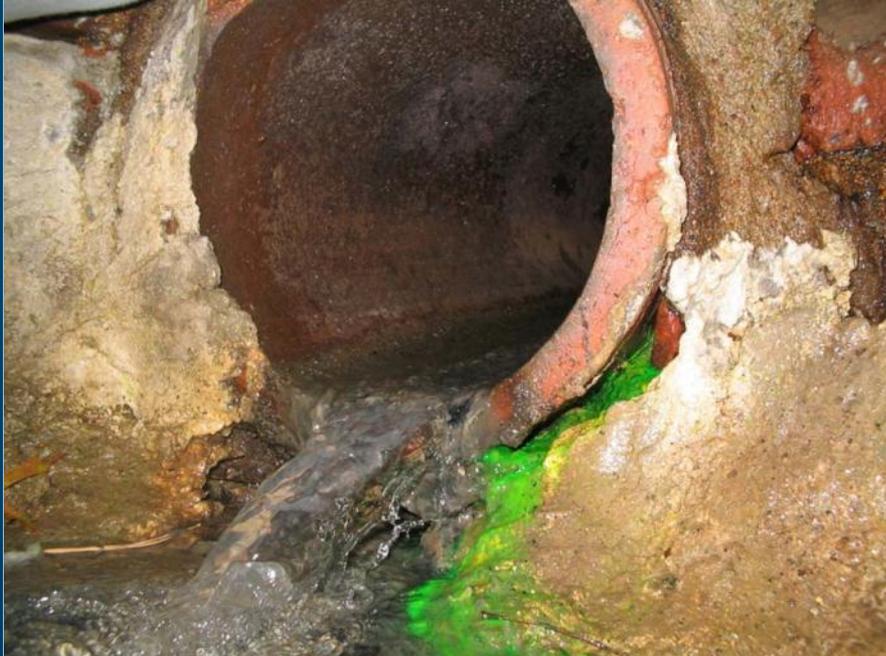
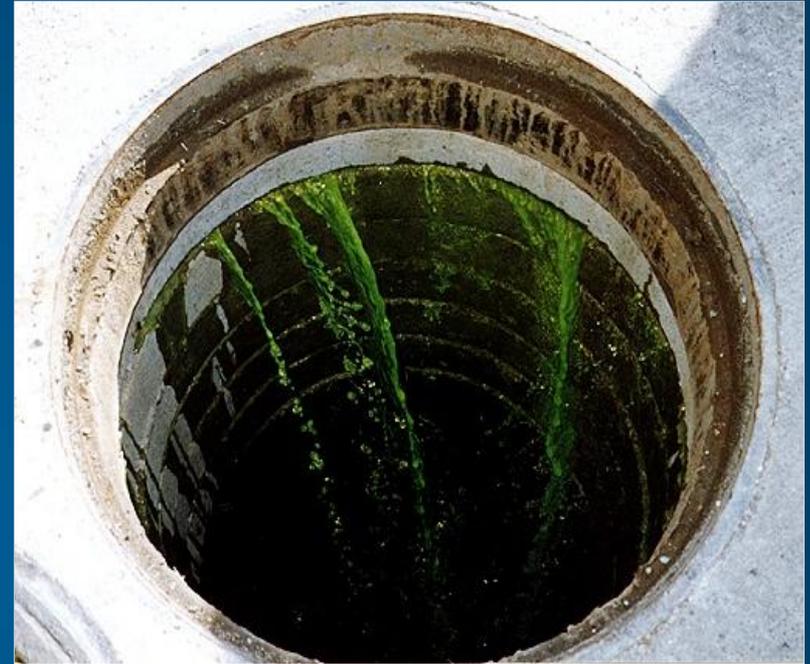
Typical Public Sector “Recurring” Sources

- Manholes
 - Frame seals
 - Pipe seals

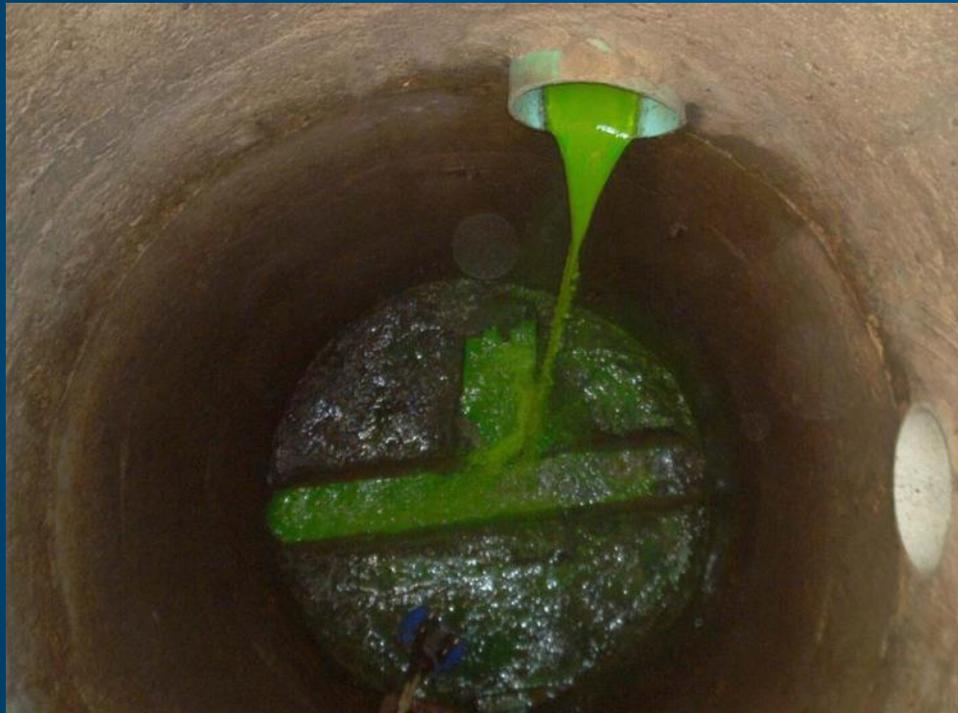
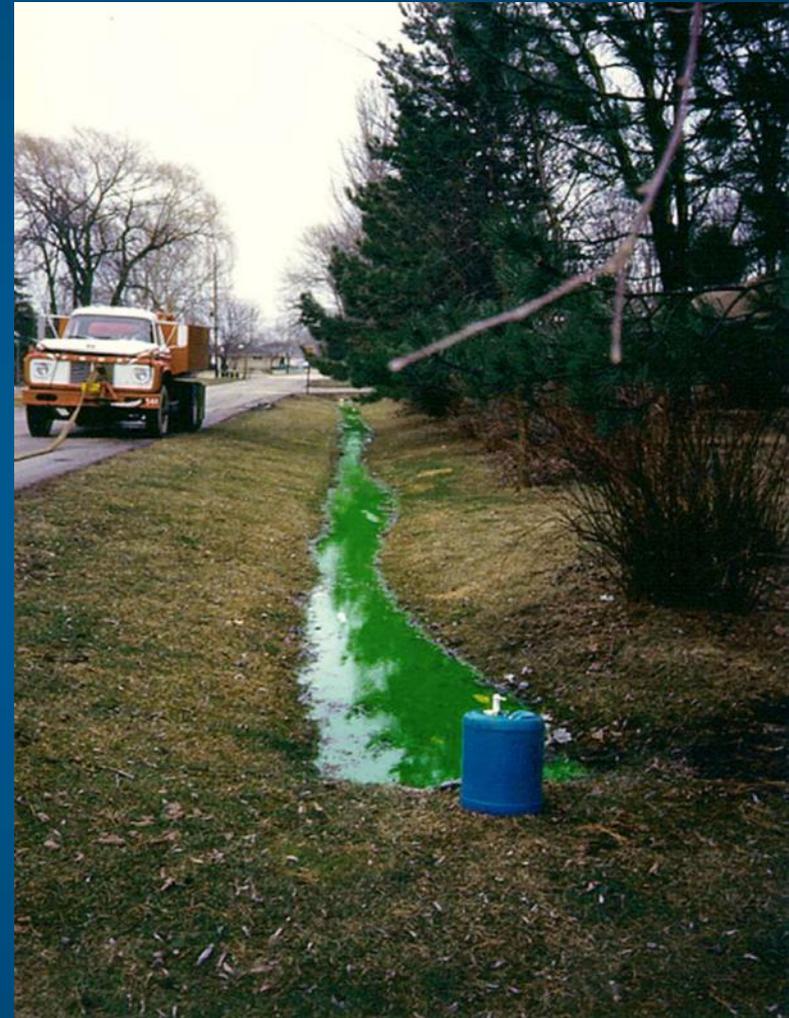
Typical Public Sector “Recurring” Sources

- Main Line Cross Connections
 - Service laterals / storm sewers
 - Service laterals / storm ditches

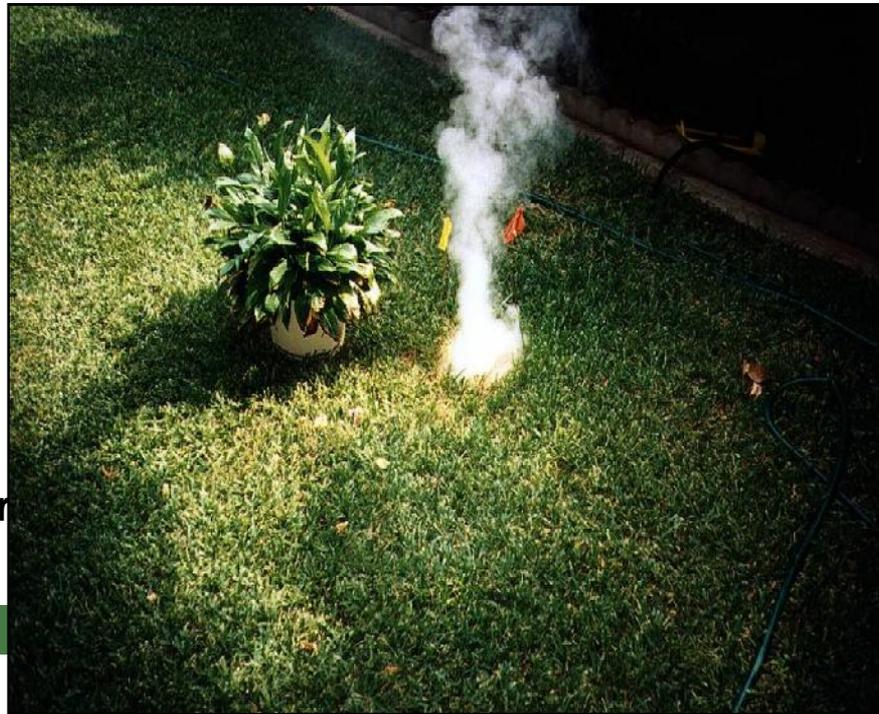
Wastewater Collection – Real World

Downspout

Window Well

Sump Pump

Footing Tile

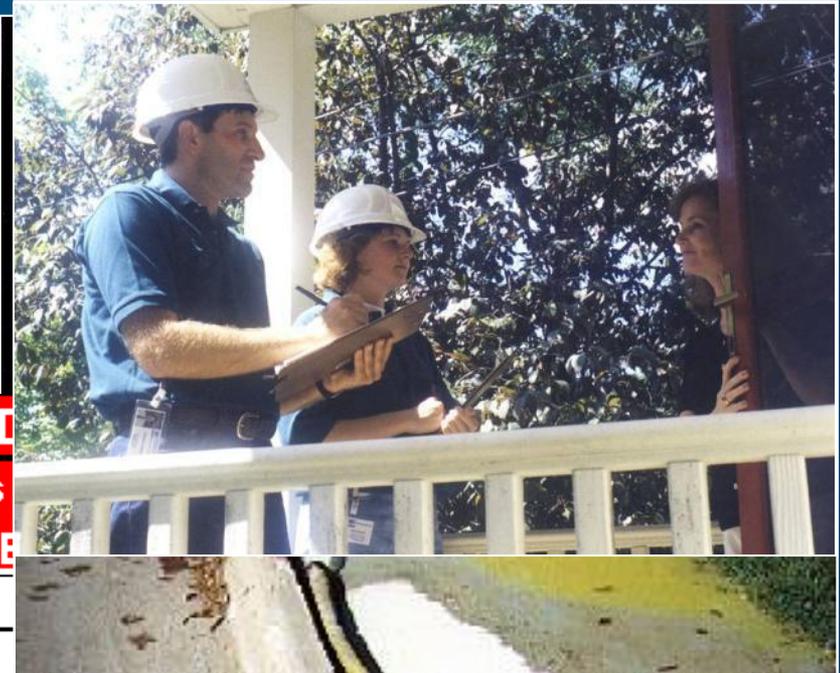
Finding Private Sector Sources

- **Smoke Testing**
 - Watch for "Suspect" Trapped Sources
 - Dual Blower With Plugging Drives Smoke Through Soil Seams

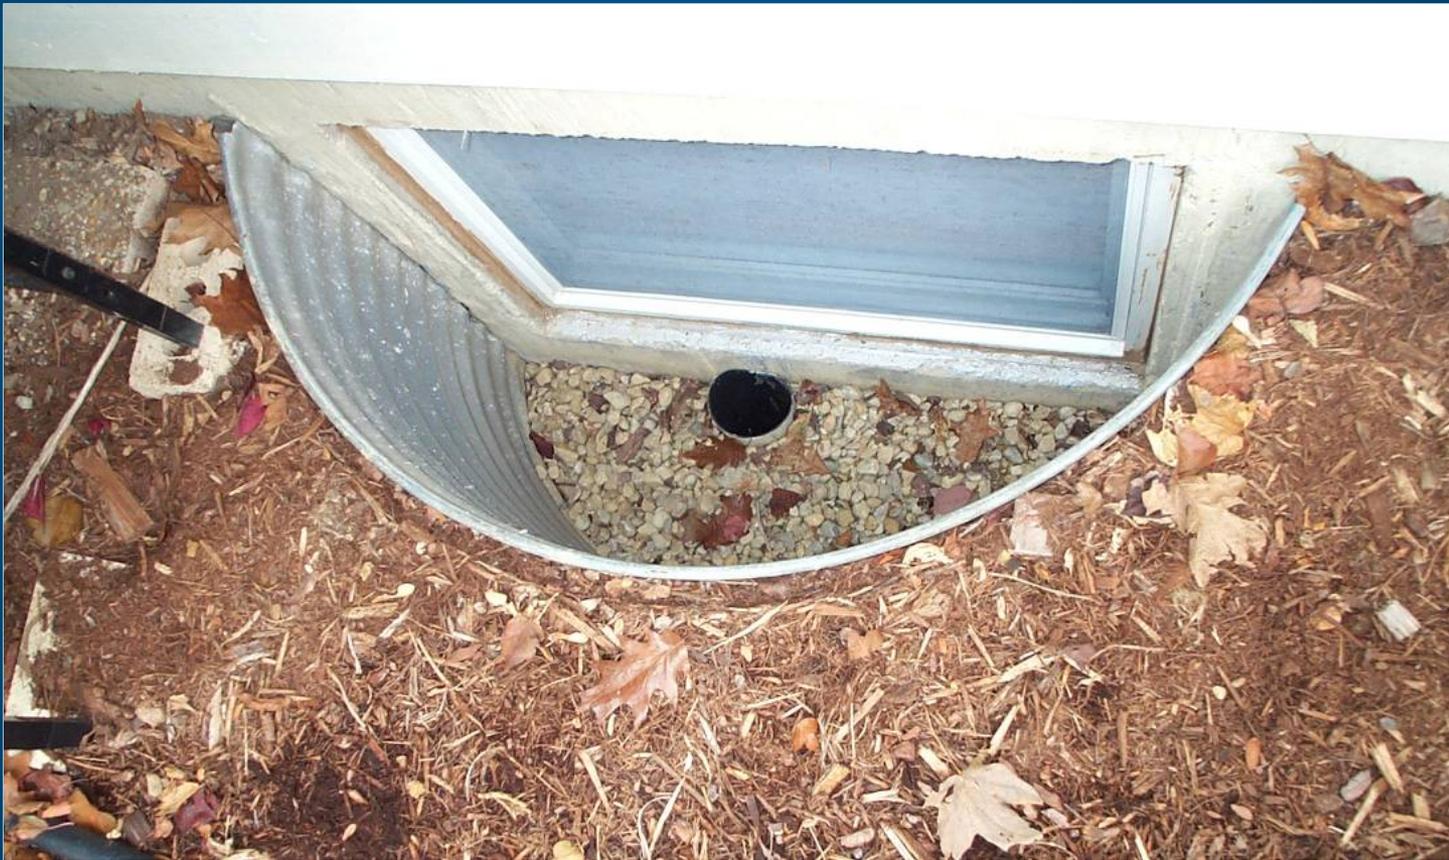
Private Sector – Exterior Sources

- Window Well

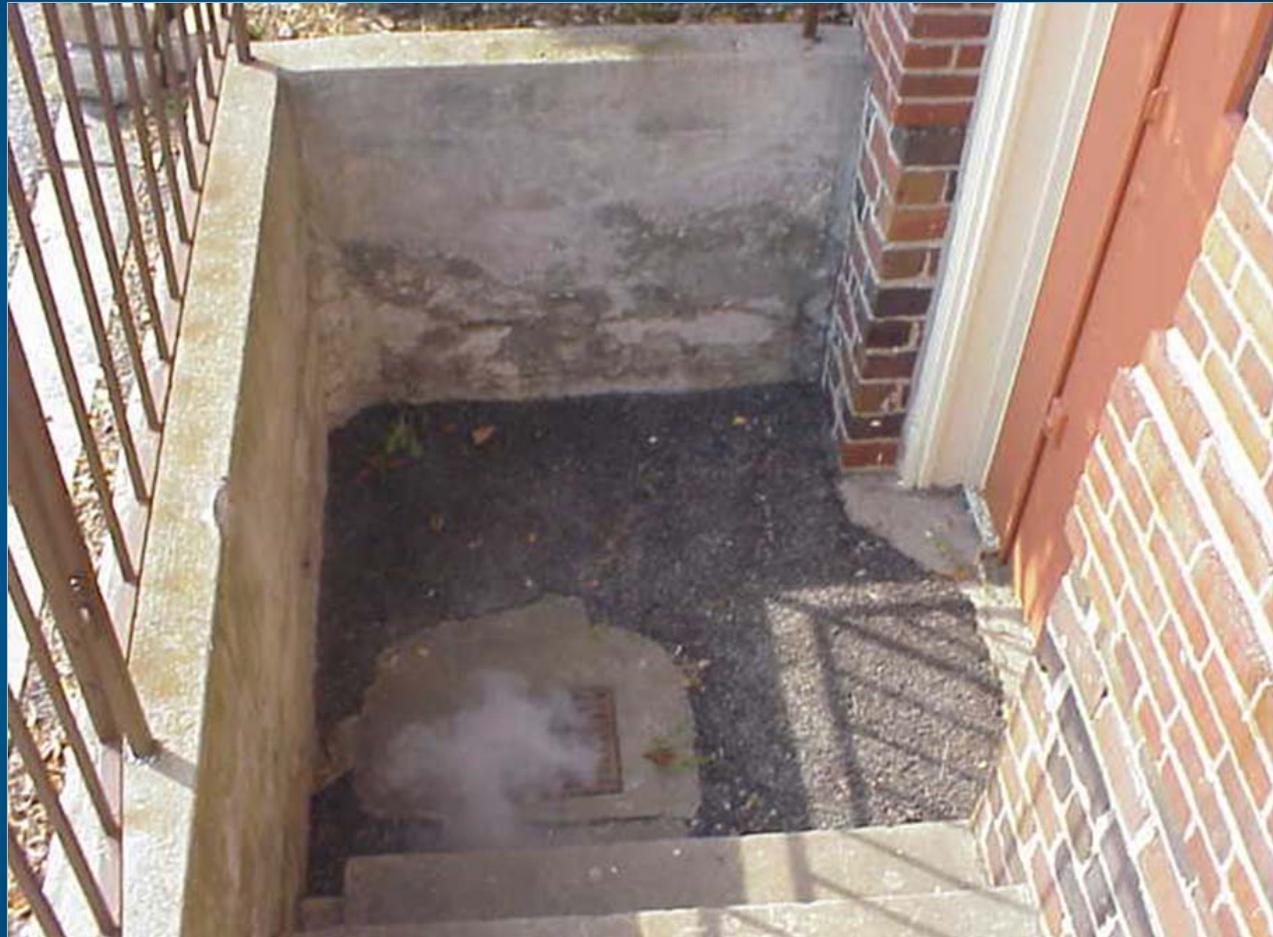
Private Sector – Exterior Sources

- Window Well
- Stairway

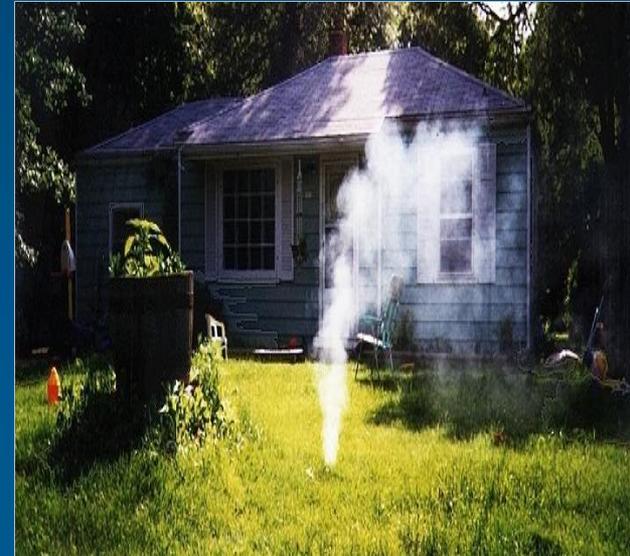
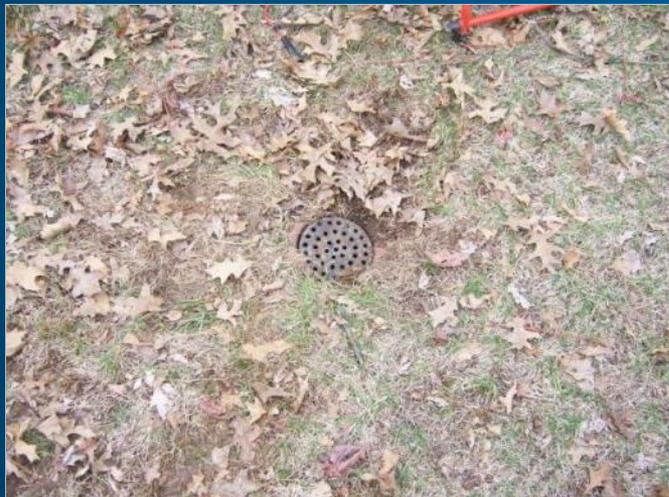
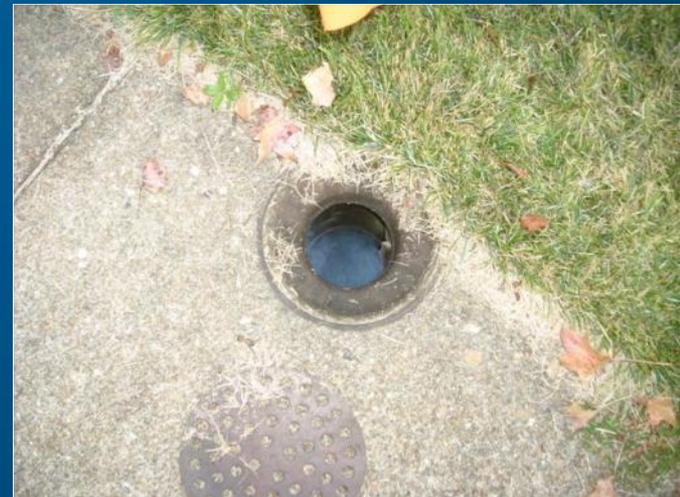
Private Sector – Exterior Sources

- Window Well
- Stairway
- Cleanout

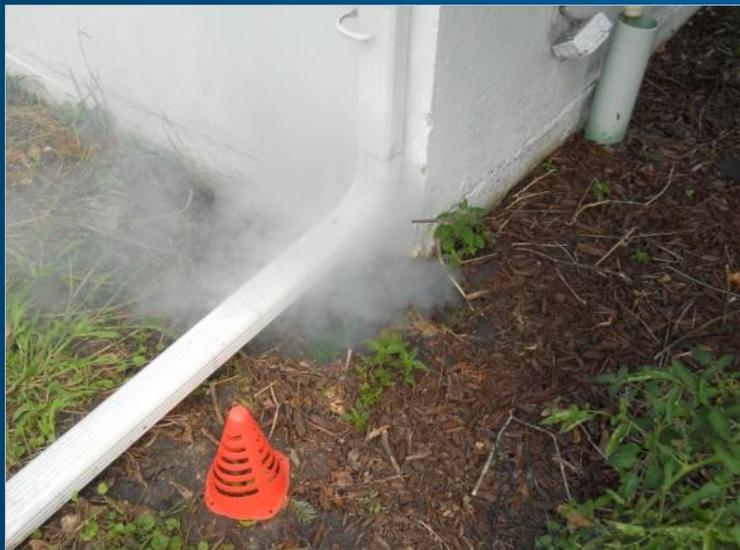
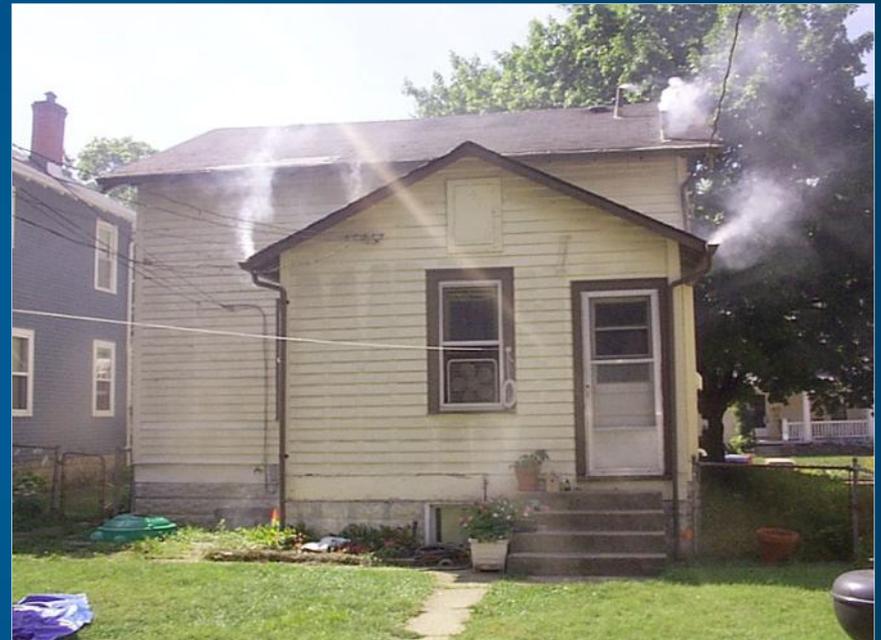
Private Sector – Exterior Sources

- Window Well
- Stairway
- Cleanout
- Downspouts

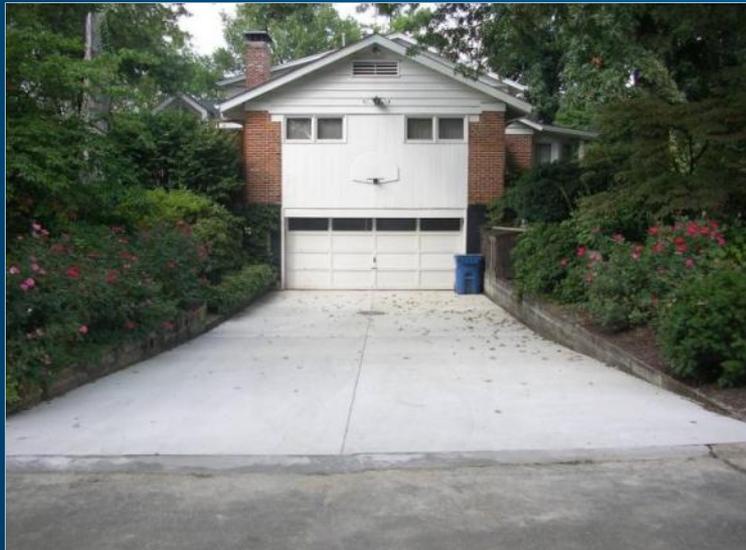
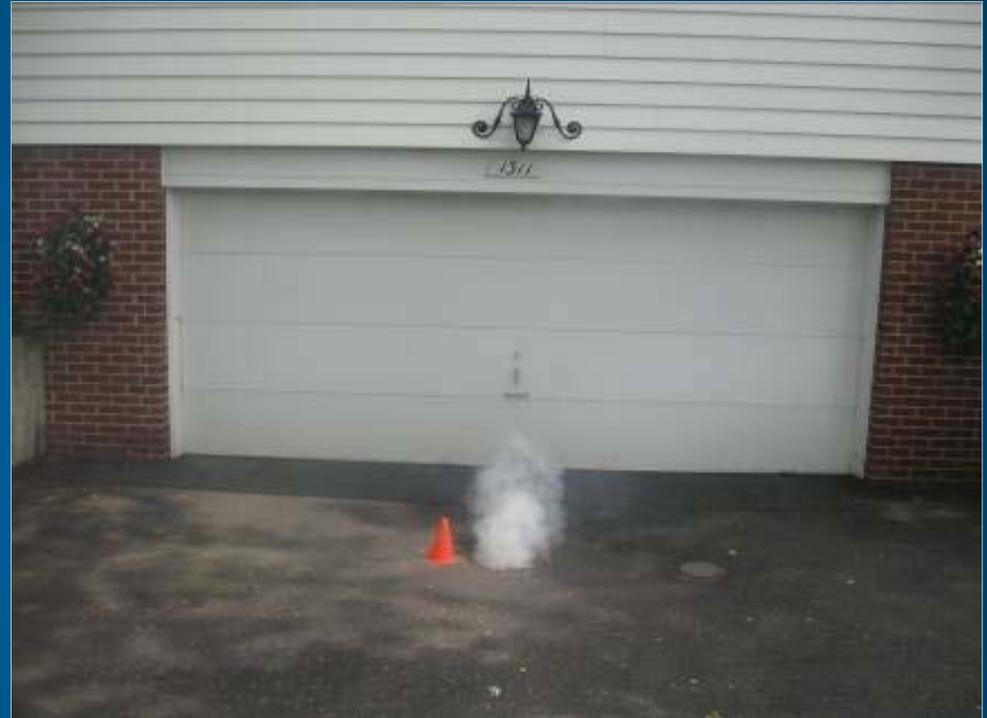
Private Sector – Exterior Sources

- Window Well
- Stairway
- Cleanout
- Downspouts
- Driveway Drains

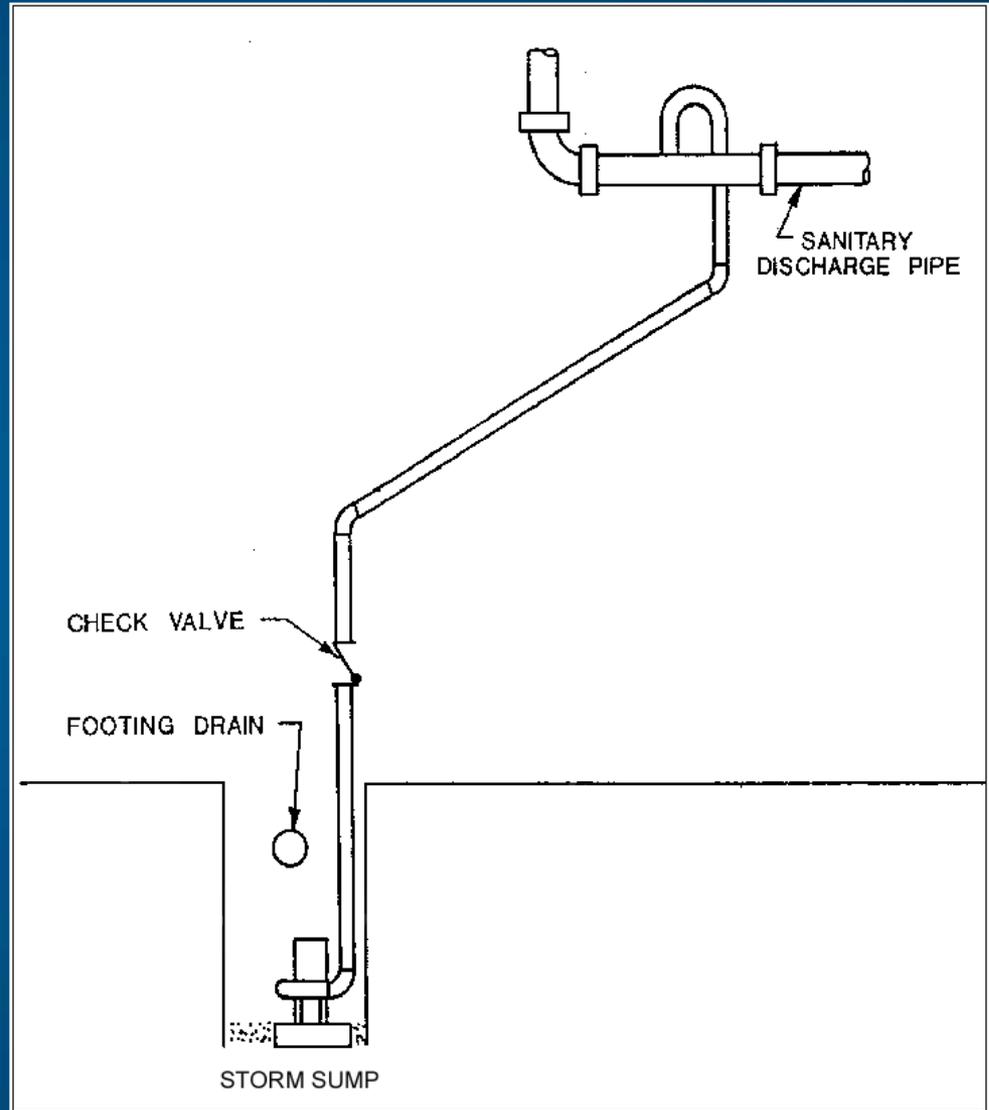
Typical Sump Pump Configuration

Storm Sump to Sanitary Sewer

- ☔ Directly Connected Foundation Drain (Basement with NO Sump Pump)
- ☔ Storm Sump Connected to Sanitary Sewer (Basement with Sump Pump)
- ☔ Combination Sump Connected to Sanitary Sewer (Basement with Laundry Tubs and Single Sump Pump)

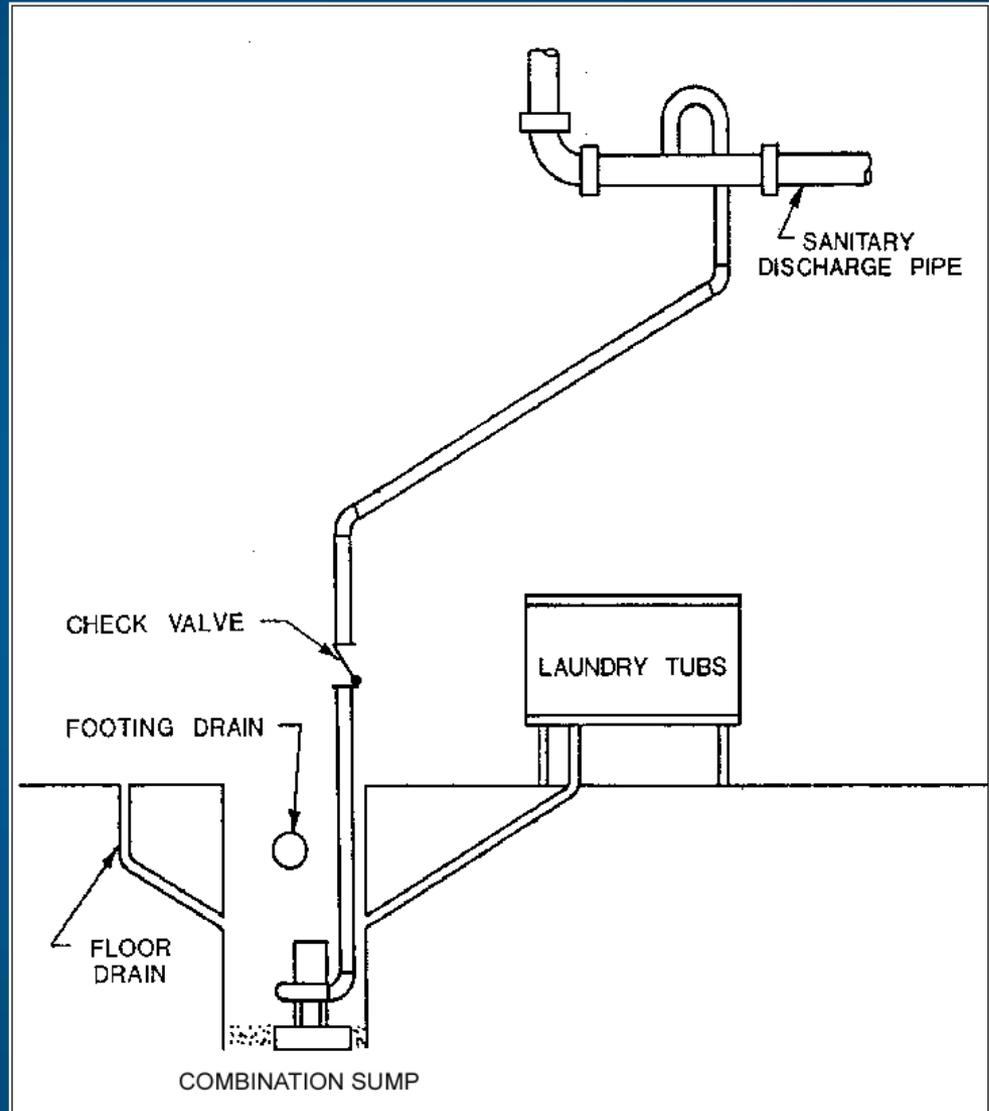
Typical Sump Pump Configuration

Combination Sump to Sanitary Sewer

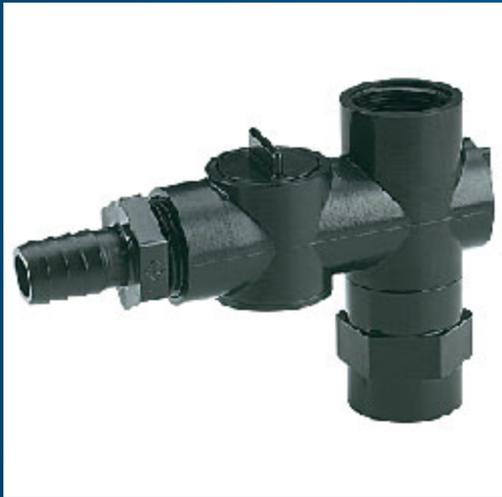
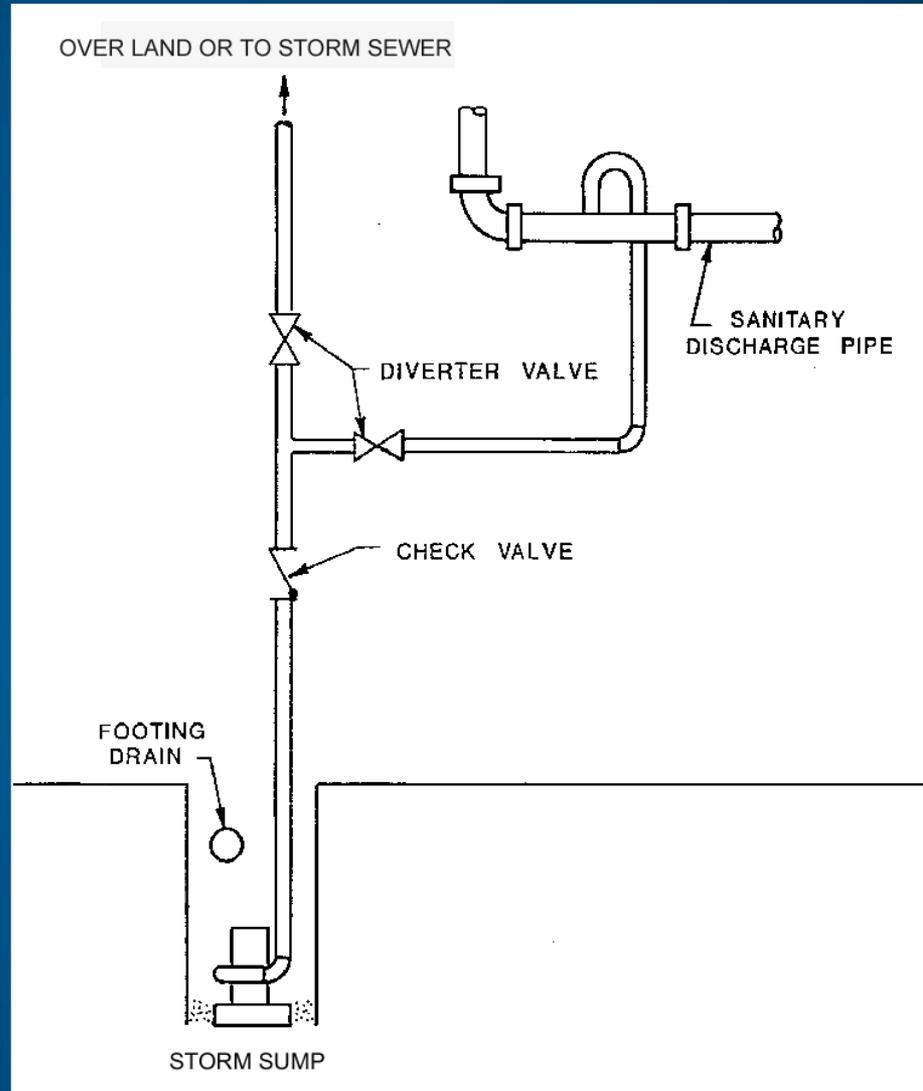
Typical Sump Pump Configuration

Storm Sump With Diverter Valve to Sanitary Sewer

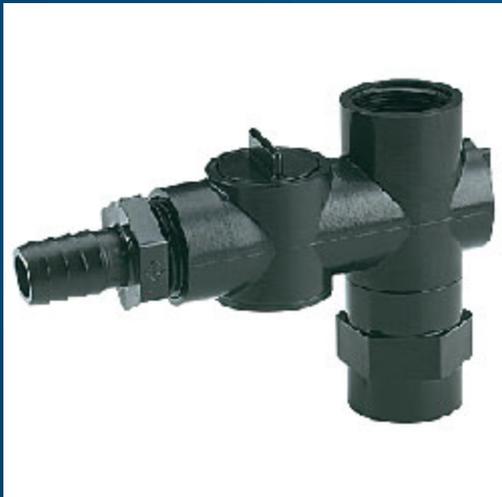
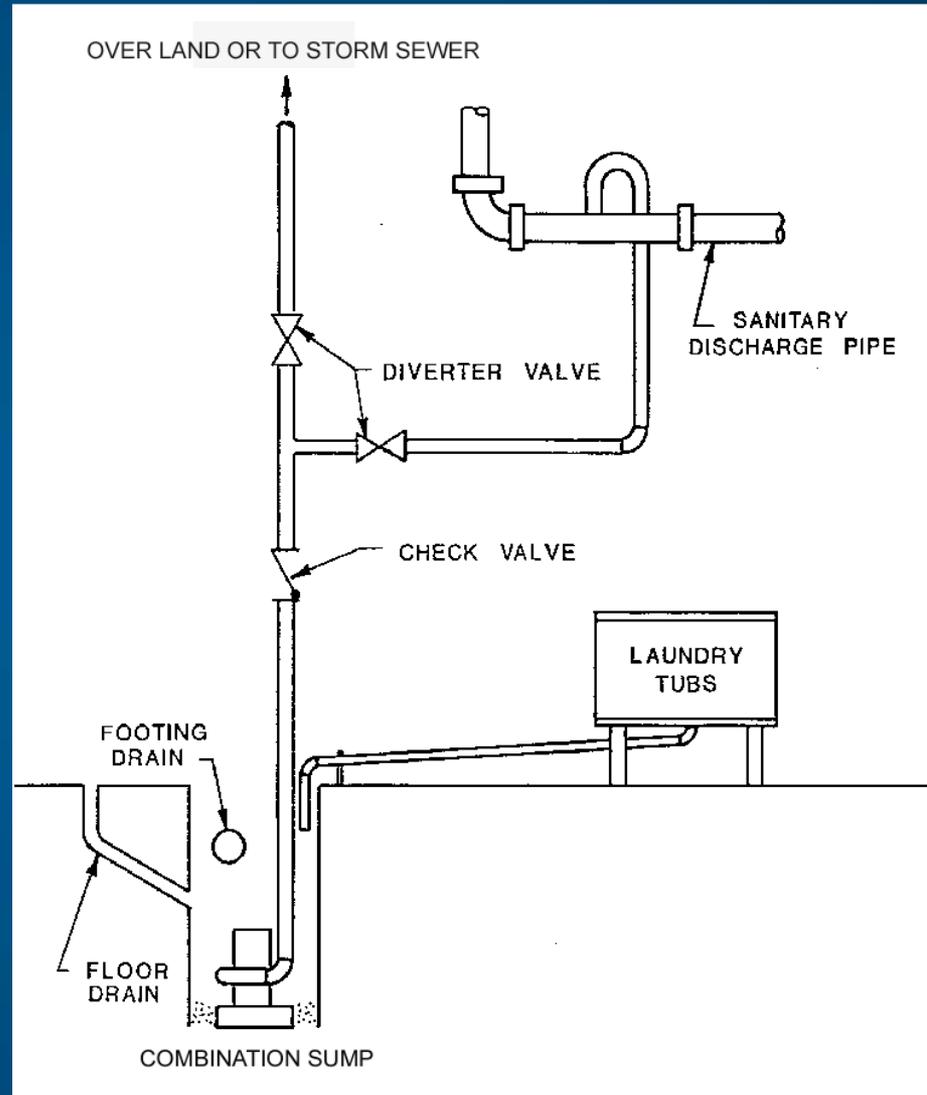
Typical Sump Pump Configuration

Combination Sump With Diverter Valve

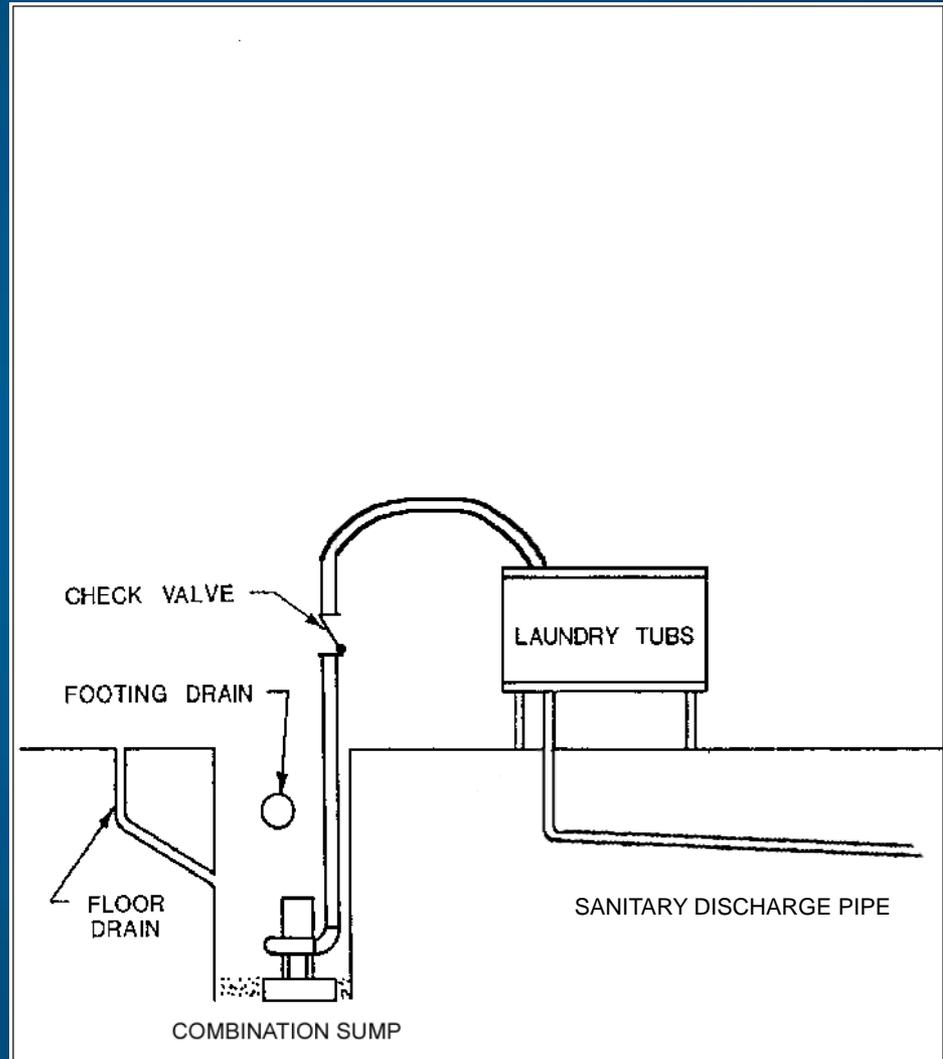
Typical Sump Pump Configuration

Storm Sump to Laundry Tub

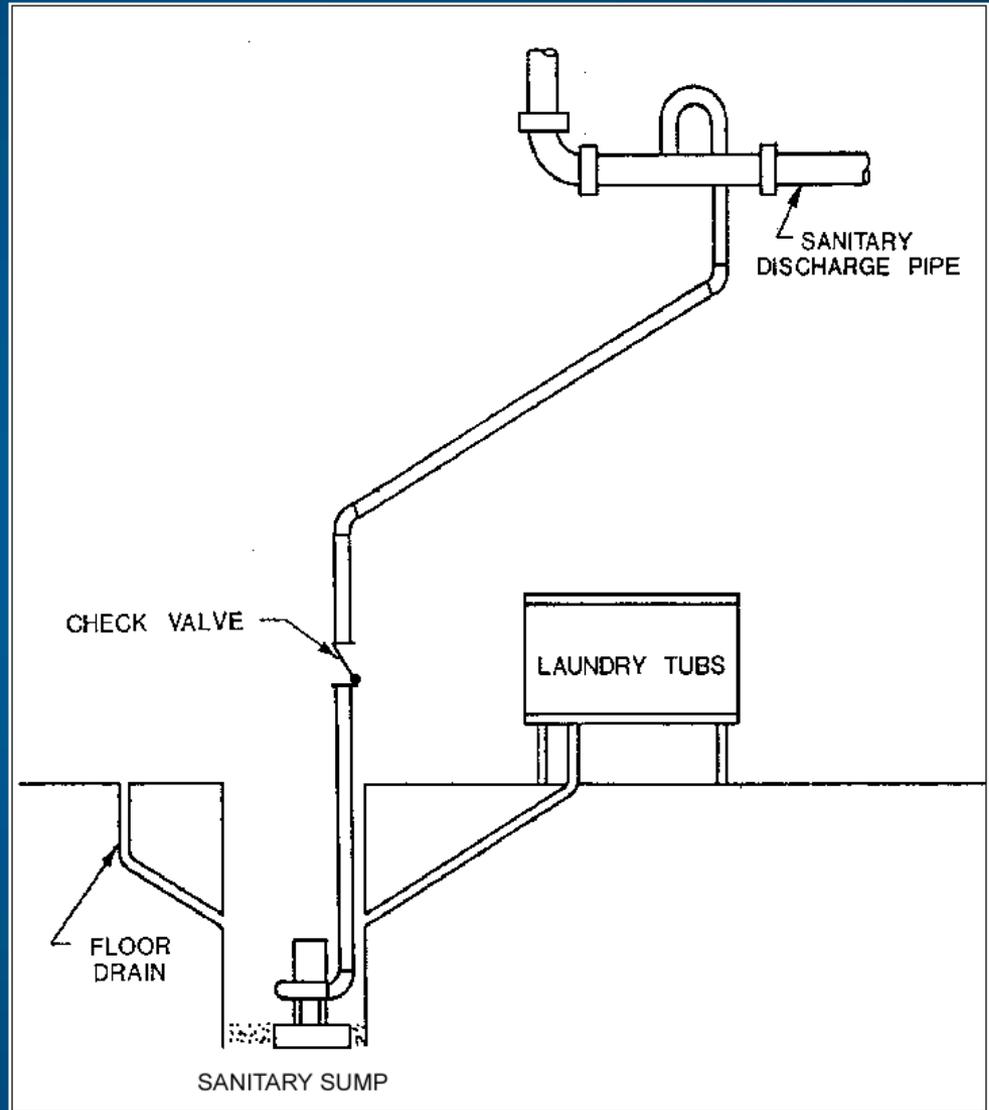
Typical Sump Pump Configuration

Unsealed Sanitary Sump

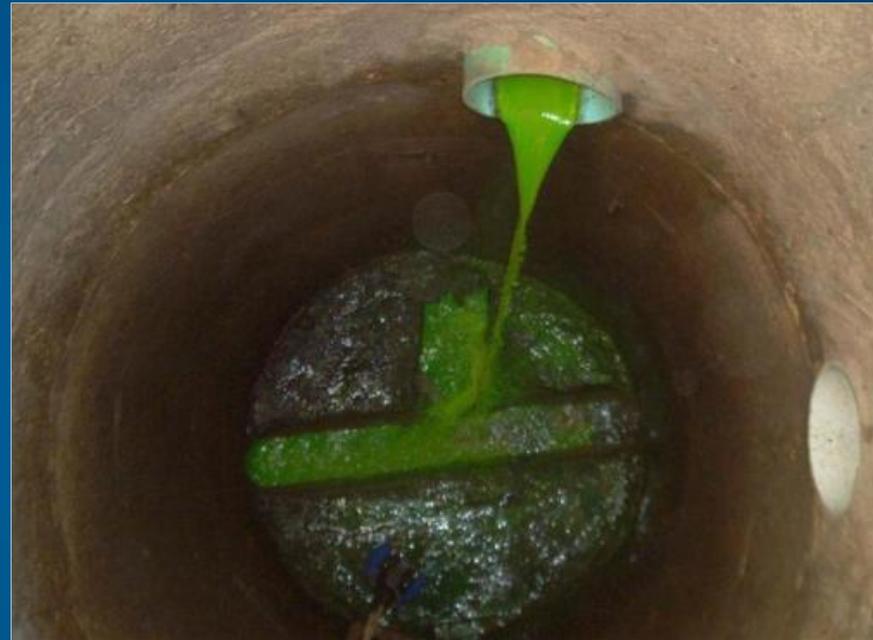
Follow-up Dye Flooding for Confirmation

- Inject Dye in Sump
- Activate Pump
- Check Storm Sewer
- Check Sanitary Sewer
- Check Yard

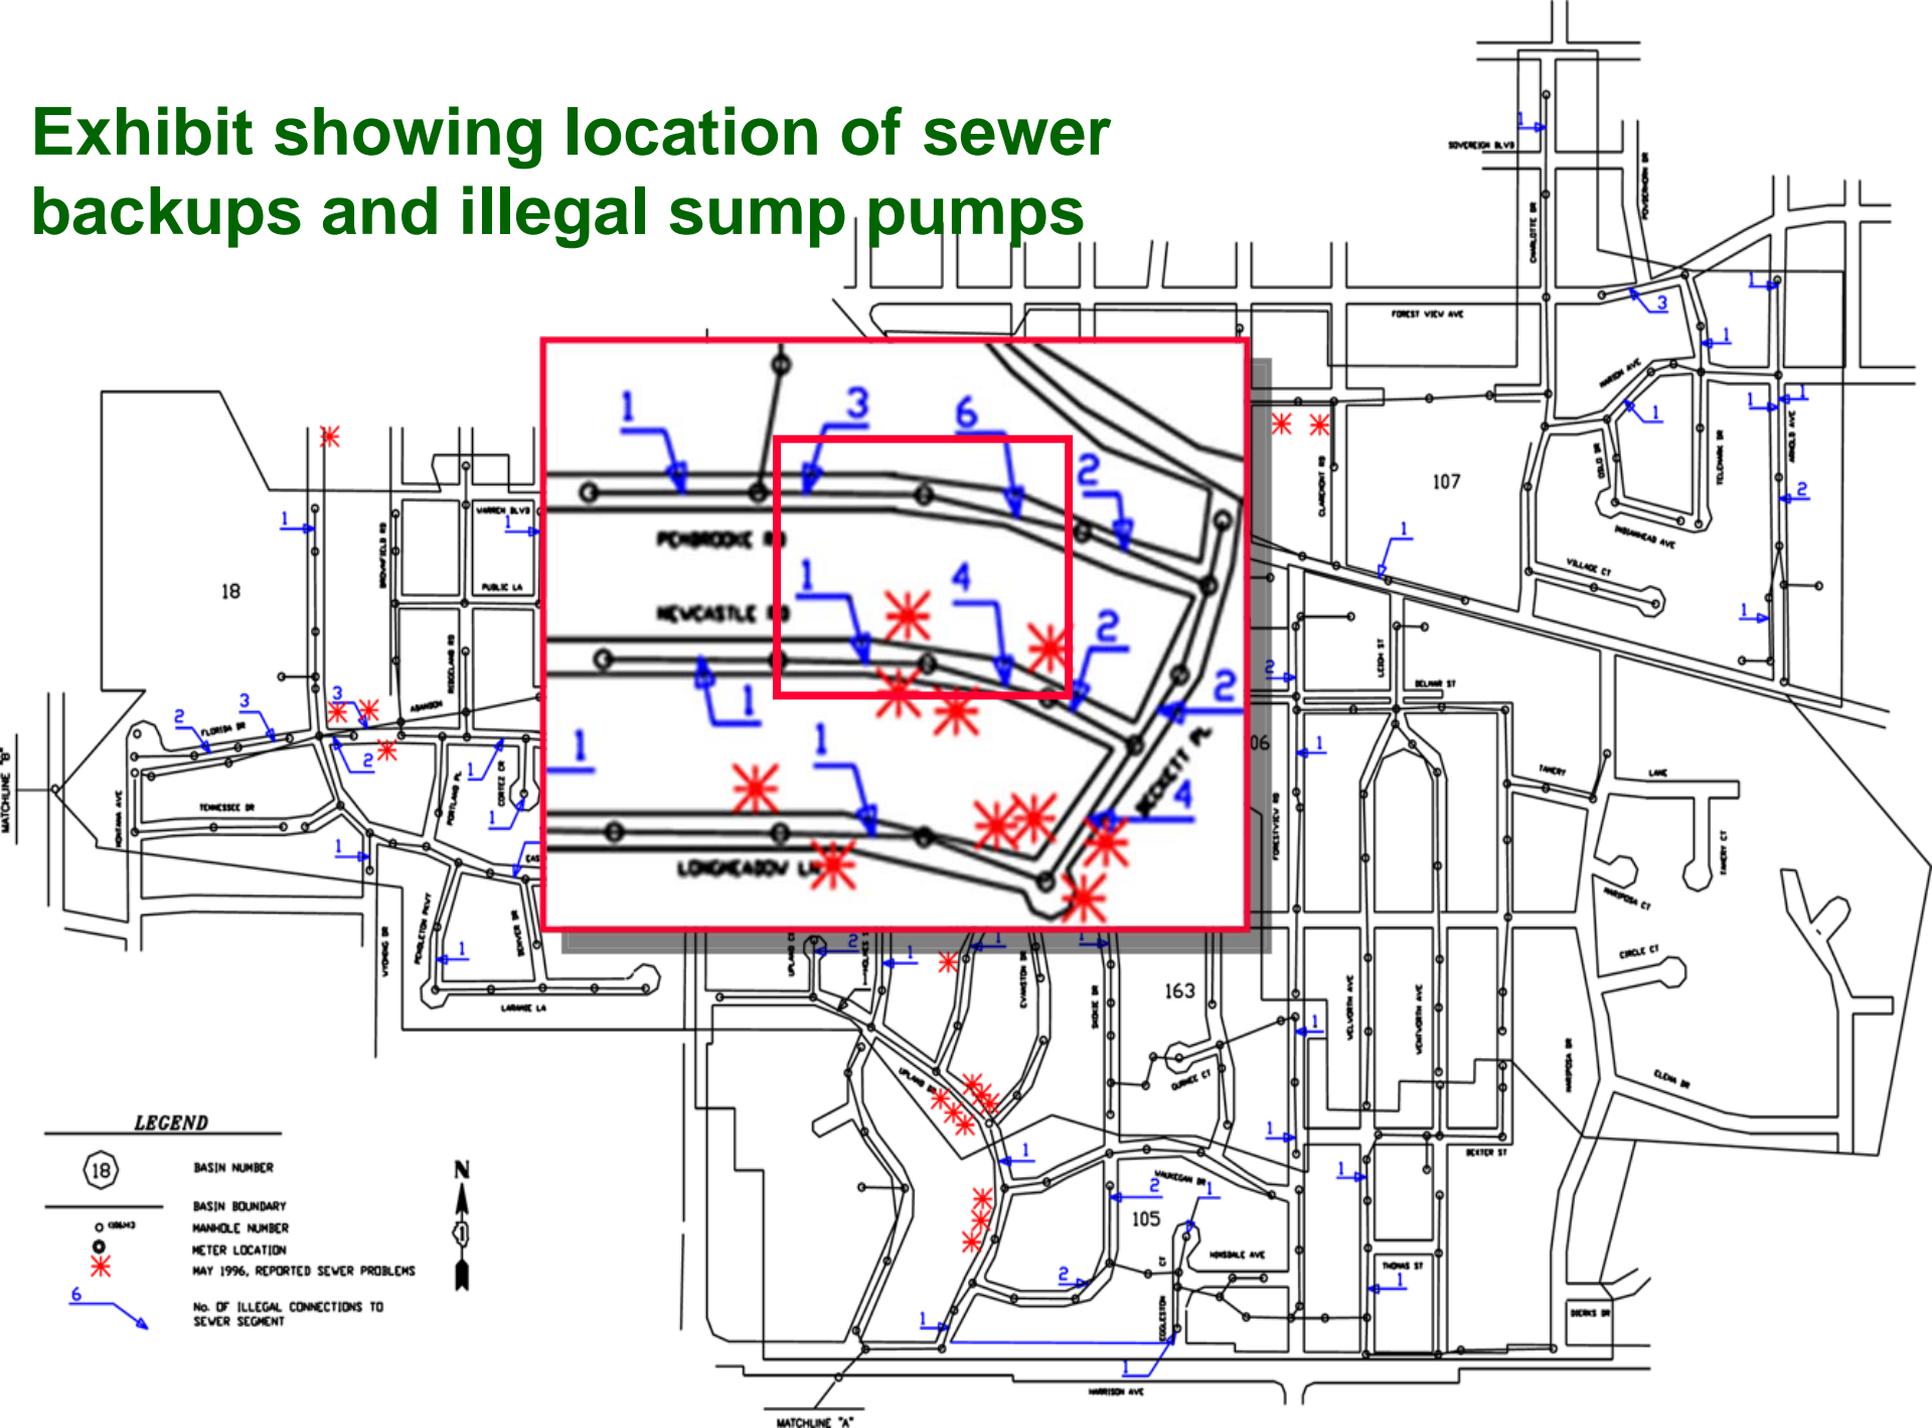
Exhibit showing location of sewer backups and illegal sump pumps

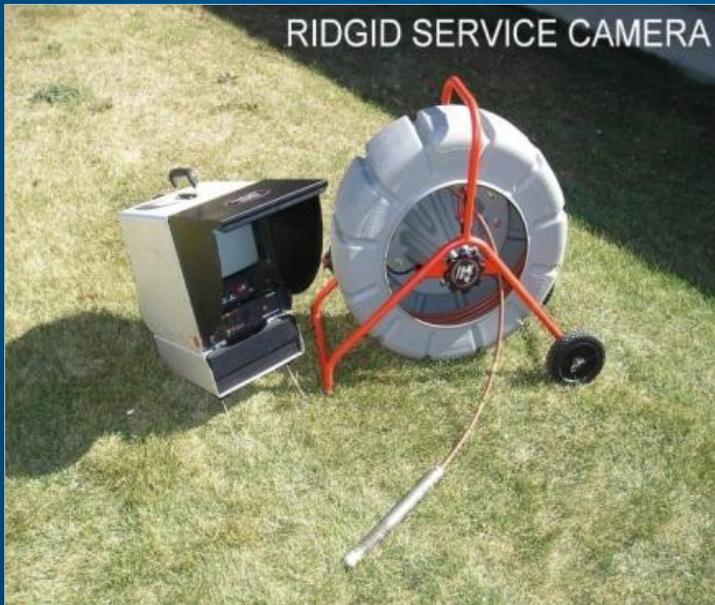
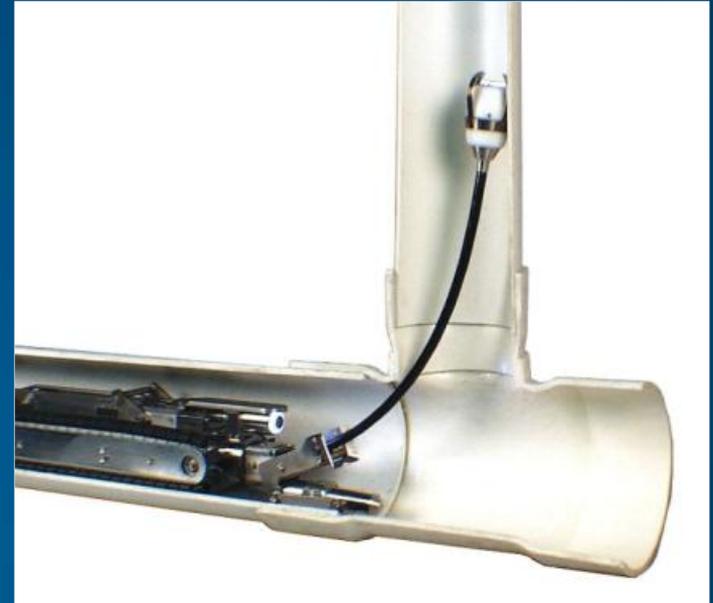
Service Lateral Television Inspection

- From the Cleanout
- Inspection Port in the House
- Lateral Launcher
