Perspectives on Private Sector Infiltration/Inflow Identification and Rehabilitation

Prepared by
Alan J. Hollenbeck, P.E., BCEE
President/CEO
RJN Group, Inc.

2012 – Original 1980's ICAP “Revisited”

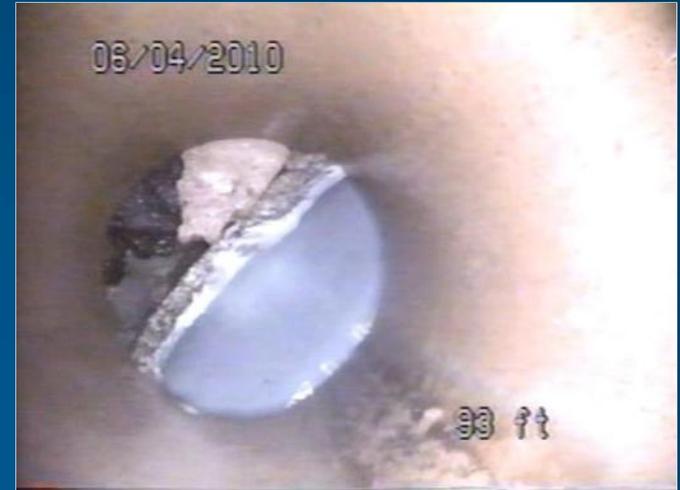
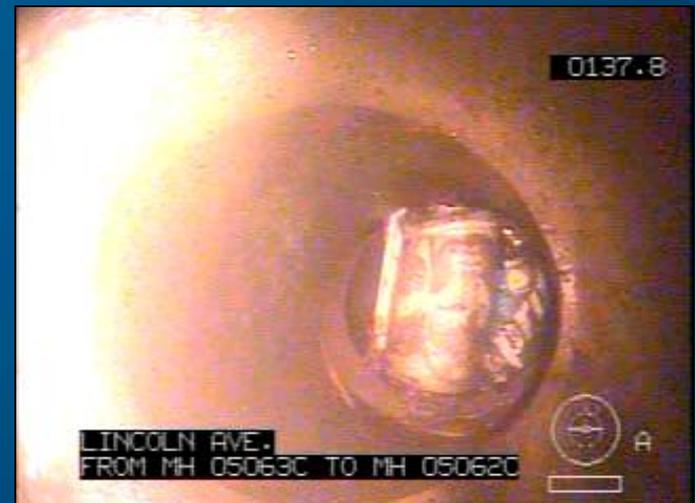
Service Lateral Television Inspection

- Look For:
 - Overall condition
 - Just one defect?
 - Obstructions
 - Narrowing
 - Connection – is it dropped?
 - Illegal I/I connections?
 - Material – PVC you cannot line it
 - Infiltration

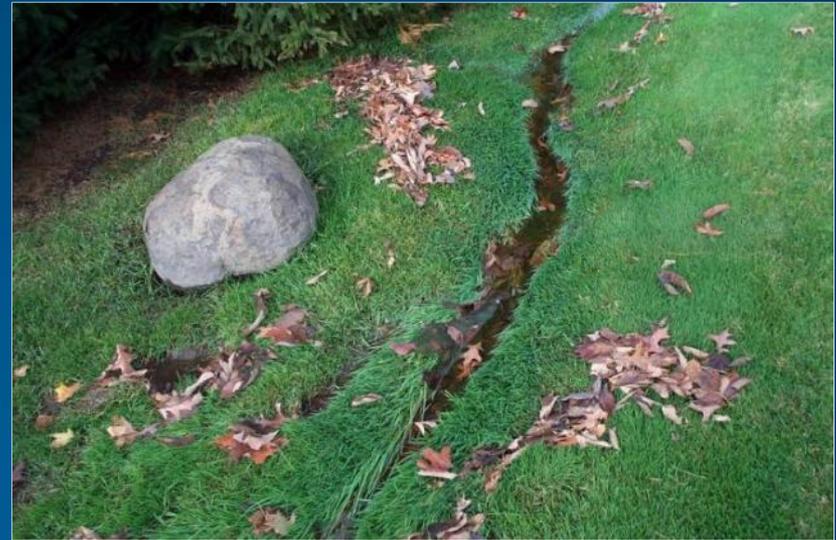
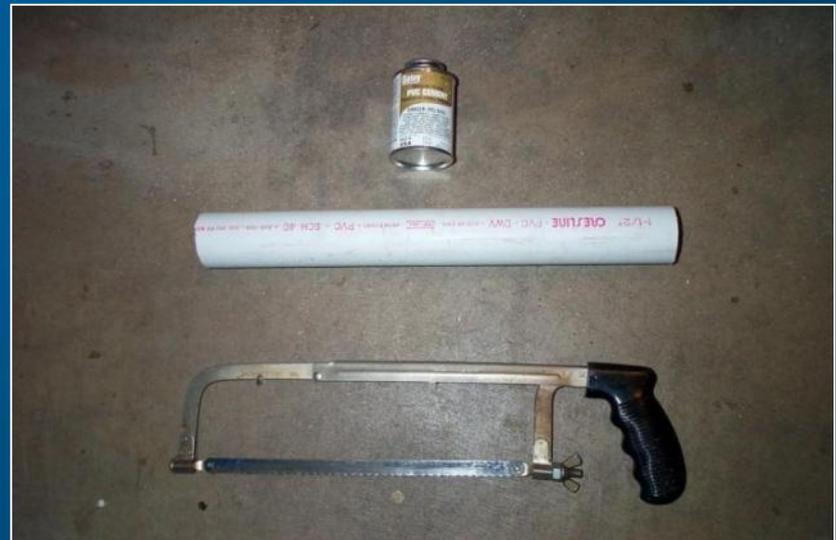
Sump Pump Disconnection Issues

- Localized Yard Ponding / Erosion
- Mosquito Breeding Areas
- Dangerous Ice Patches on Street / Sidewalk if Front Yard / Driveway Discharge
- “Now We Have Stormwater Flooding”
- PVC Easy to Reconnect

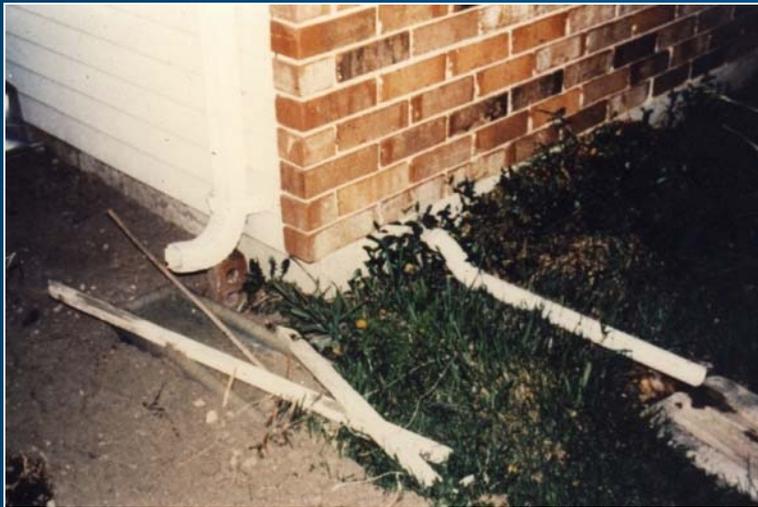
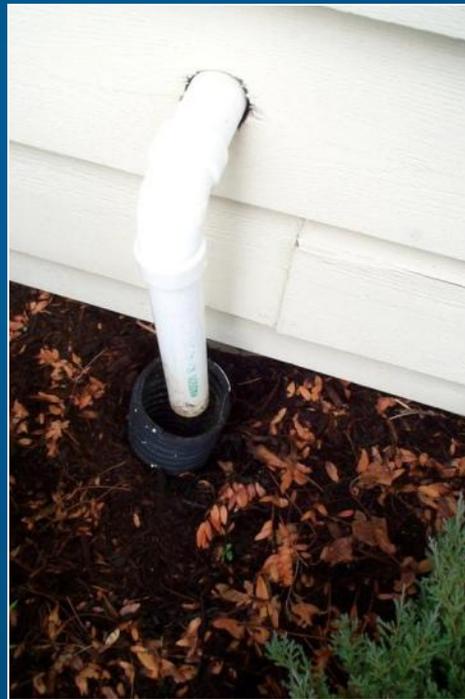
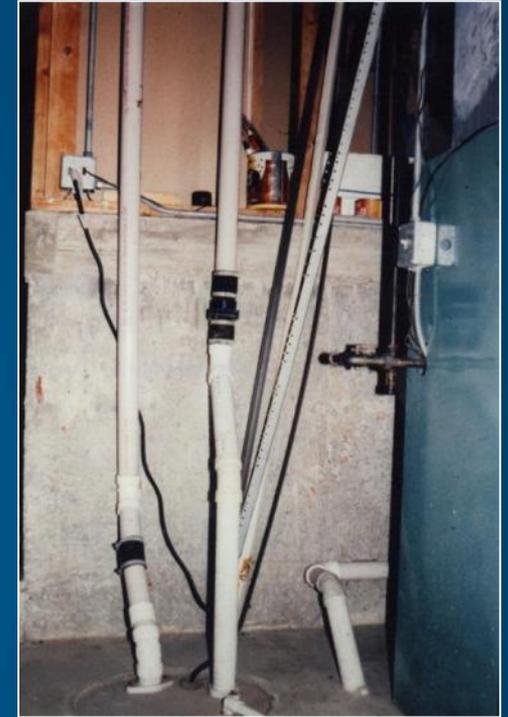
Sump Pump Disconnection

- Air Gap / Storm Sewer

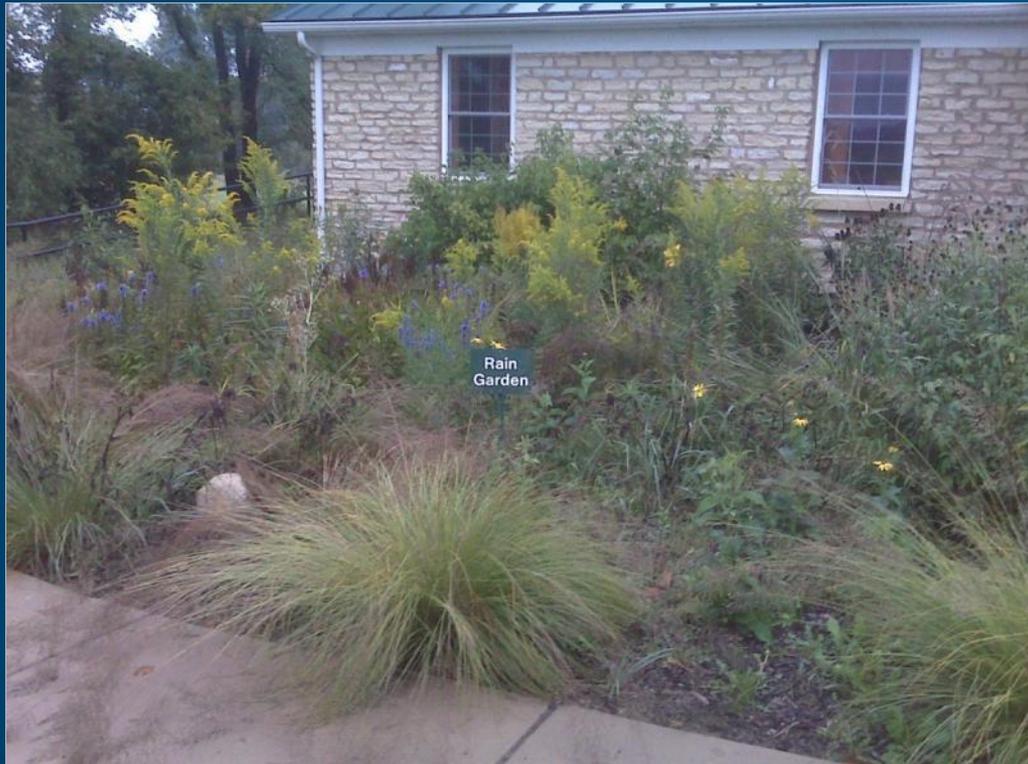
PROFILE VIEW

Rain garden should be located at least 15 feet away from building foundation and outside the zone of influence of the sanitary sewer.

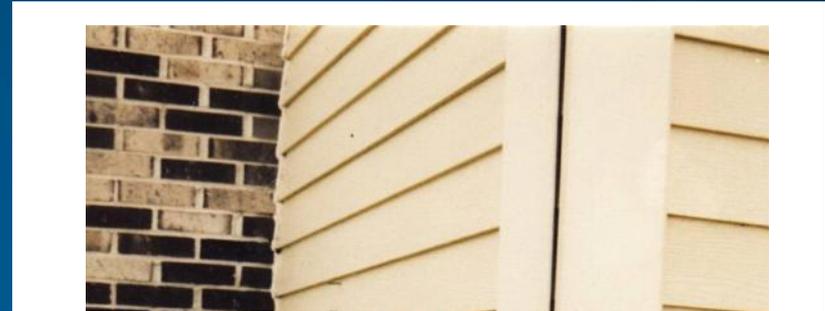
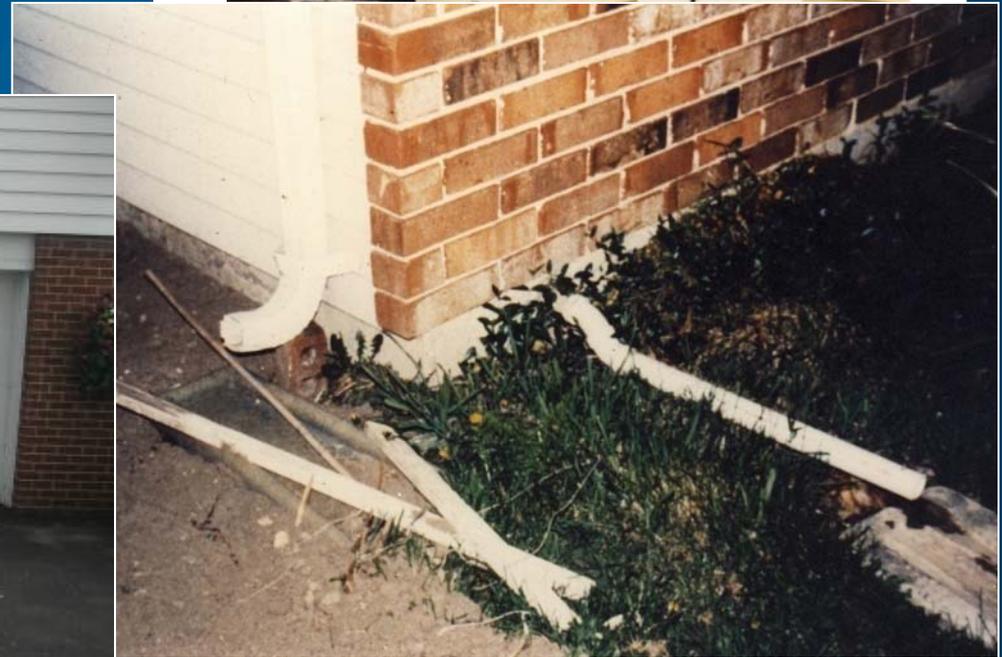
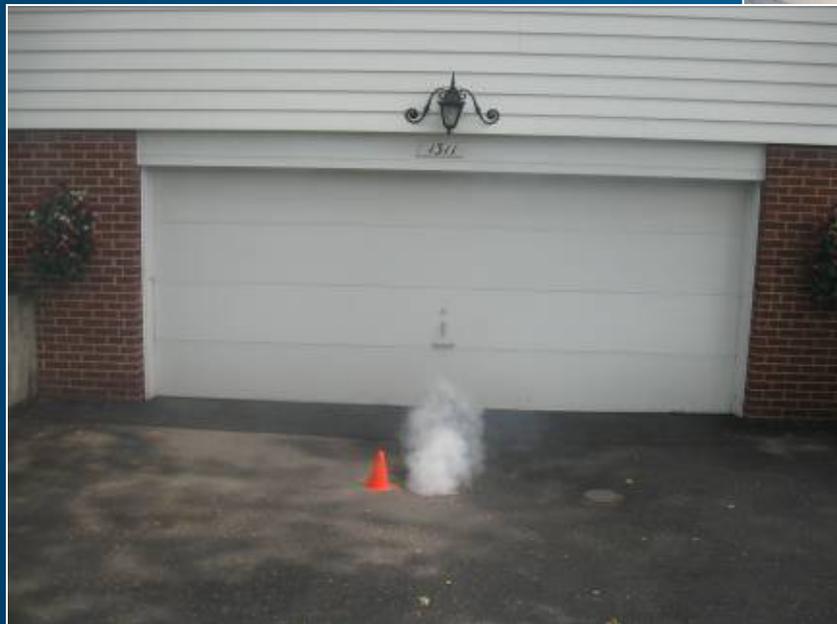
“Exterior” Source Disconnection

- Cleanout
- Downspouts
- Driveway Drains

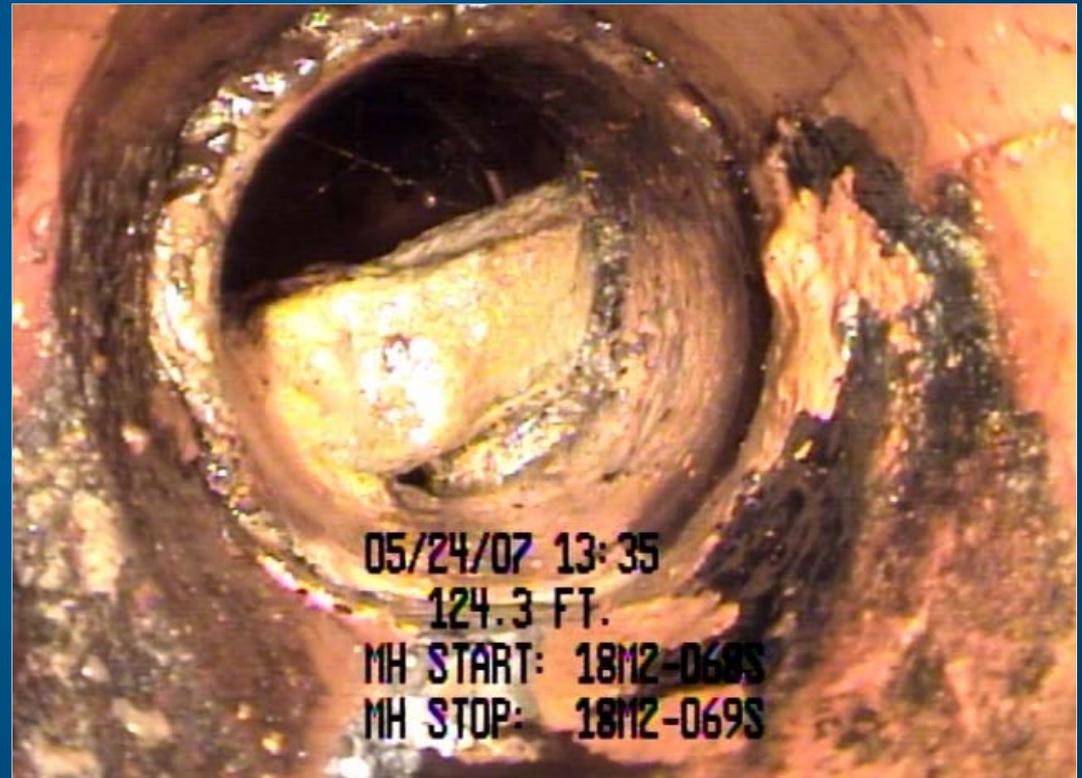
Service Lateral Rehabilitation

- Excavation Not Always Required
- Lots of Unpredictable Service Lateral Alignments, Materials and Blockages

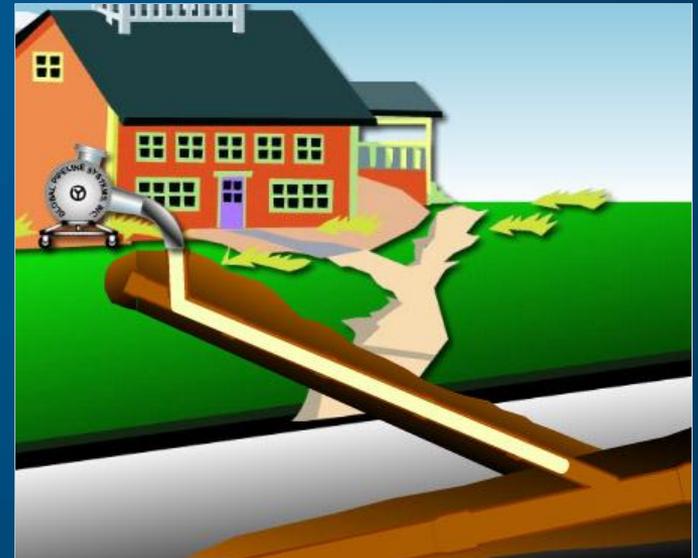
Lateral Lining

- Lateral:
 - Inversion or pull-in (same as main-line)
 - Needs cleanout
 - Needs relatively uniform cross-section
 - Gentle bends – otherwise liner will “pleat” and reduce area
 - Paid for per foot (+ cost of TV+ cost of cleanout)
 - Short-liner (spot repair)

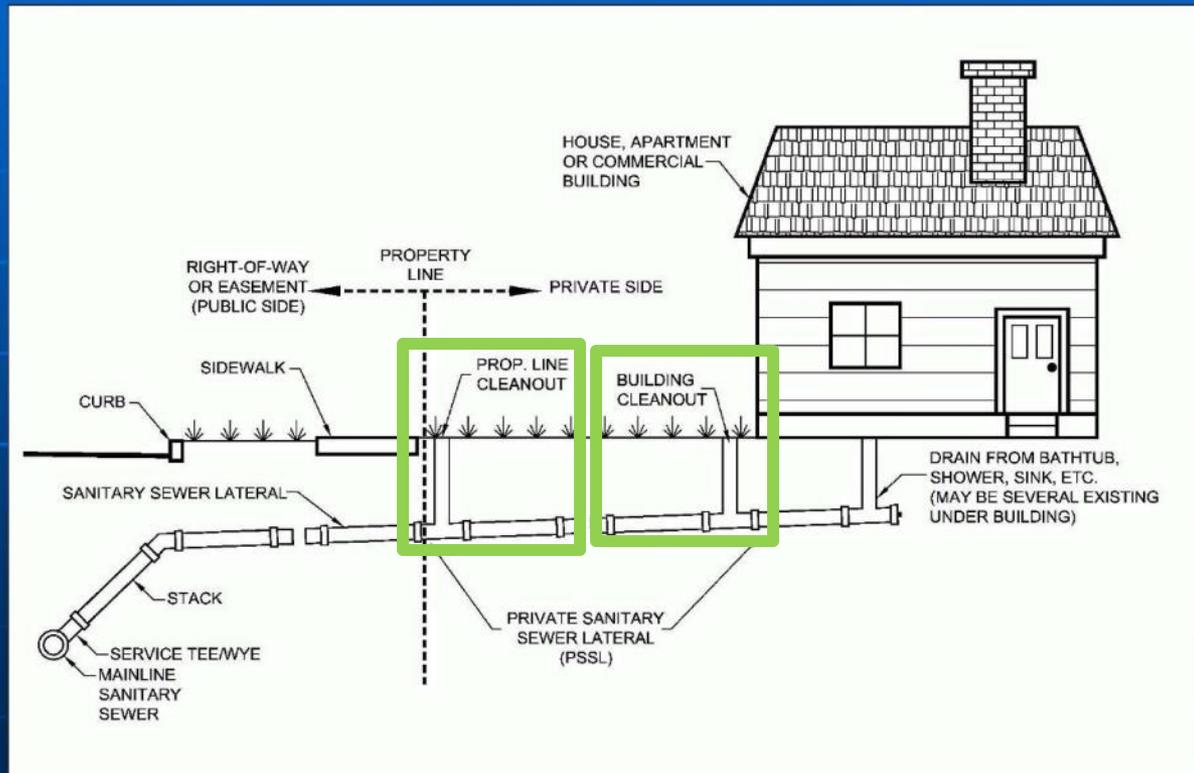
Typical Sanitary Sewer Lateral

Importance of Cleanout

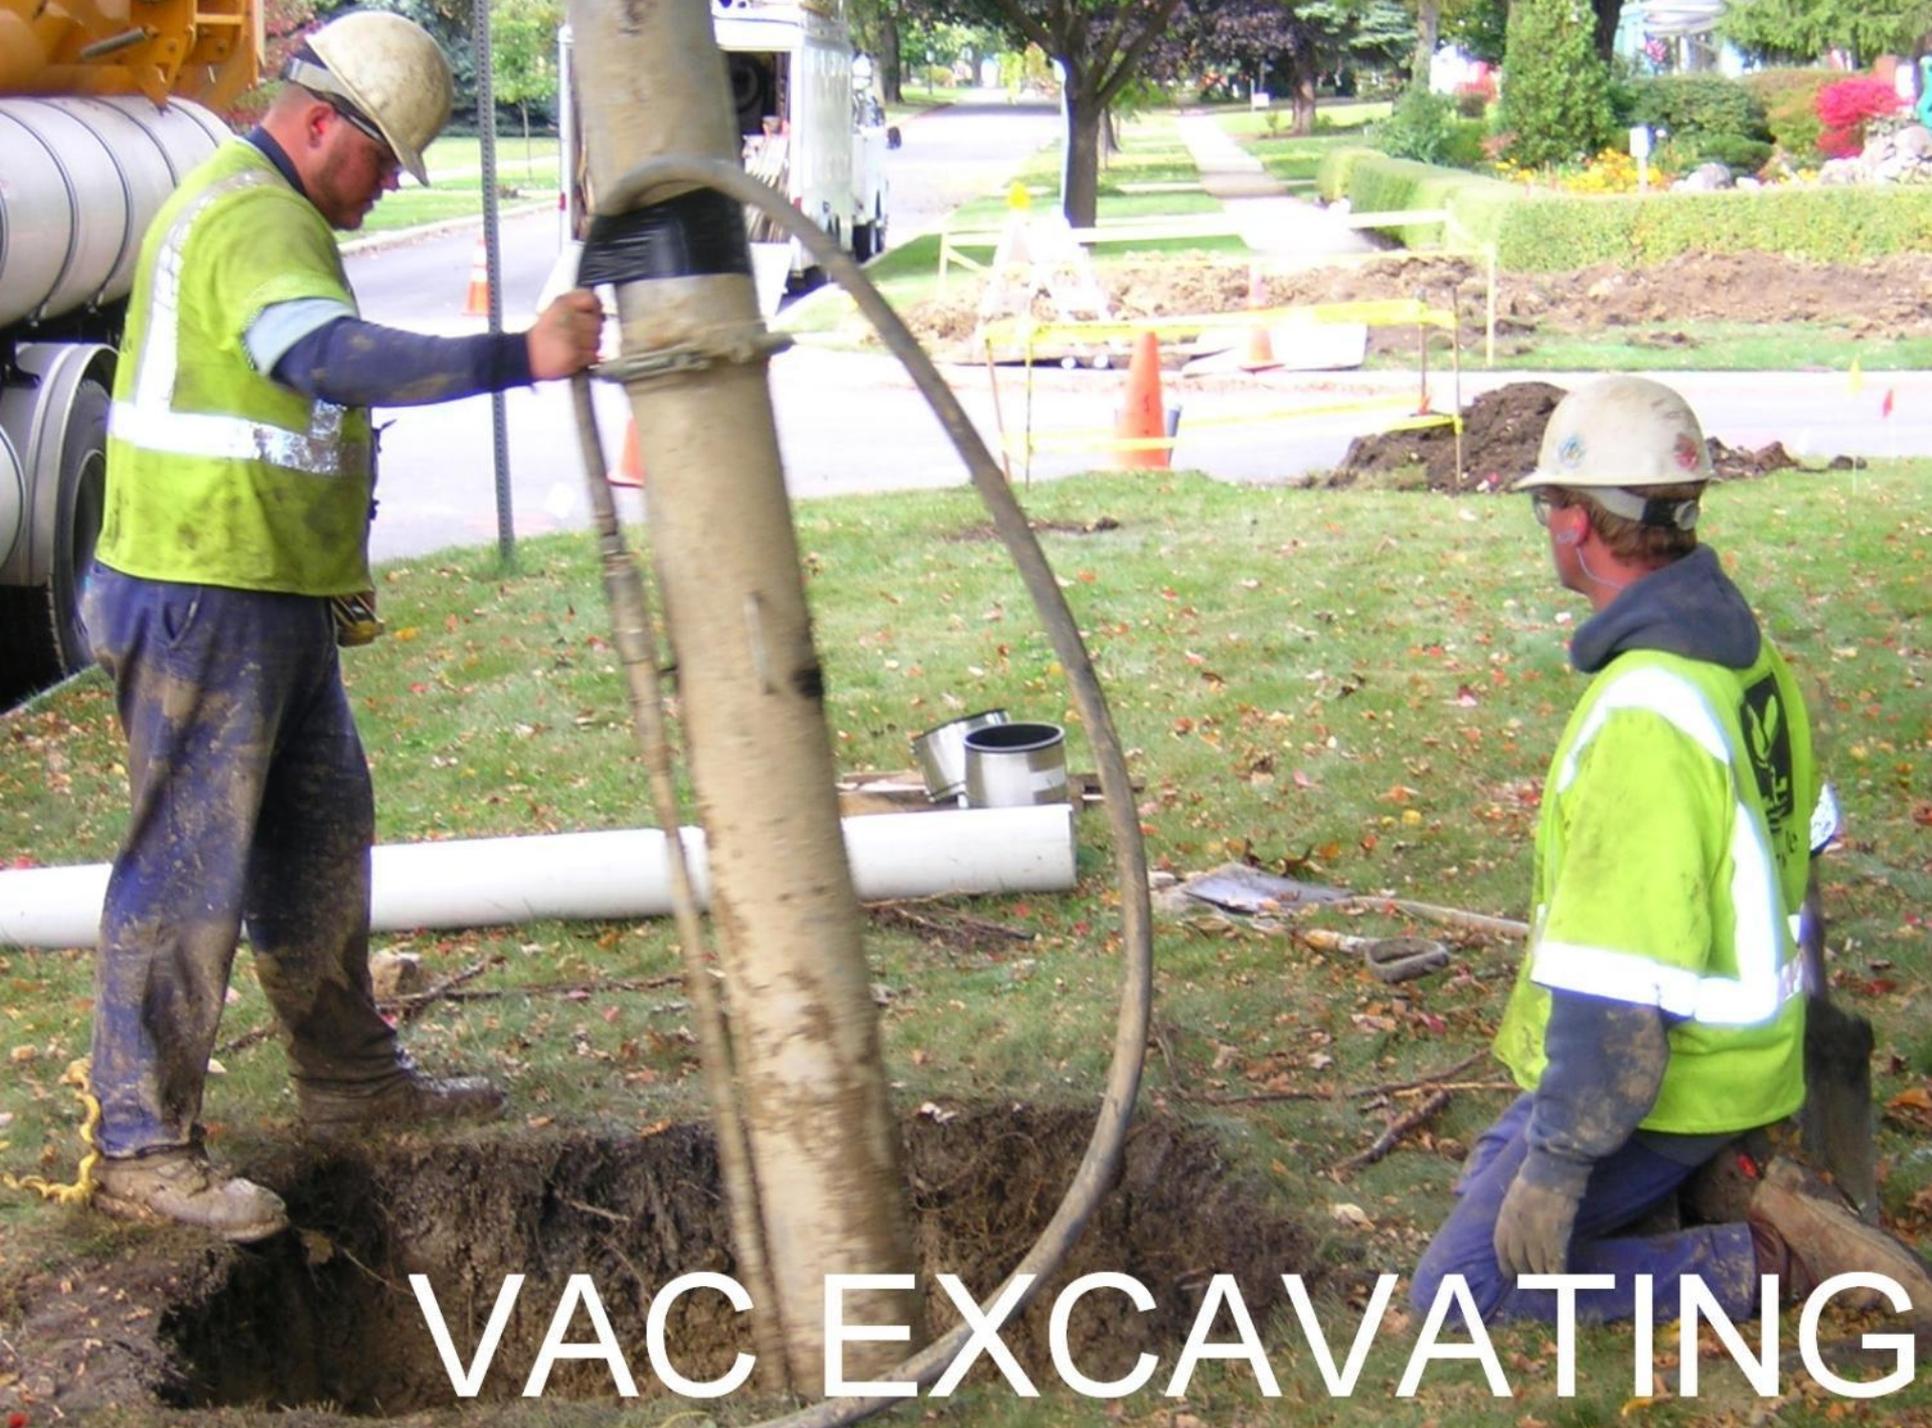
VAC EXCAVATING

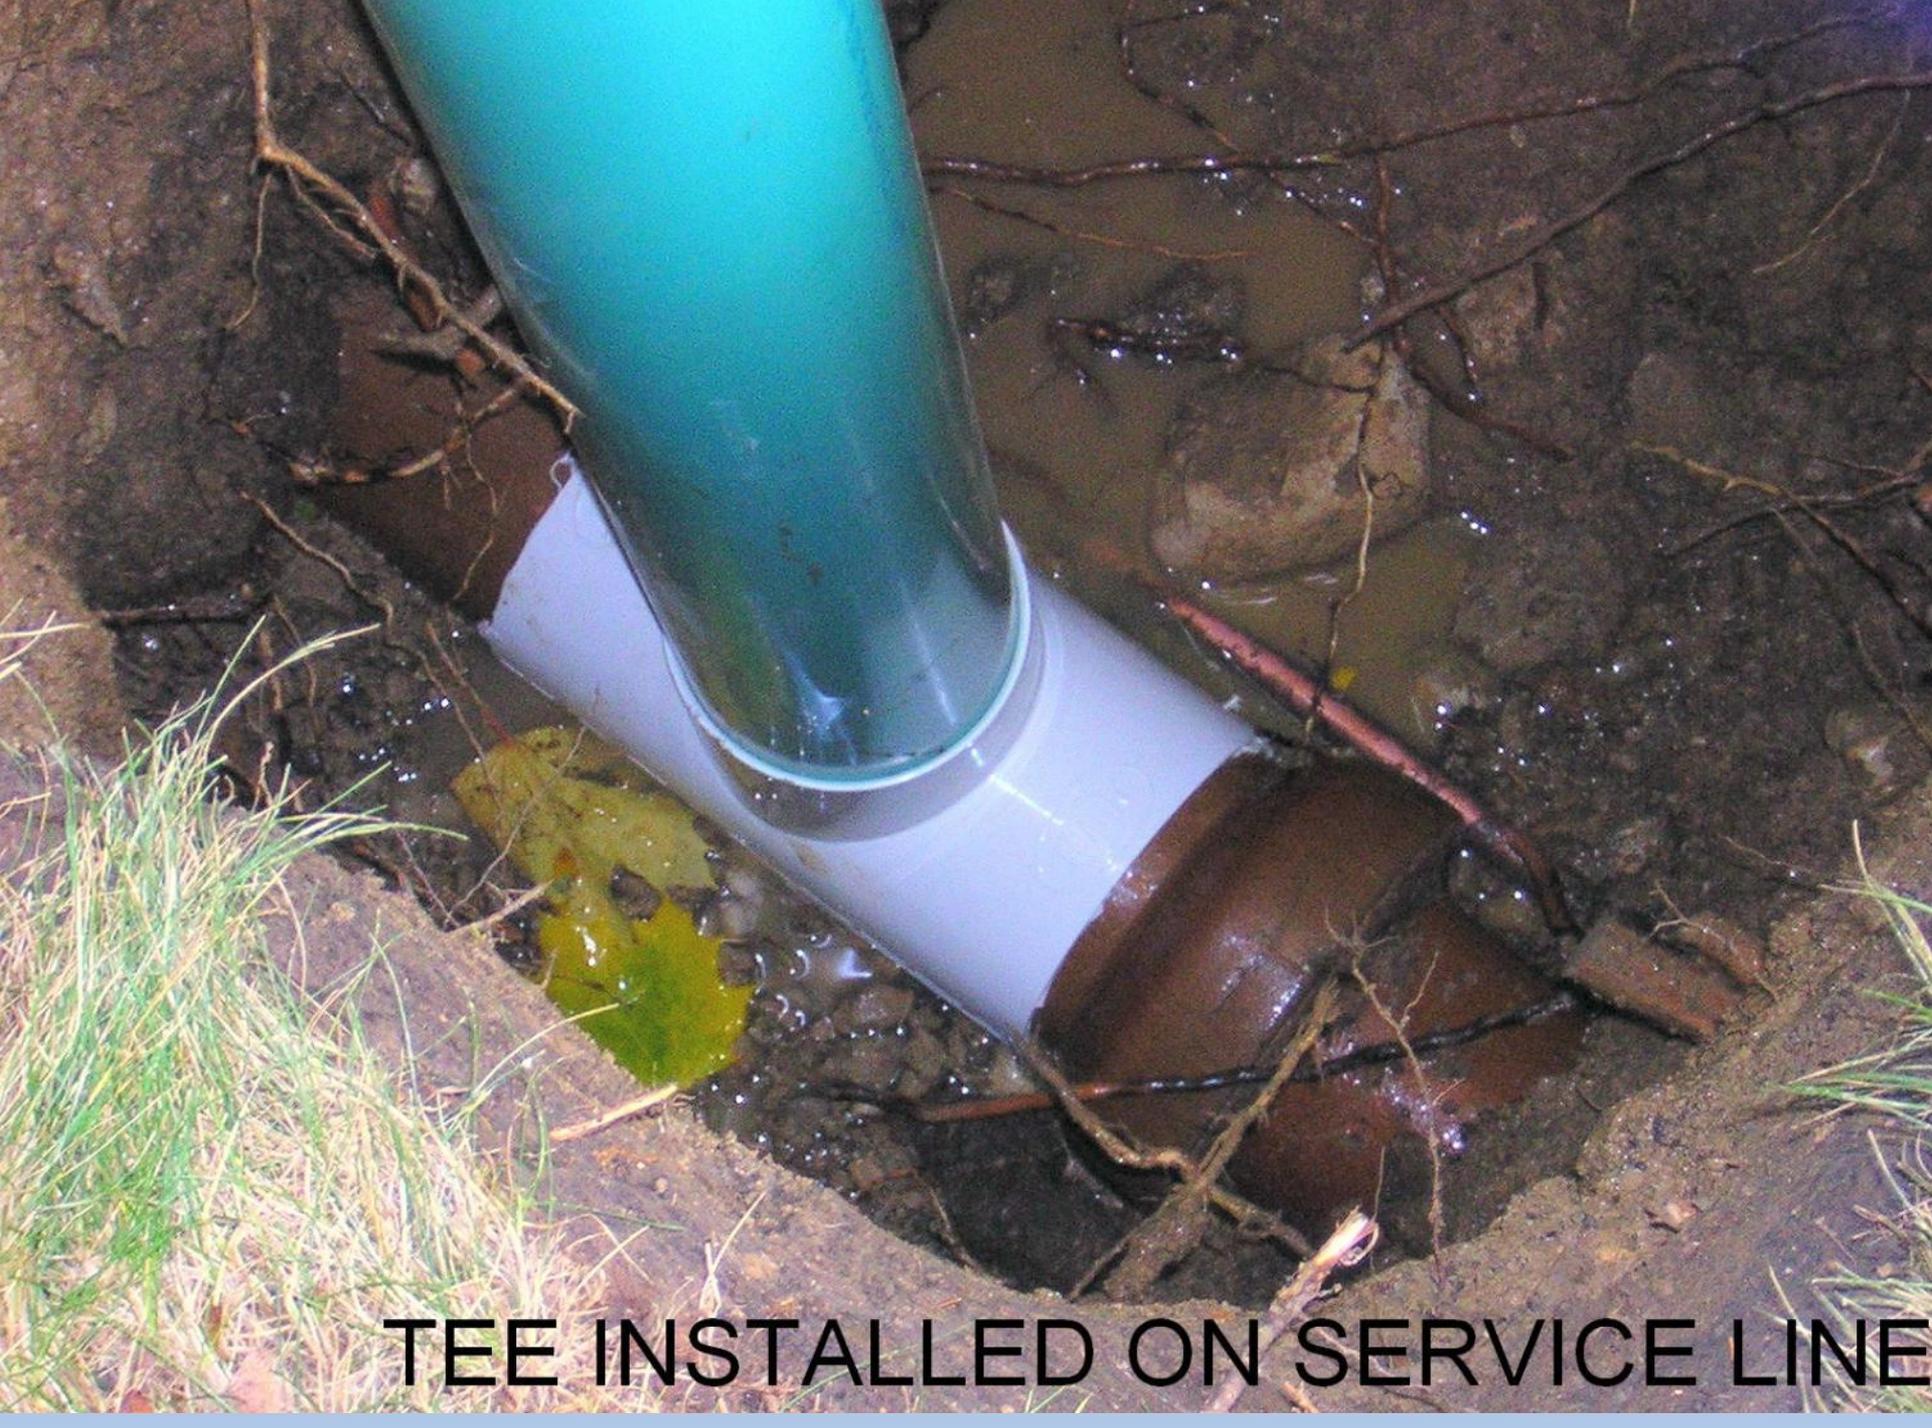
TEE INSTALLED ON SERVICE LINE

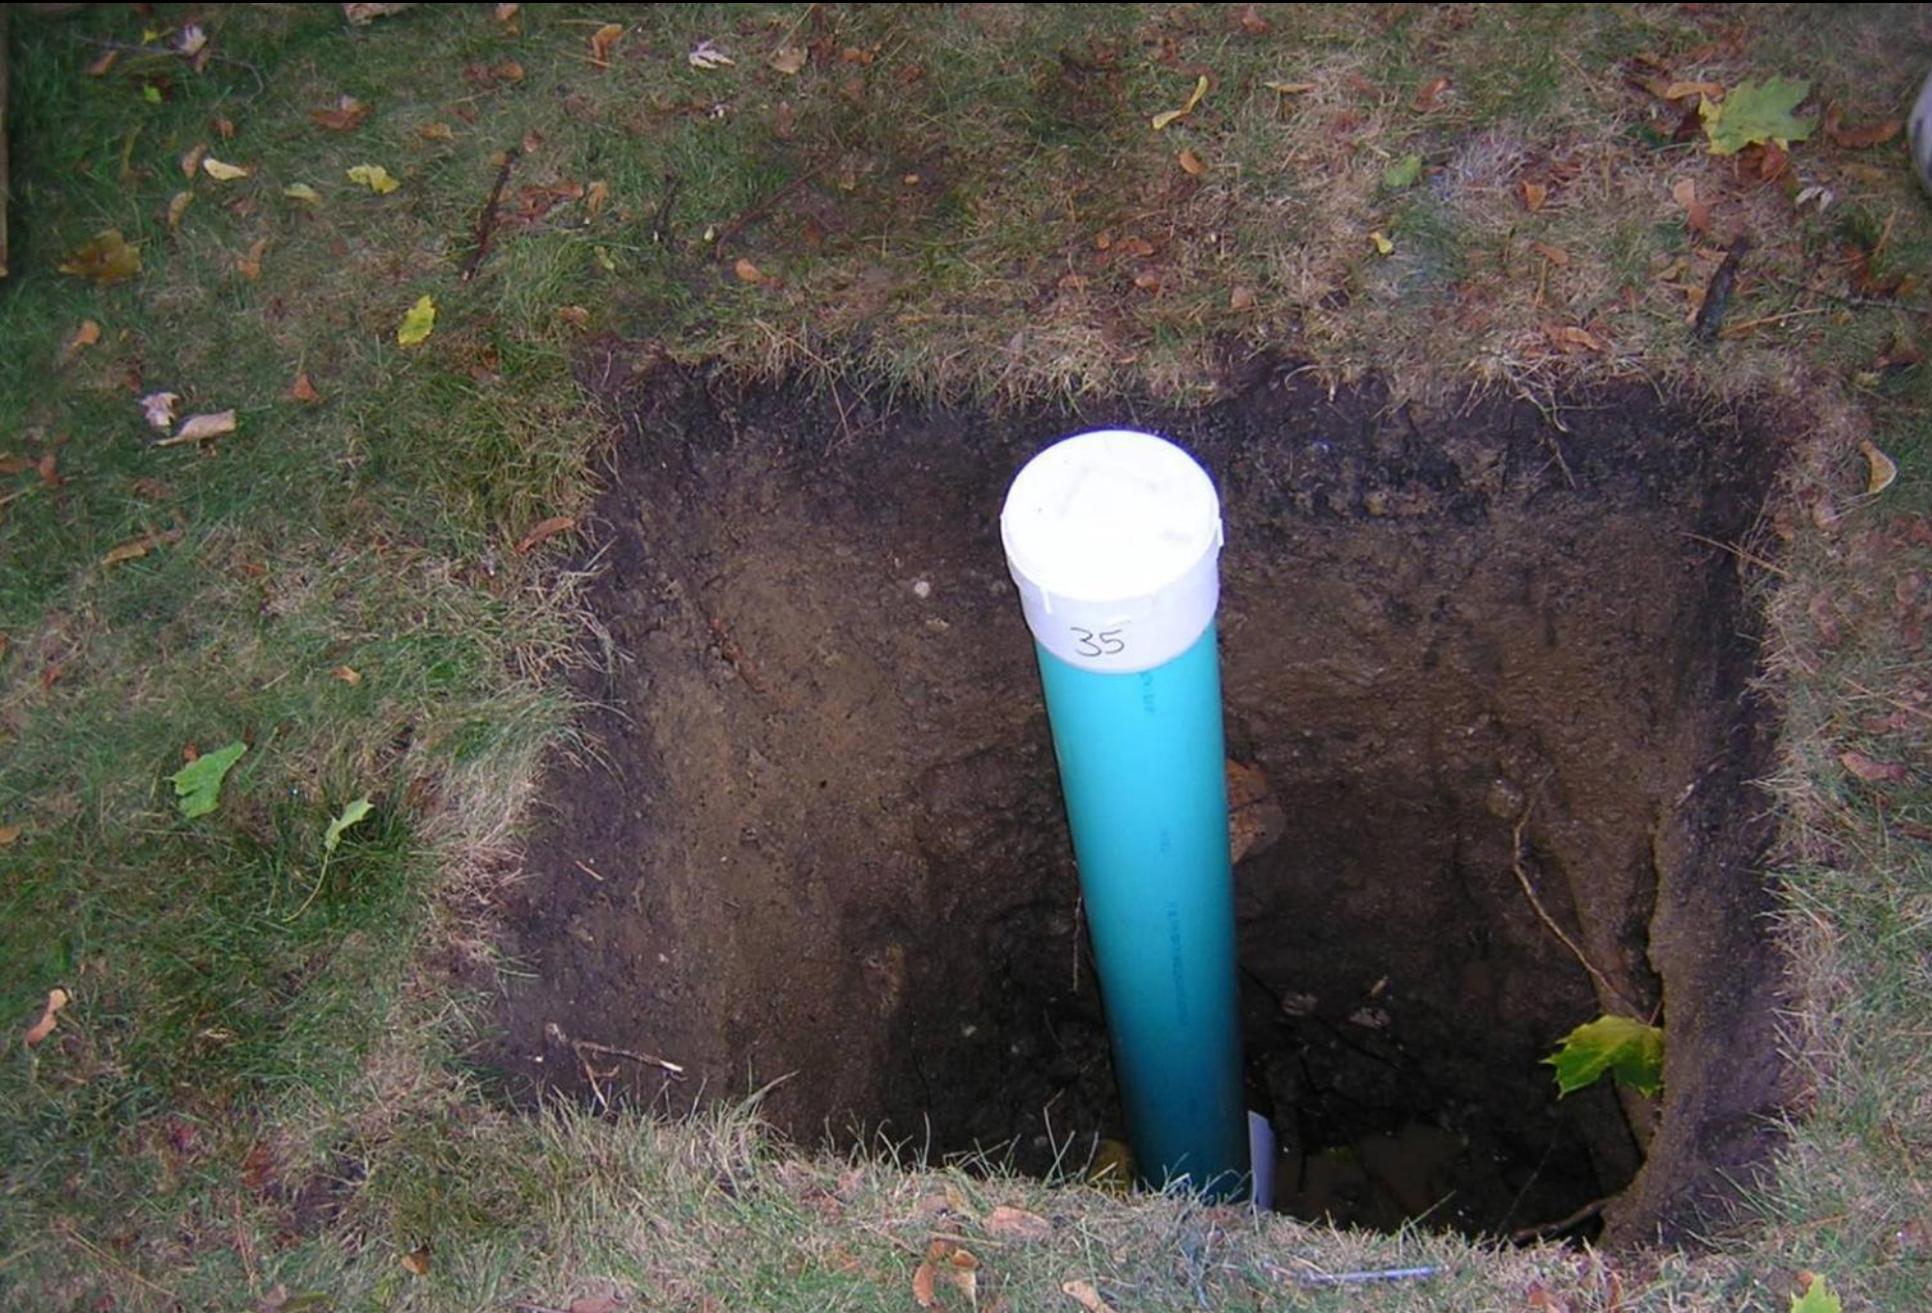
CLEANOUT PRIOR TO RESTORATION

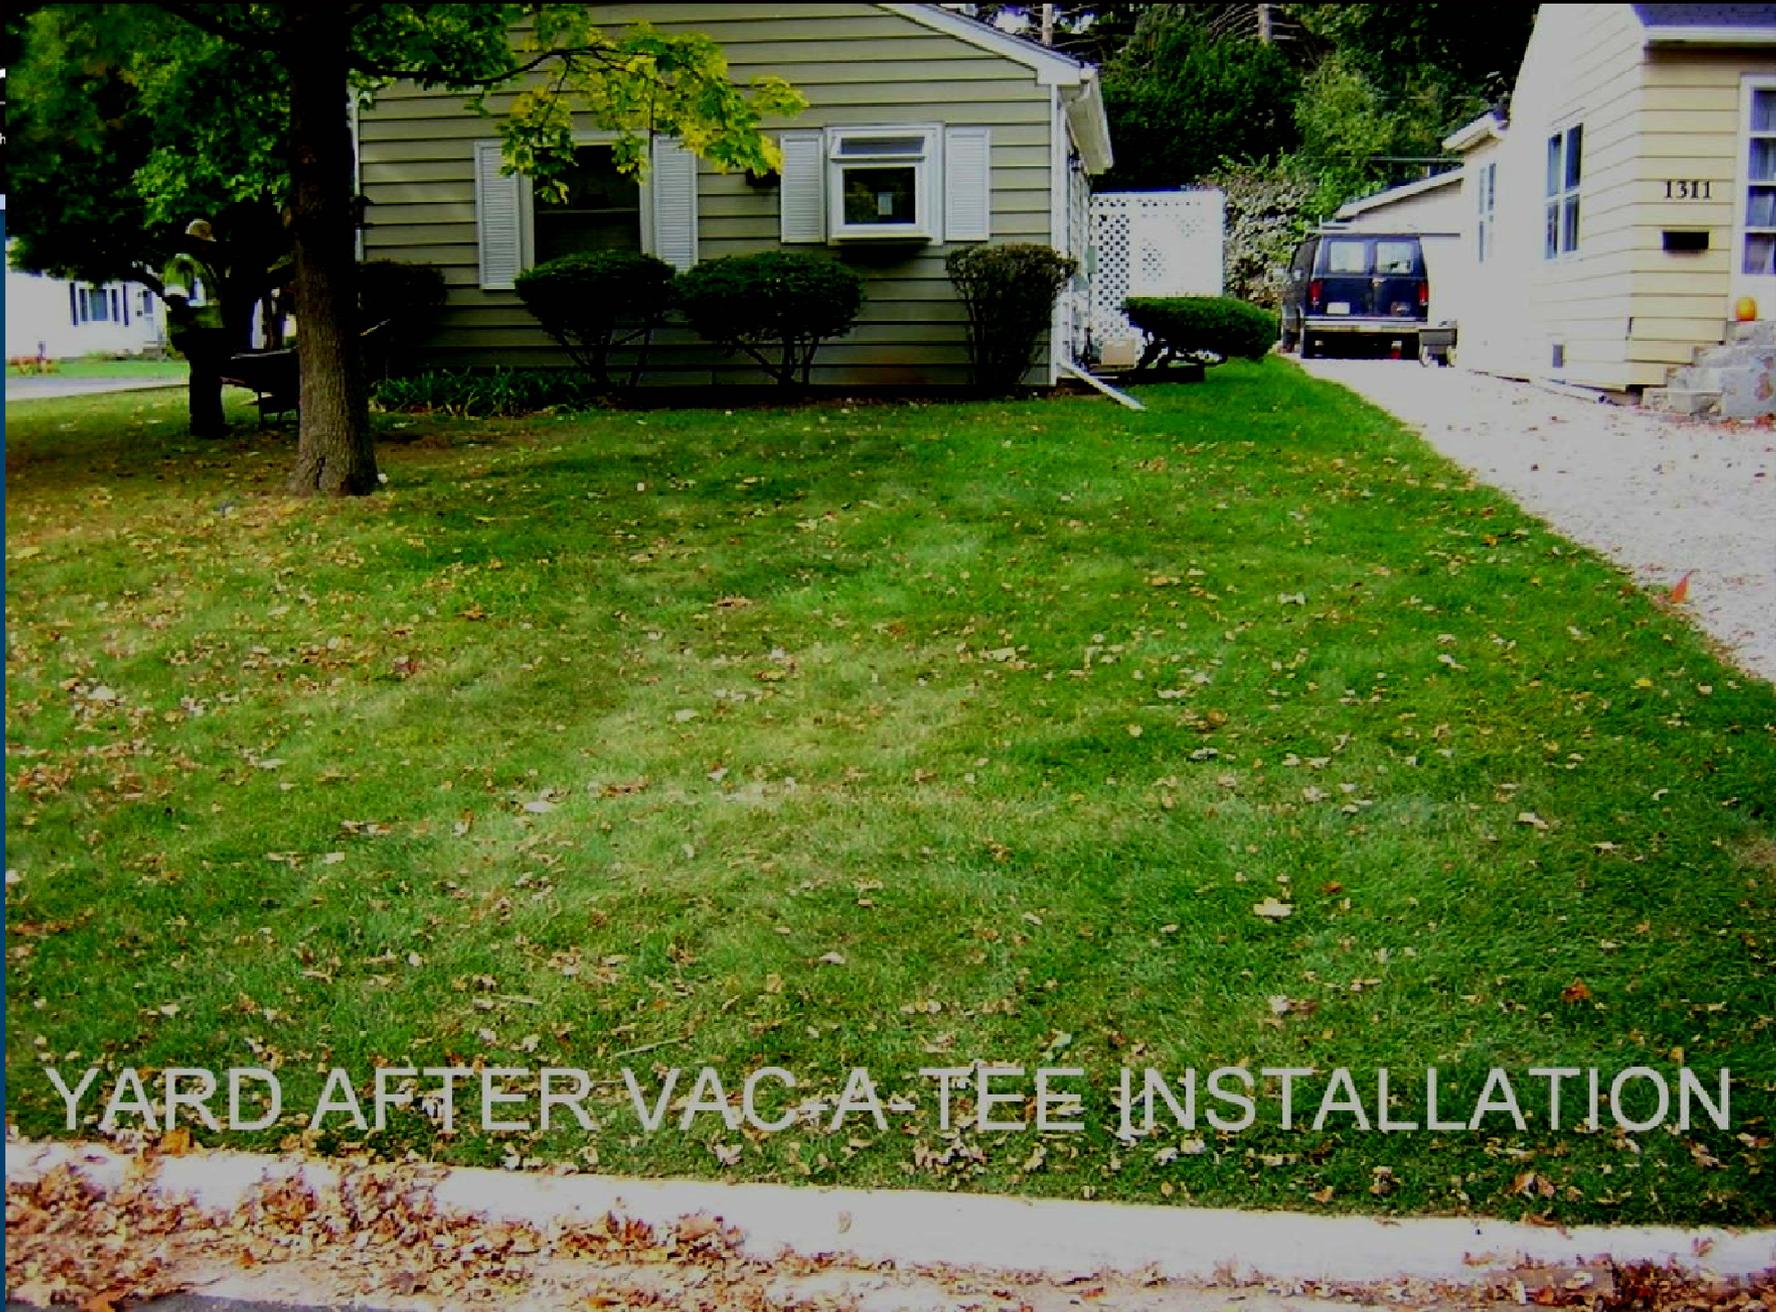
YARD AFTER VAC-A-TEE INSTALLATION

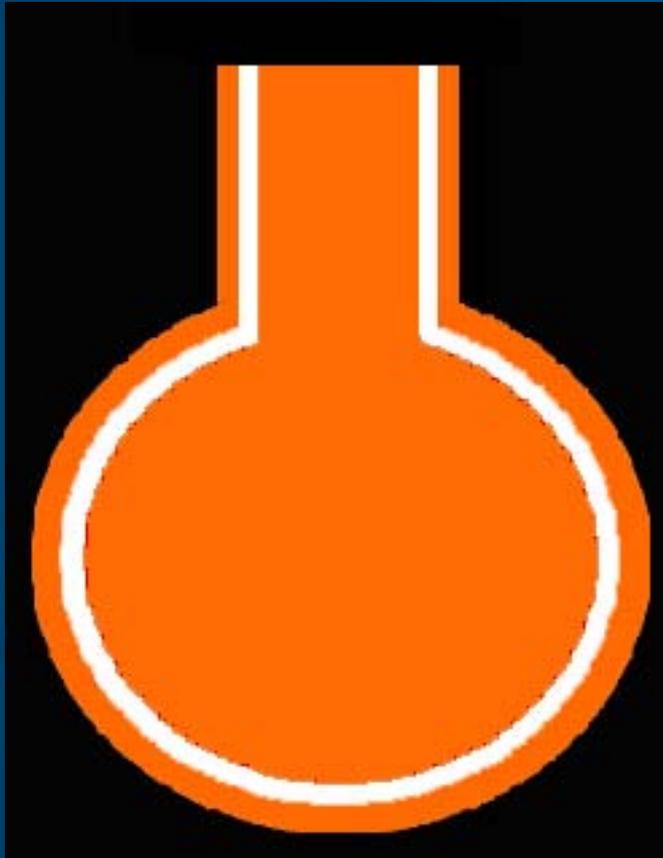
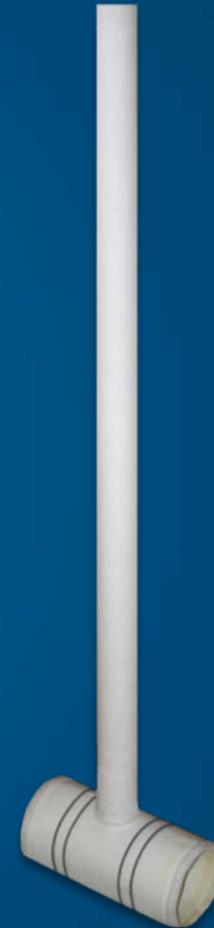
T-Liner Approach to Lateral Lining

**Full-Circle Seal/
a “Stand Alone” Structural Repair**

- Very Good Seal Between Lined Pipe and Into Lateral
- Can Vary Length
 - Stubby – 6 inches
 - Shorty – 3 feet
 - Long – 3 to 80+ feet
- Stubby Does Not Need a Cleanout
- If Install Cleanout at Building Connection Can Line Entire Section from Main Line
- Usually Paid Per Segment Set-Up then Per Lateral Per Length (cost is in the connection additional feet are relatively good value \$30-\$40 per foot)

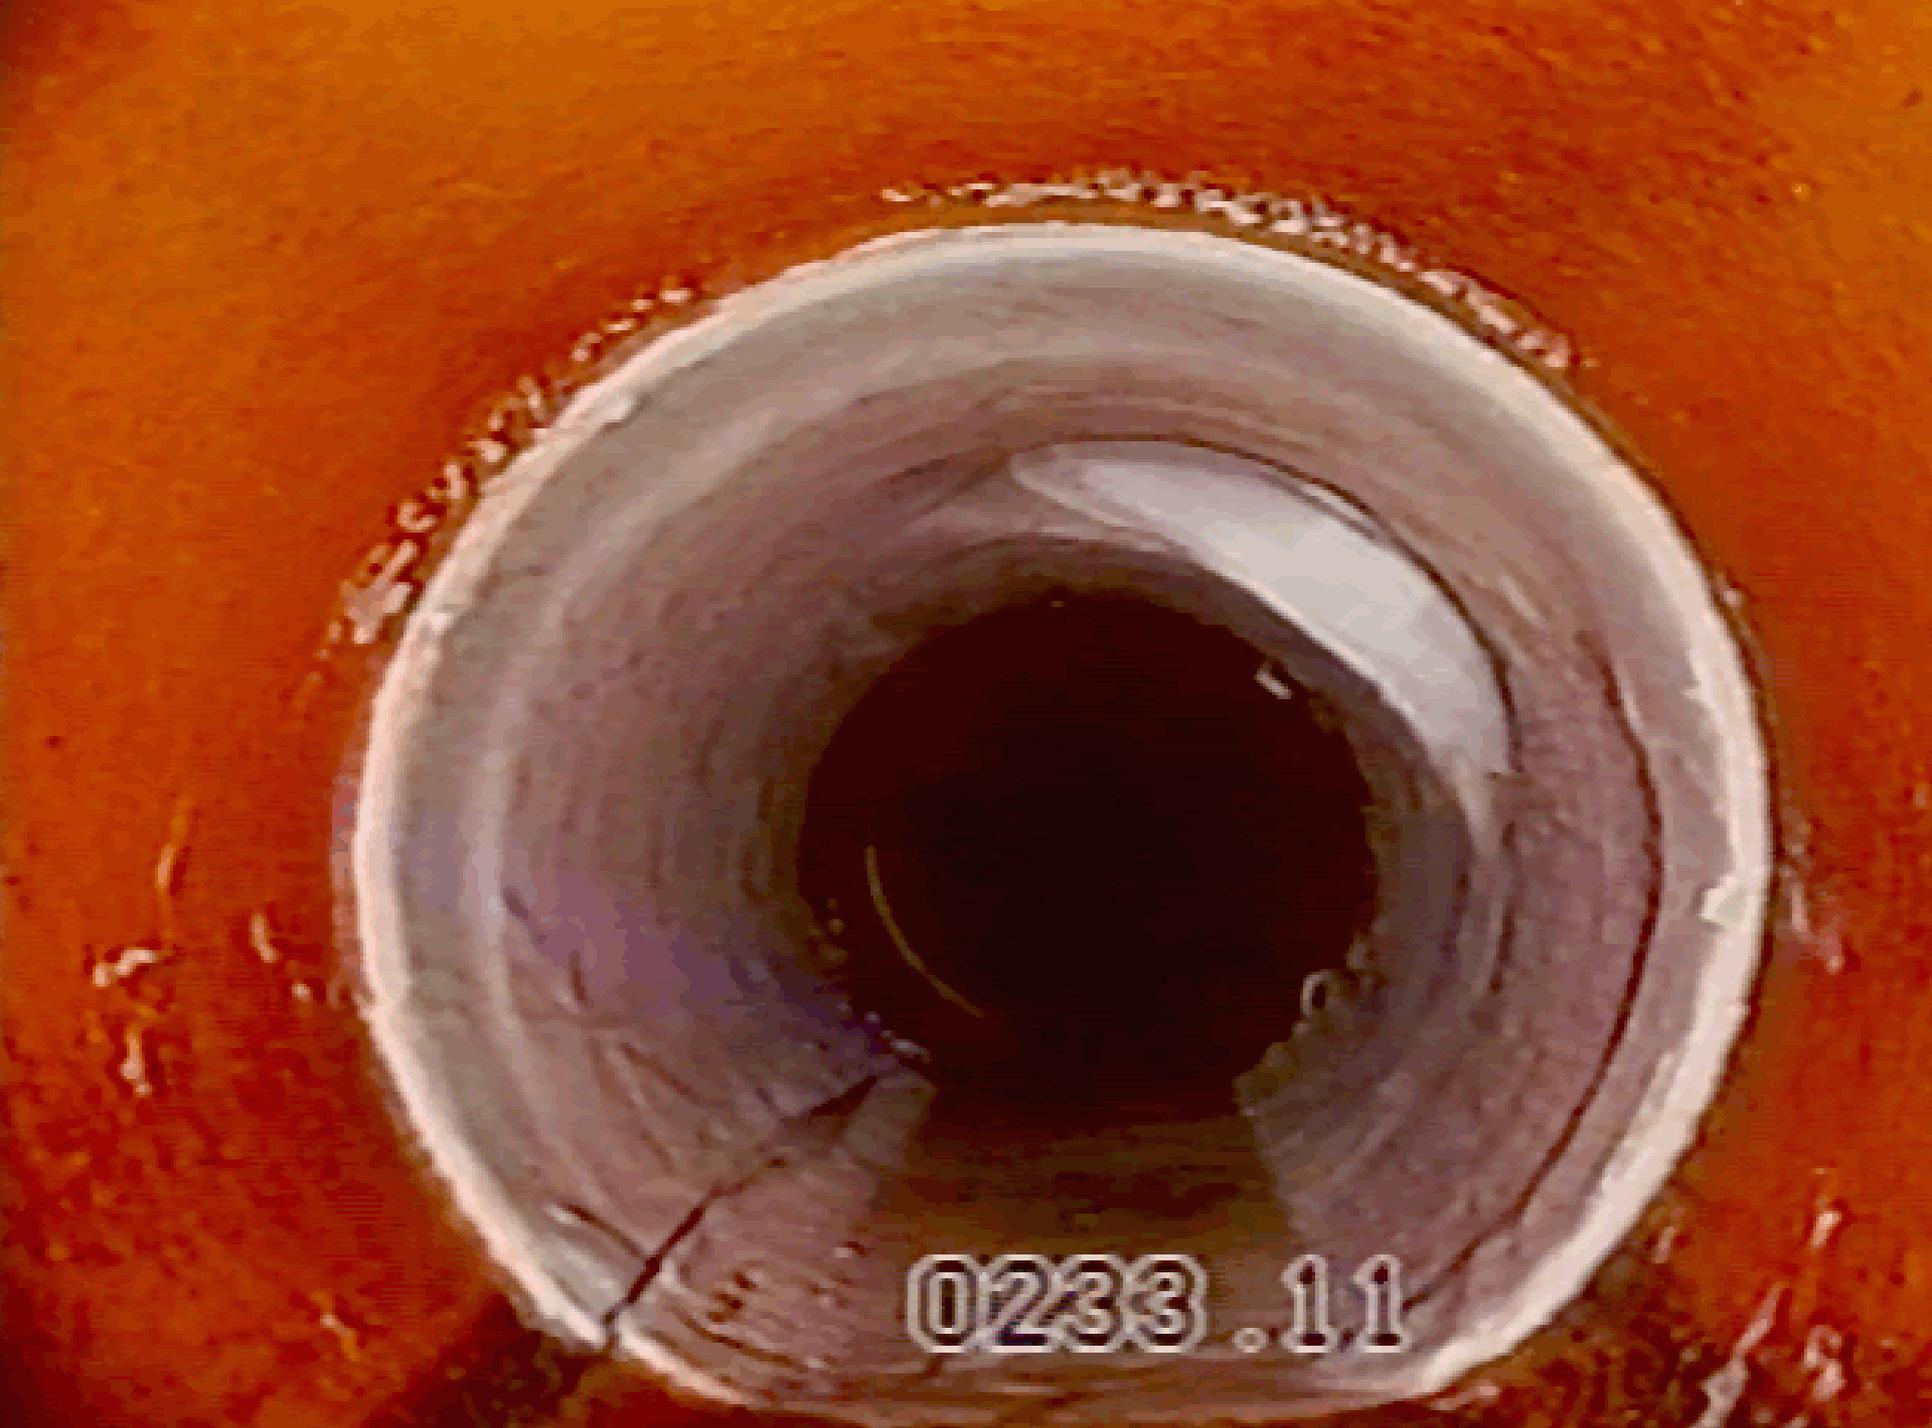
0233.11

A top-down view of a circular hole in a brown, textured surface. The hole's interior is lined with a white, fibrous material that has been layered or built up, creating a funnel-like structure. The layers are uneven and show some cracking. The center of the hole is dark and shadowed.

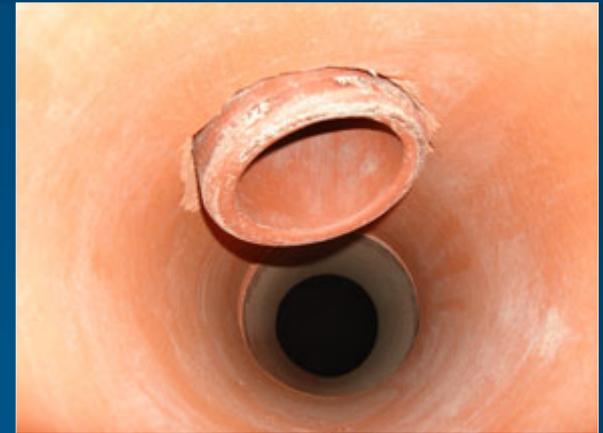
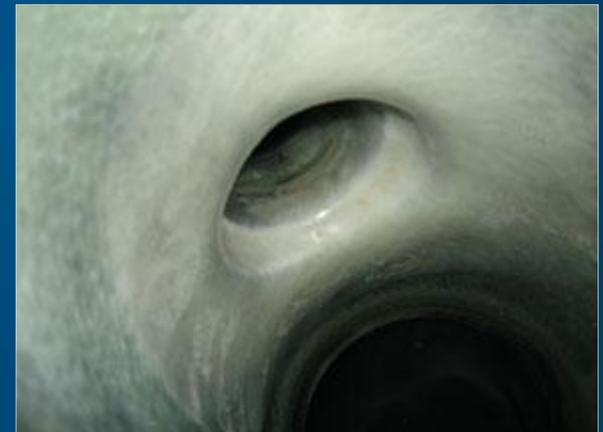
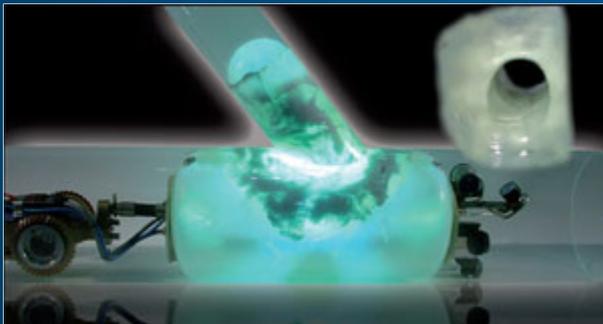
Connection Lining - Top Hat

- Top Hat
 - Does not need cleanout
 - Only seals connection
 - Addresses I/I well (not gushing)
 - Good for break-ins and PVC to VCP connection
 - Some instances of de-lamination
 - Paid for per segment set-up and then per connection
 - Problems if severe dropped connection
