Perspectives on Private Sector Infiltration/Inflow Identification and Rehabilitation

Prepared by
Alan J. Hollenbeck, P.E., BCEE
President/CEO
RJN Group, Inc.

2012 – Original 1980's ICAP “Revisited”

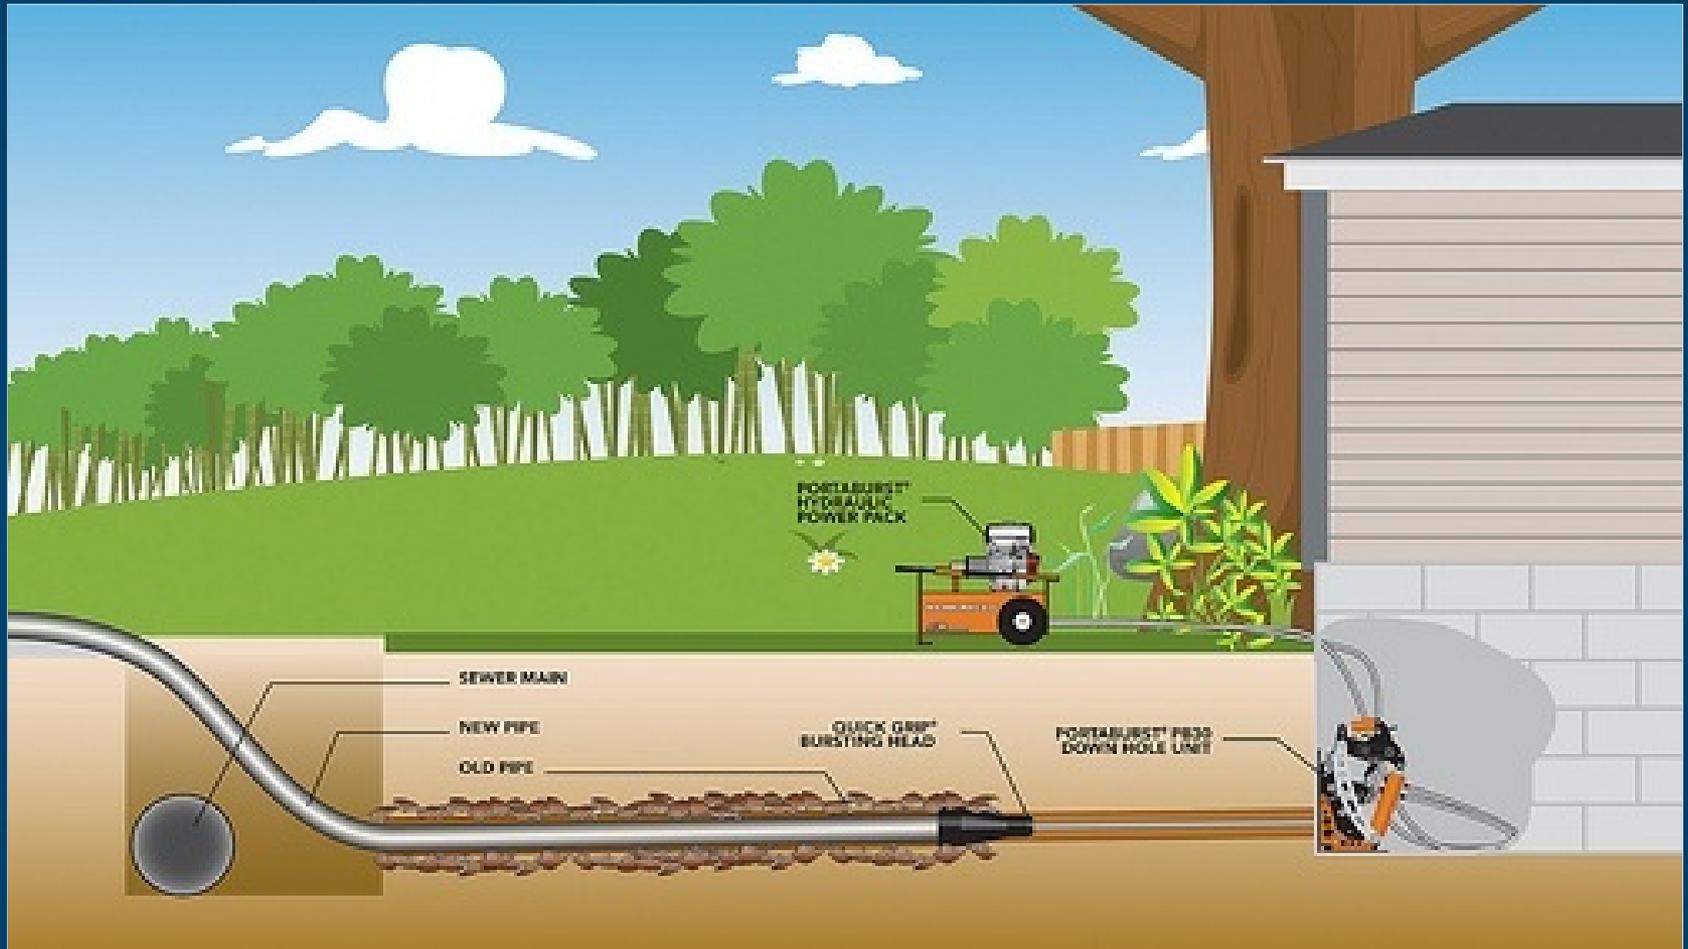
Pipe Bursting

- More Expensive Option
- Excavation – Needs Access Pits
 - Cleanout to main
 - Basement to main
 - Main to basement
- When to Consider?
 - Lateral needs upsizing
 - Very difficult access
 - Very deep lateral
 - Lateral “twists and turns”
 - Lateral is very long

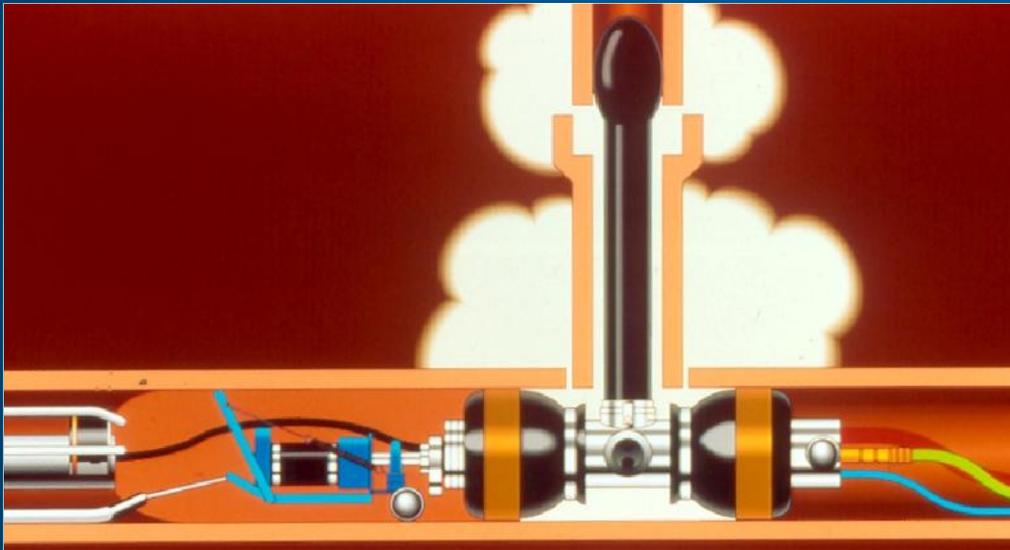
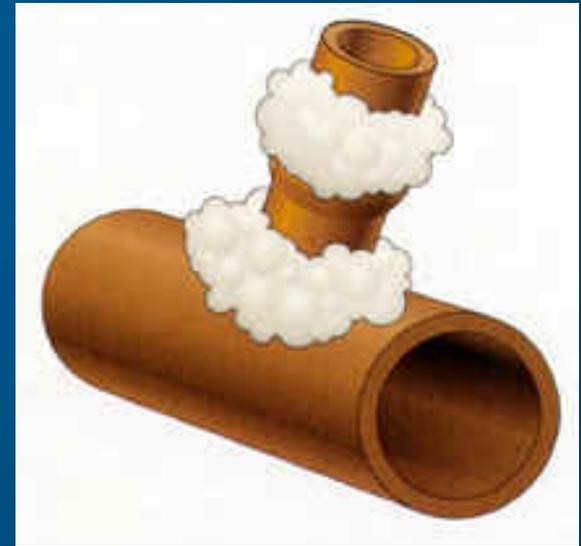
Grouting the Connection

Similar to Mainline Grouting, Special Packer Positioned at Service Connection that Extends Up the Lateral 30 Inches

- Pros:
 - Can be used very effectively at connection and first joint
 - Historically – long-term improvement (if in wet environment)
 - Cheaper than top-hat or T-liner
- Cons
 - May need more than one application on severe infiltration
 - If lateral is cracked cannot use
 - Needs to stay wet
 - Not as “neat-looking” on protruding taps
 - Not structural repair
- Pay Per Segment Set-Up, Then Per Connection or Per Gallon

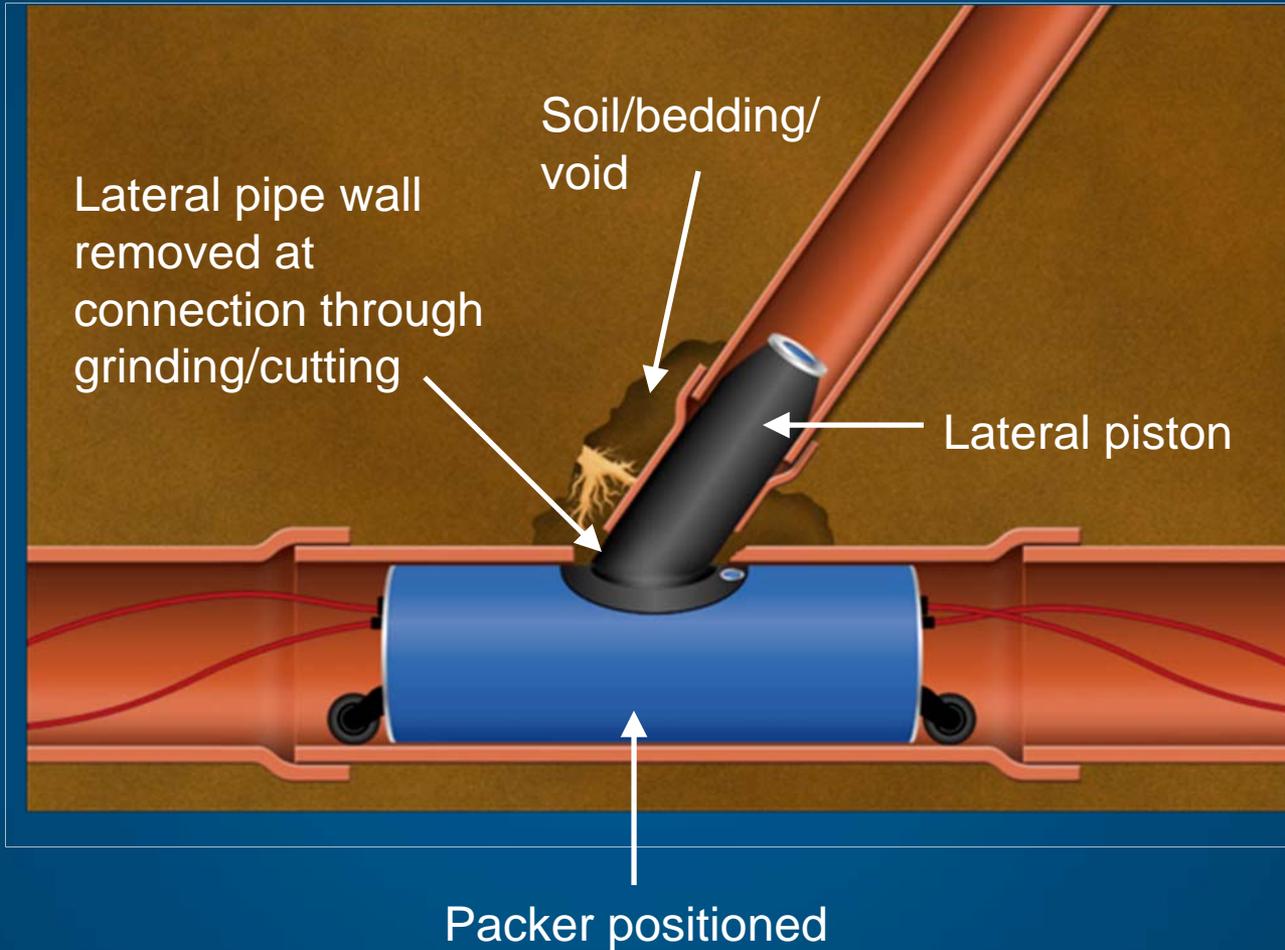
Packer Inserted

- Relatively New
- Full Structural Repair of the Connection
- Addresses I/I Gushing at the Connection Excellently
- Injects Epoxy Concrete Mix
- Can Be Installed with Cracked Laterals (Provided Not Longitudinal)

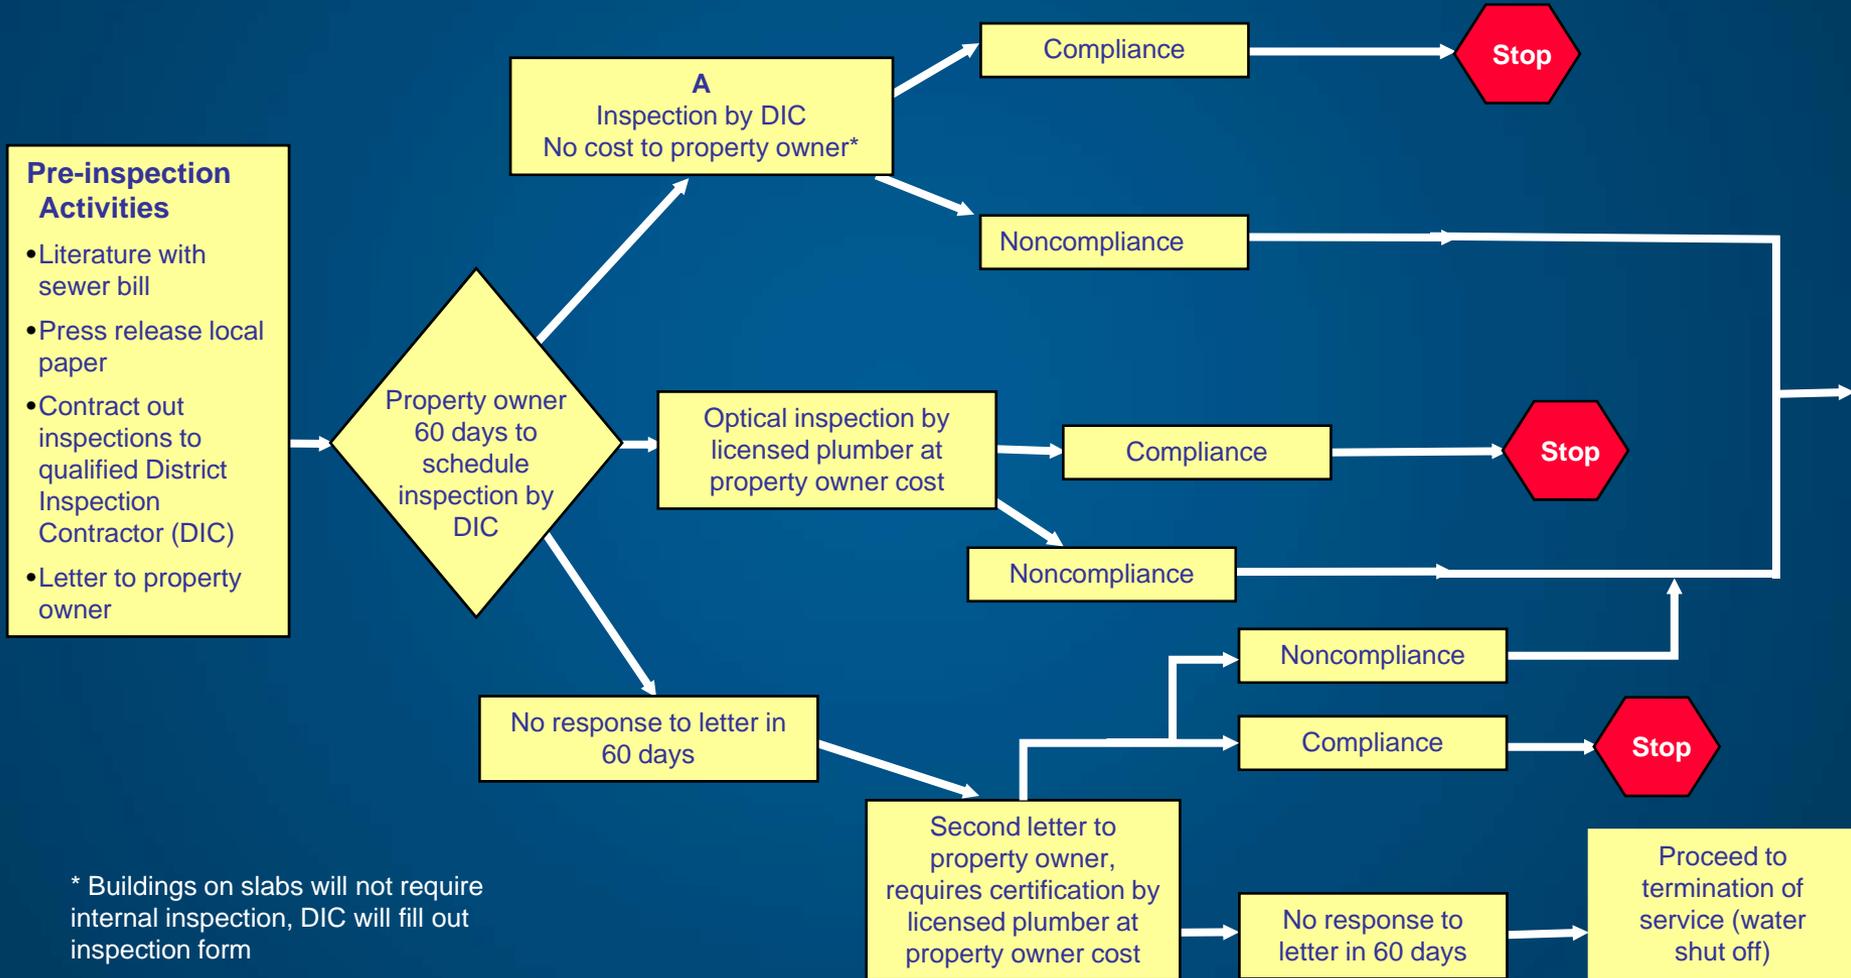
Initial Inspection

RRWRD Updated Private Property Inflow Source Disconnection Program

* Buildings on slabs will not require internal inspection, DIC will fill out inspection form

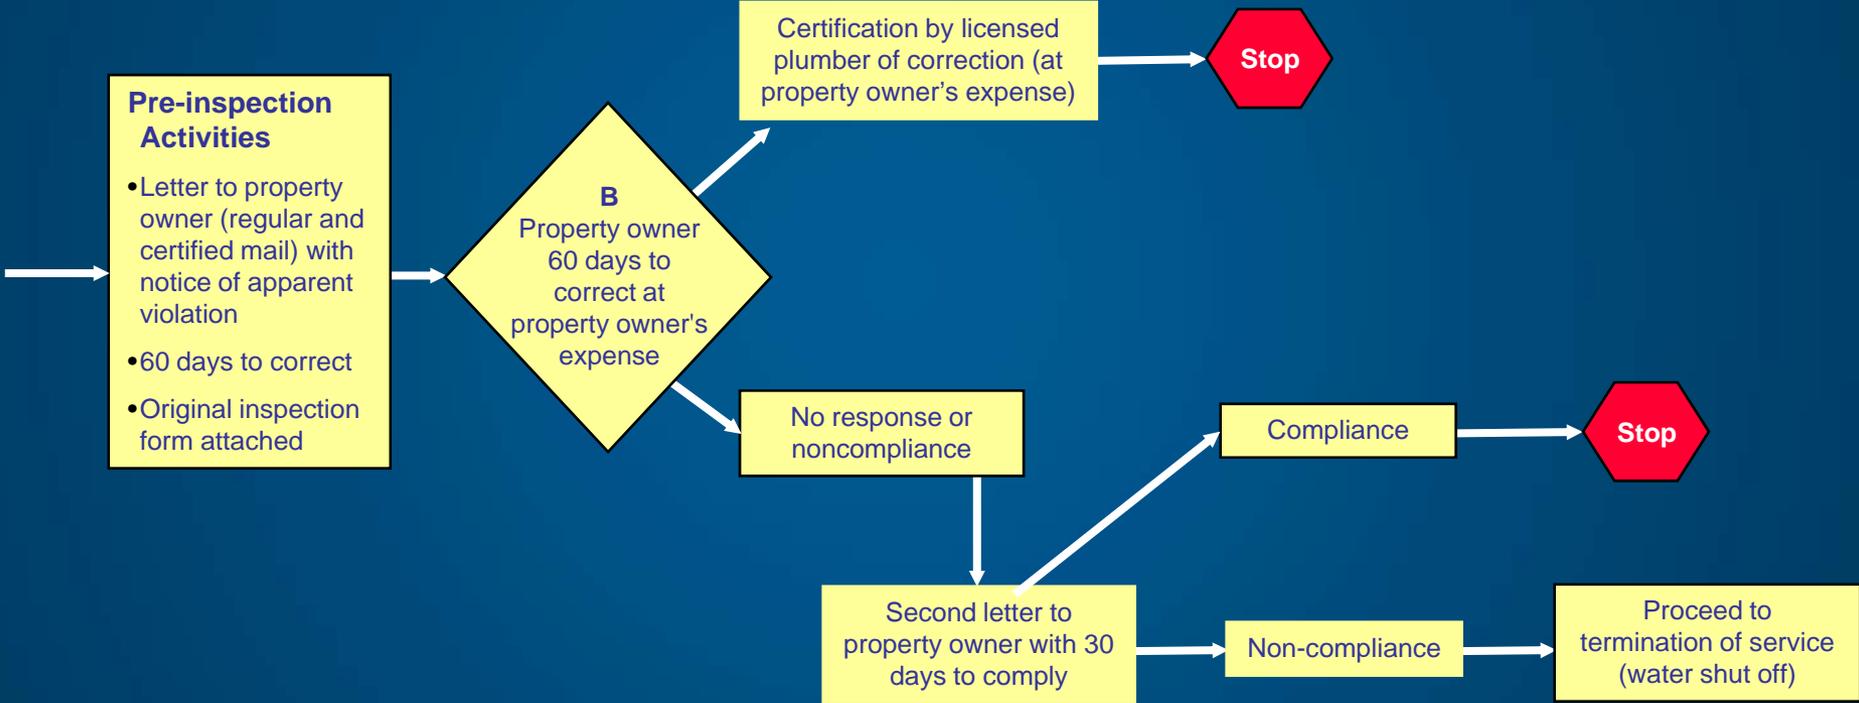
Follow-up Inspection – Illegal Connection Verified During Initial Inspection

RRWRD Updated Private Property Inflow Source Disconnection Program
