Executive Summary

Background

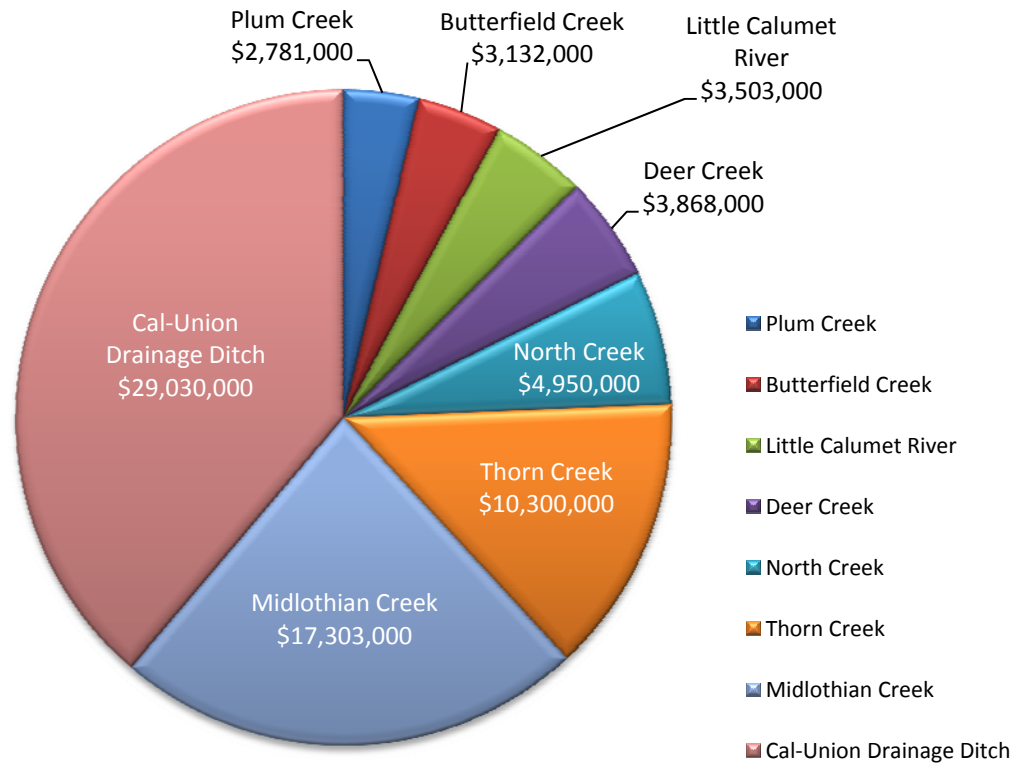
Figure ES.2: Distribution of Existing Condition Damages within the Little Calumet River Watershed

Figure ES.2 summarizes the distribution of existing condition damages within the Little Calumet River Watershed over a planning period of analysis of 50 years.

Existing condition damages within the Cal-Union Drainage Ditch subwatershed are significantly higher than that predicted within other subwatersheds. Due to relatively large areas of shallow flooding created by low topography, there are significantly larger numbers of impacted structures (over 1,250), and multiple impacted roadways. Damages predicted for other subwatersheds range according to the number of impacted structures and roadways, and the severity of the associated flooding.

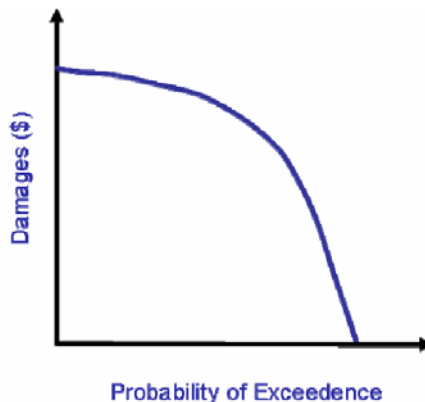
Figure 1.4.1: Hypothetical Damage-Frequency Relationship

The estimated structure value, flooding depth, and depth-damage curve information were used to estimate the property damage from flooding for a specific structure due to a storm of given recurrence interval. Higher magnitude events, such as the 100-year event, cause higher damages for flooded properties but also have a lower likelihood of occurring in a given year. **Figure 1.4.1** shows the hypothetical relationship between expected damage and modeled recurrence interval. Estimated annual damages were calculated according to the CCSMP, essentially weighting the expected annual damages by their annual probability of occurrence. Damages were then capitalized over a 50-year period of analysis, consistent with the period of analysis over which maintenance and replacement costs were calculated, using the federal discount rate for 2008 of 4.875 percent.

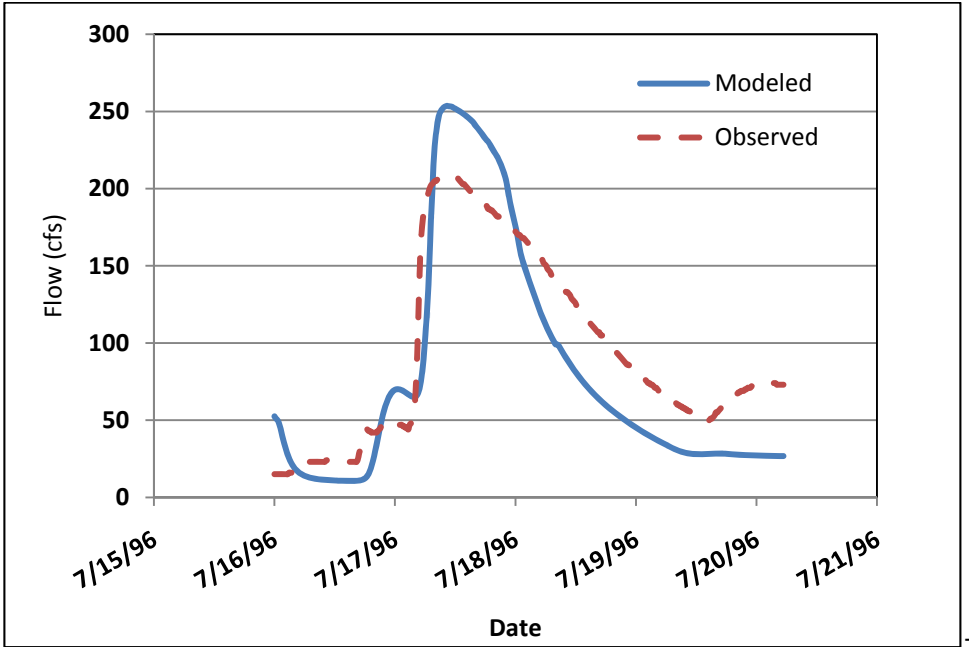
Figure 3.1.2: Butterfield Creek Subwatershed Calibration Results, July 1996 Storm Event

¹Flow within 30% and stage within 6 inches.

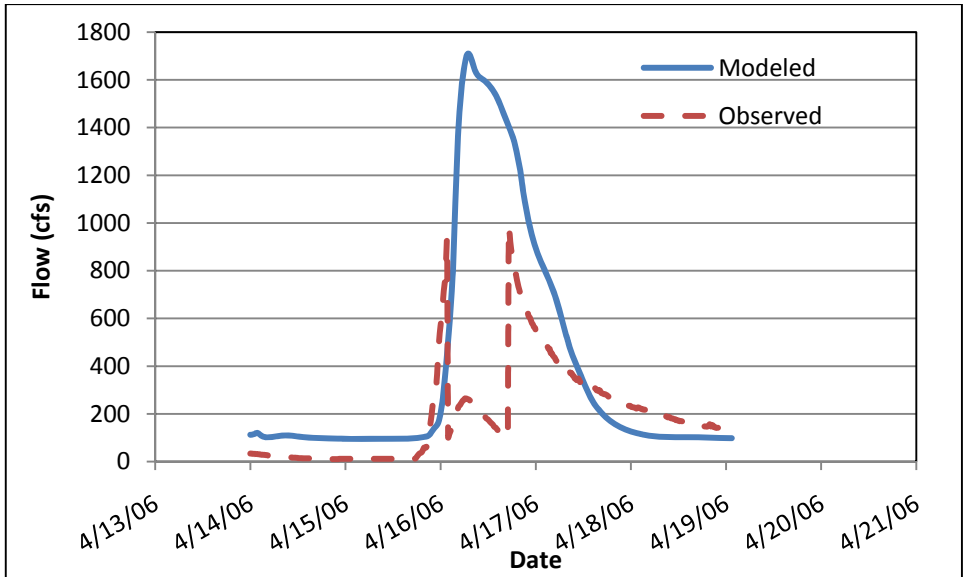
Figure 3.1.3: Butterfield Creek Subwatershed Calibration Results, April 2006 Storm Event

²April 2006 event did not meet the CCSMP criteria. The stream gauge was malfunctioning during this event and it appears that this rainfall event was not uniform across the Butterfield Creek watershed.

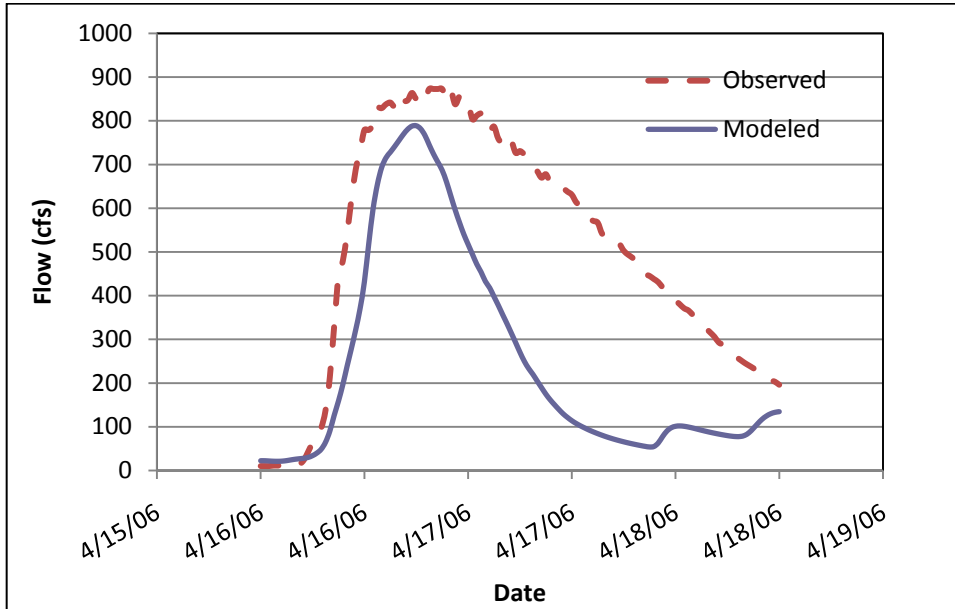
Figure 3.3.2: Deer Creek Calibration Results, April 2006 Storm Event

Although the April 2006 and April 2007 storm events do not meet the CCSMP's criteria, the model is considered well calibrated. Since the stages are seen to be generally on the low side, raising the Manning's n-values was initially considered, but more research was performed to understand this discrepancy, as follows.

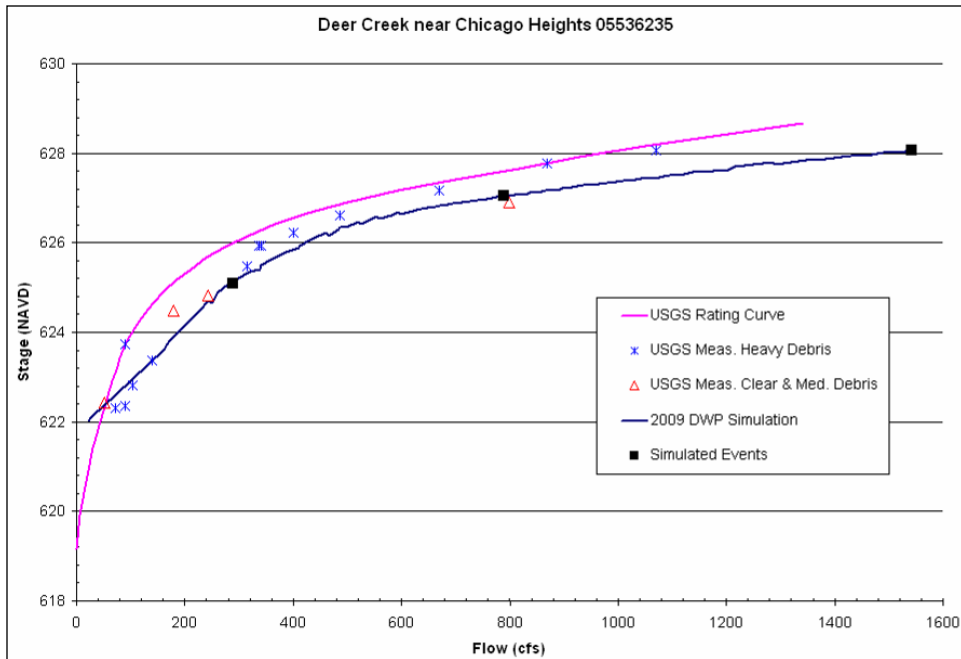
Figure 3.3.5: USGS Rating Curve vs. Simulated Events, Deer Creek Gage

Figure 3.3.5 depicts the rating curve with the three simulated events (black squares) as well as all events measured by the USGS since 1995. The USGS measurements have been further broken down into those for which the field notes stated "Heavy Debris", and those for which the field notes stated "Clear or Medium Debris".

Although the three simulated events are slightly outside the limits for stage as required by the CCSMP, the three USGS measurements that were noted either “Clear” or “Medium” debris lie very close to the simulated rating curve. The modeled event of April 2006 lies almost directly over one of the USGS “Clear or Medium” measurements (Dated January 8, 2008 with flow = 799 cfs and stage = 626.91 feet). This measurement’s flow is within 10 cfs of the simulated event and has a stage within 0.13 feet of the simulated event.

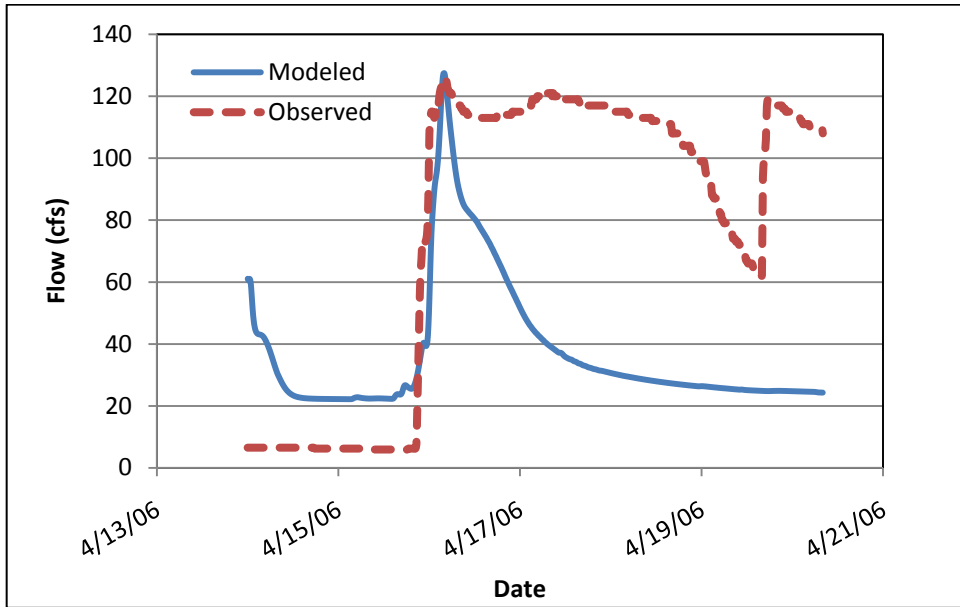
Figure 3.4.3: Midlothian Creek Subwatershed Calibration Results, April 2006 Storm Event

The receding limbs for April 2006 storm event do not correlate between the observed and modeled hydrographs; this may be due to operation of the reservoir pump stations. In the Midlothian Creek subwatershed model, the reservoir pump stations are not simulated and this excess volume shown in the observed graph may be due to the draining of the flood control facilities.

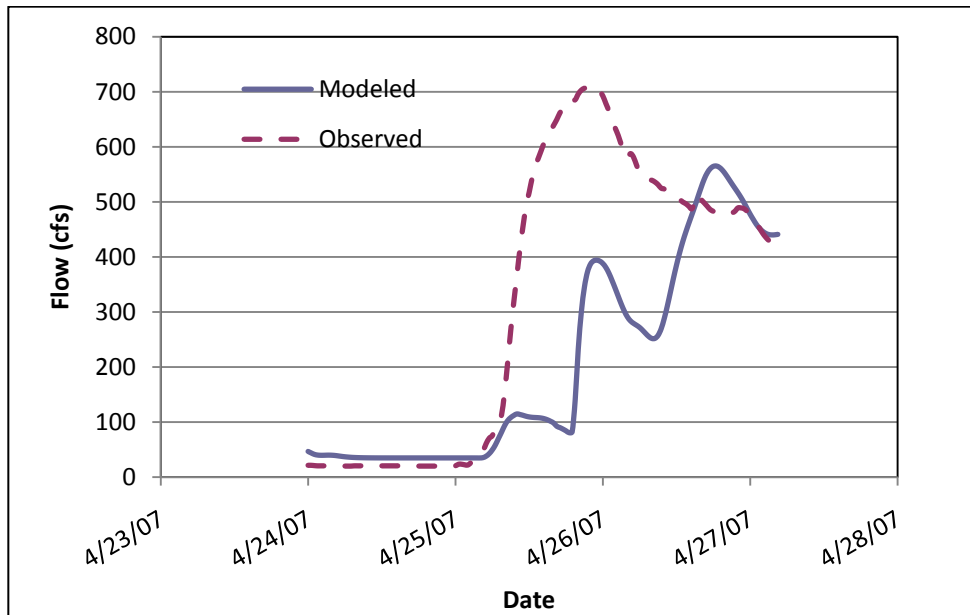
Figure 3.6.3: Plum Creek Subwatershed Calibration Results, April 2007 Storm Event

²Stage data not available for April 2007 storm event.
