*REPORT NO. 21-17*

*HANOVER PARK WATER RECLAMATION PLANT*

*FISCHER FARM MONITORING REPORT FOR*

*FIRST QUARTER 2021*

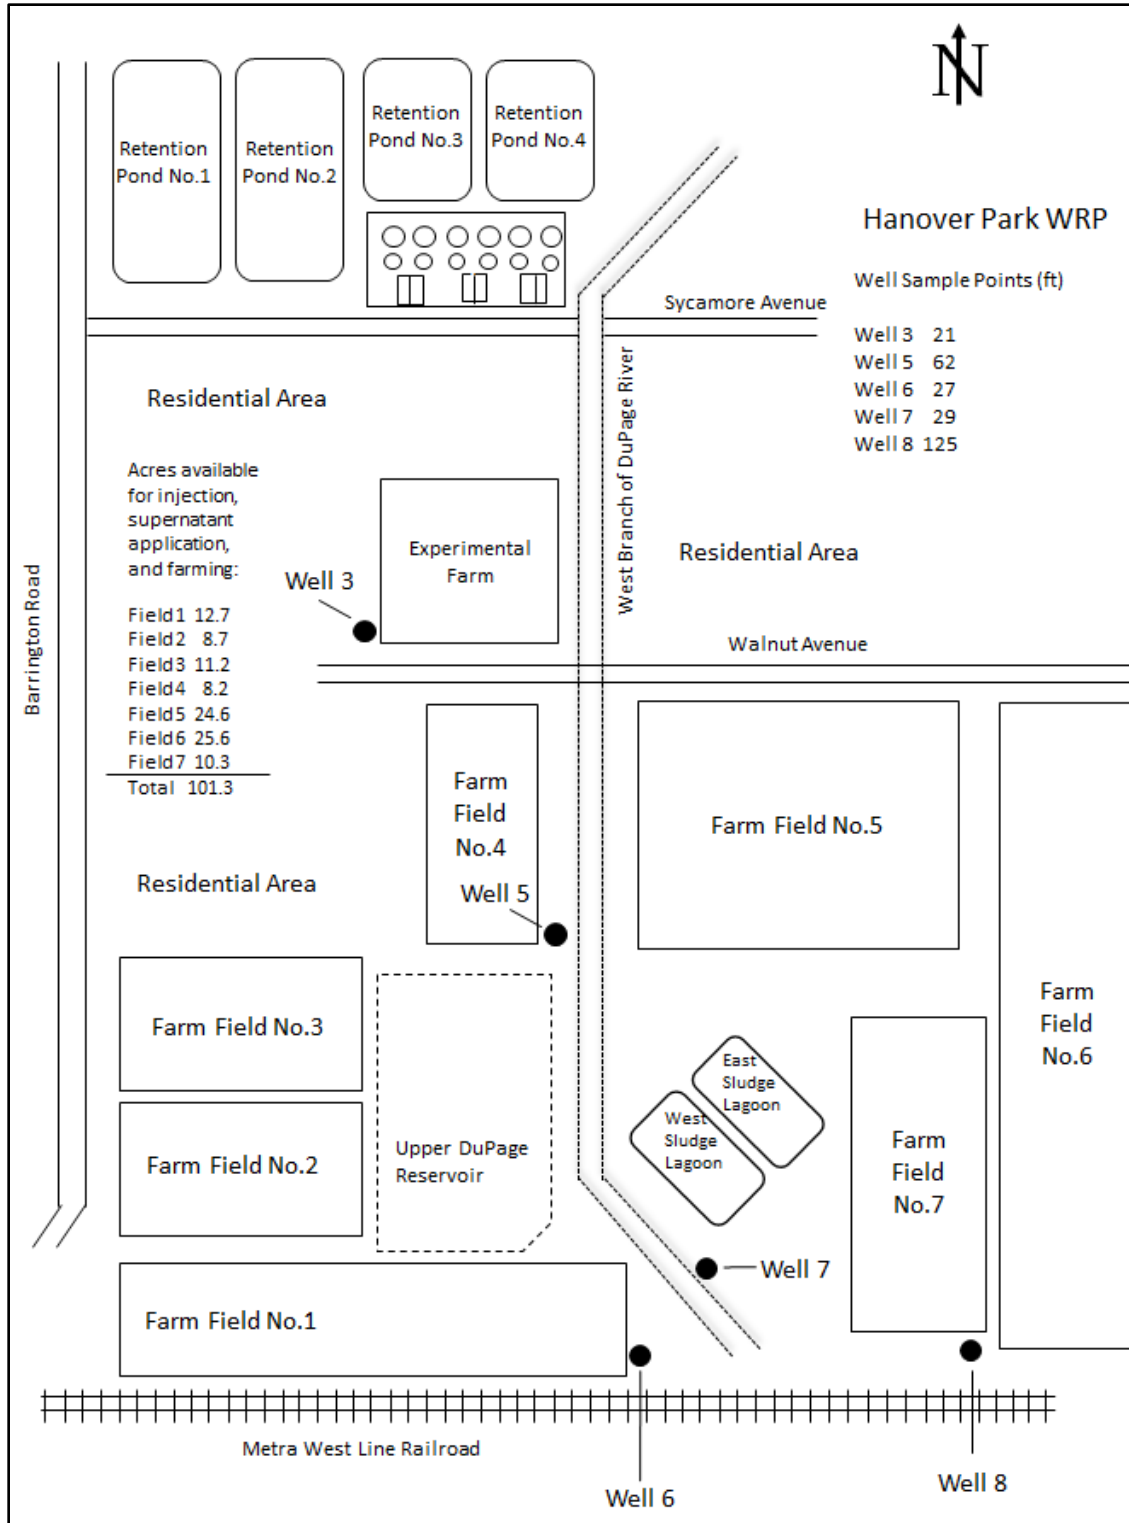
FIGURE 1 MAP OF FIELDS AND WELLS AT THE HANOVER PARK FISCHER FARM SITE OF THE METROPOLITAN WATER RECLAMATION DISTRICT OF GREATER CHICAGO

Drainage water (combined surface and subsurface) returned to the Hanover Park WRP from the farm fields was sampled in January, February, and March 2021, and data for these samples are presented in [Table 2](#). The volumes of drainage water returned to the WRP during the first quarter were estimated as 3.9, 6.4, and 26 million gallons in January, February, and March, respectively. There was no lagoon supernatant or biosolids applied to fields in the first quarter of 2021. Field and water monitoring locations are presented in [Figure 1](#).
